Pantex Plant

2016 Annual Progress Report

Remedial Action Progress

In Support of Hazardous Waste Permit 50284 and
Pantex Plant Interagency Agreement

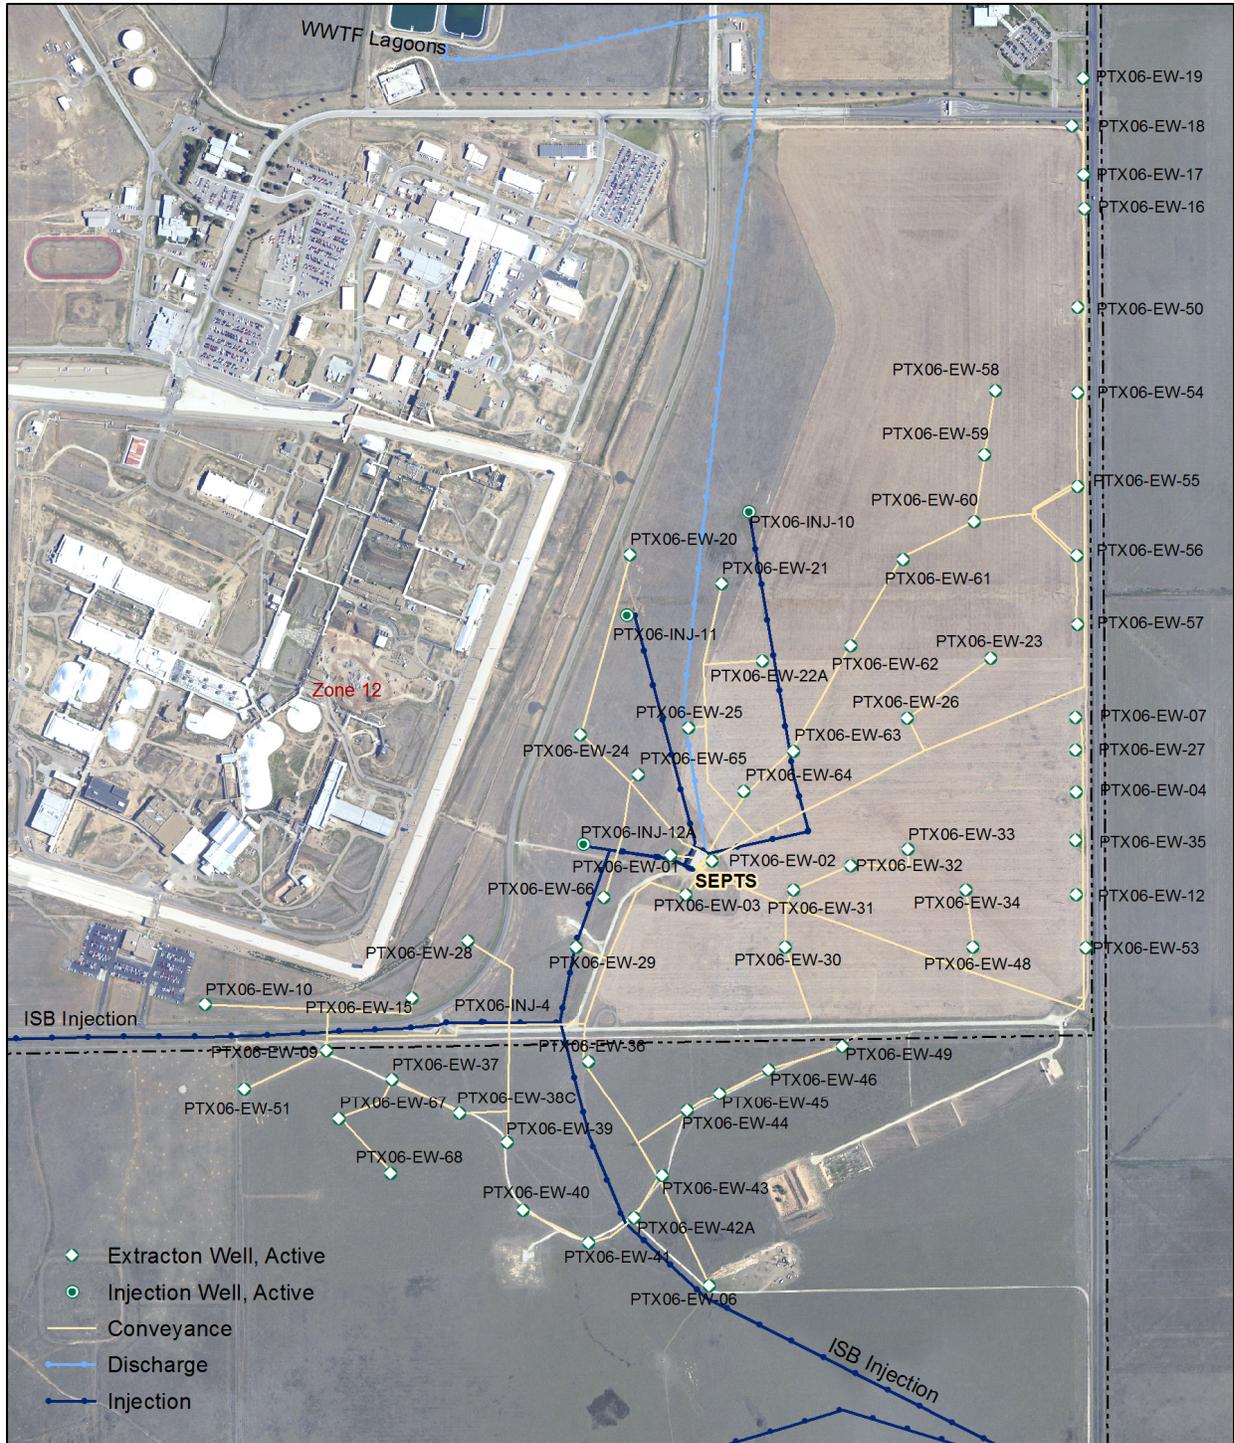
Figure 2-8. SEPTS Wells and Conveyance Lines

The SEPTS was originally installed at Pantex in 1995 as part of a treatability study. Since then, the pump and treat system has been expanded to meet the objectives of the environmental restoration project and final remedy established in the ROD and HW-50284. The SEPTS currently consists of a treatment building, 59 extraction wells, and 3 injection wells (see Figure 2-8). This system treats the water through a series of GAC vessels and ion exchange resin beds to reduce concentrations below the GWPS established in the ROD and HW-50284.

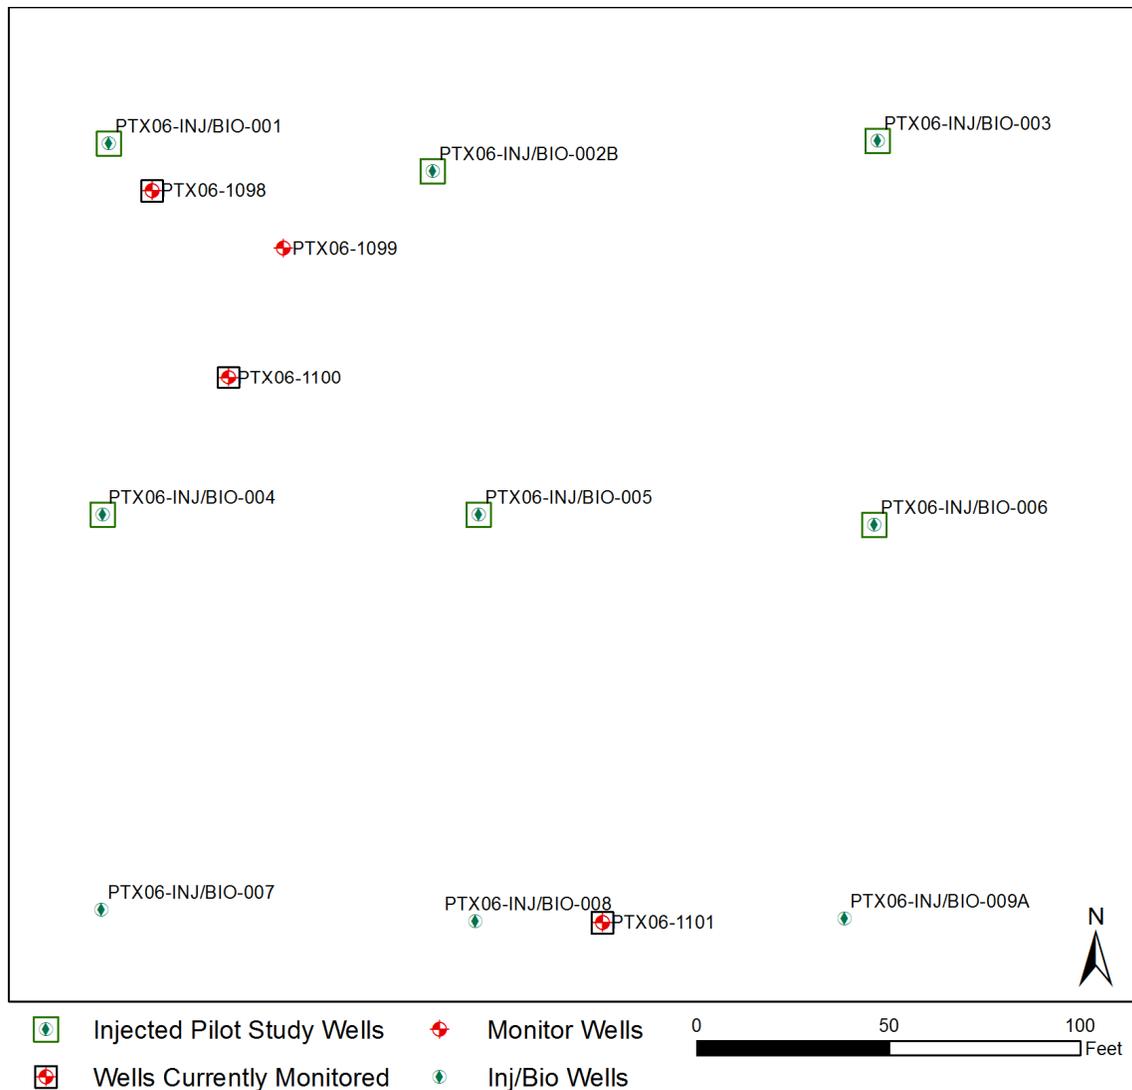
Figure 2-18. Pilot Study Wells

To evaluate the effectiveness of continued treatment with less frequent injections, the ISB Pilot Study data were evaluated. A pilot study was conducted from October 2005 through May 2007 to assist with determining the feasibility of in situ bioremediation using an emulsified vegetable oil. The pilot study results served as a basis for the design of the two ISB systems at Pantex. For the pilot study, nine ISB wells were installed in a square configuration (three rows of three wells) in an area that is northeast of the current Southeast ISB. The system was designed to treat hexavalent chromium, RDX, and other HE contaminants. Saturated thickness in the area was over 10 ft at the time of injection. Six ISB injection wells were used for this study, with an initial injection occurring in November–December 2005. Only three wells (PTX06-INJ/BIO-001, -002 and -005) were injected a second time in October–November 2006. Three downgradient ISB wells were used to initially monitor results of the injection. Four other monitoring wells were also installed to monitor results within and downgradient of the system. Three of those monitoring wells continue to be sampled by Pantex. Figure 2-18 depicts the pilot study wells.

Data at the monitoring wells installed at the Pilot Study indicated that complete treatment of HEs and hexavalent chromium occurred in less than two years at most downgradient wells, with the best results demonstrated at PTX06-1098, PTX06-1100, and PTX06-1101. PTX06-1099 did not treat as well possibly because of less favorable geologic conditions in that area preventing delivery of amendment to the maximum distance between wells. Pantex has continued monitoring the three monitoring wells listed above to determine long-term performance of the Pilot Study. All other well sampling was discontinued in 2008.

Where monitoring was continued at three wells, the results indicate that the ISB is continuing to treat RDX and hexavalent chromium with no further injections in the Pilot Study wells. RDX is no longer treated to GWPS (2 ug/L) at PTX06-1101, but concentrations remain low (<30 ug/L). Data collected from PTX06-1101 indicate that treatment started declining in 2013. Hexavalent chromium is being treated below the GWPS at all of the monitored wells. Results for these wells, along with the baseline concentrations is presented in Table 2-5.

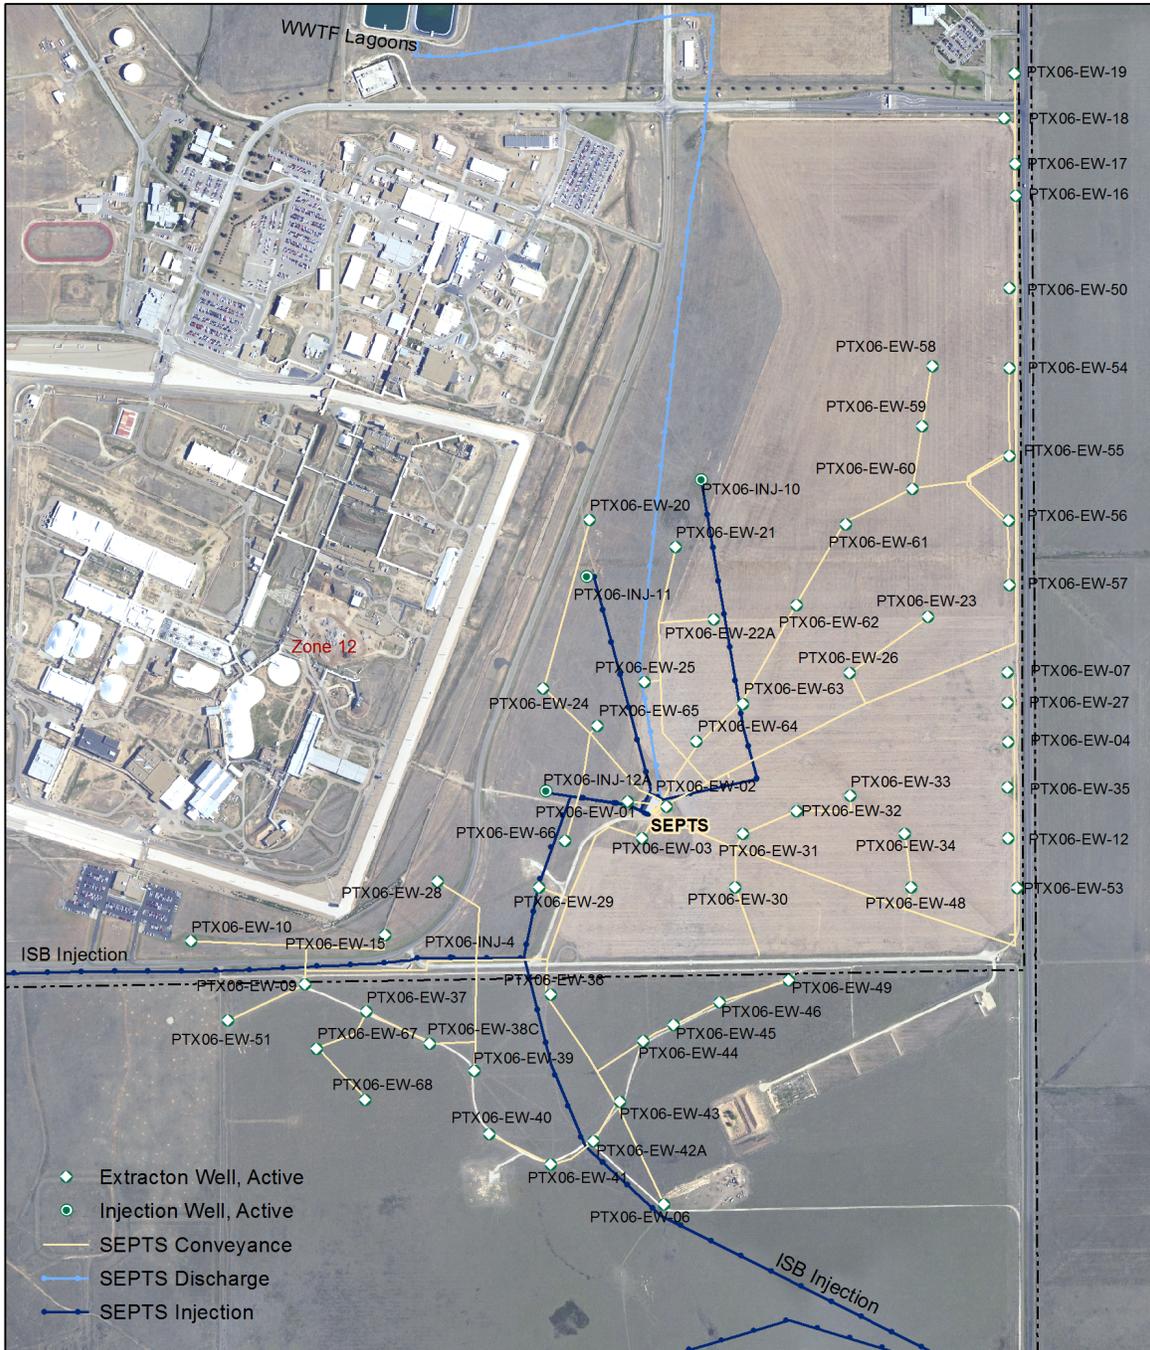
Figure 3-45. SEPTS Extraction Wells and Conveyance Lines

The objective of the SEPTS (Figure 3-45) is to remove contaminated perched groundwater and treat it for industrial and/or irrigation use. While the capability is being maintained for injection of treated water back into the perched zone, the intent is to permanently remove perched groundwater to gradually reduce the saturated thickness in this zone in order to achieve two important goals:

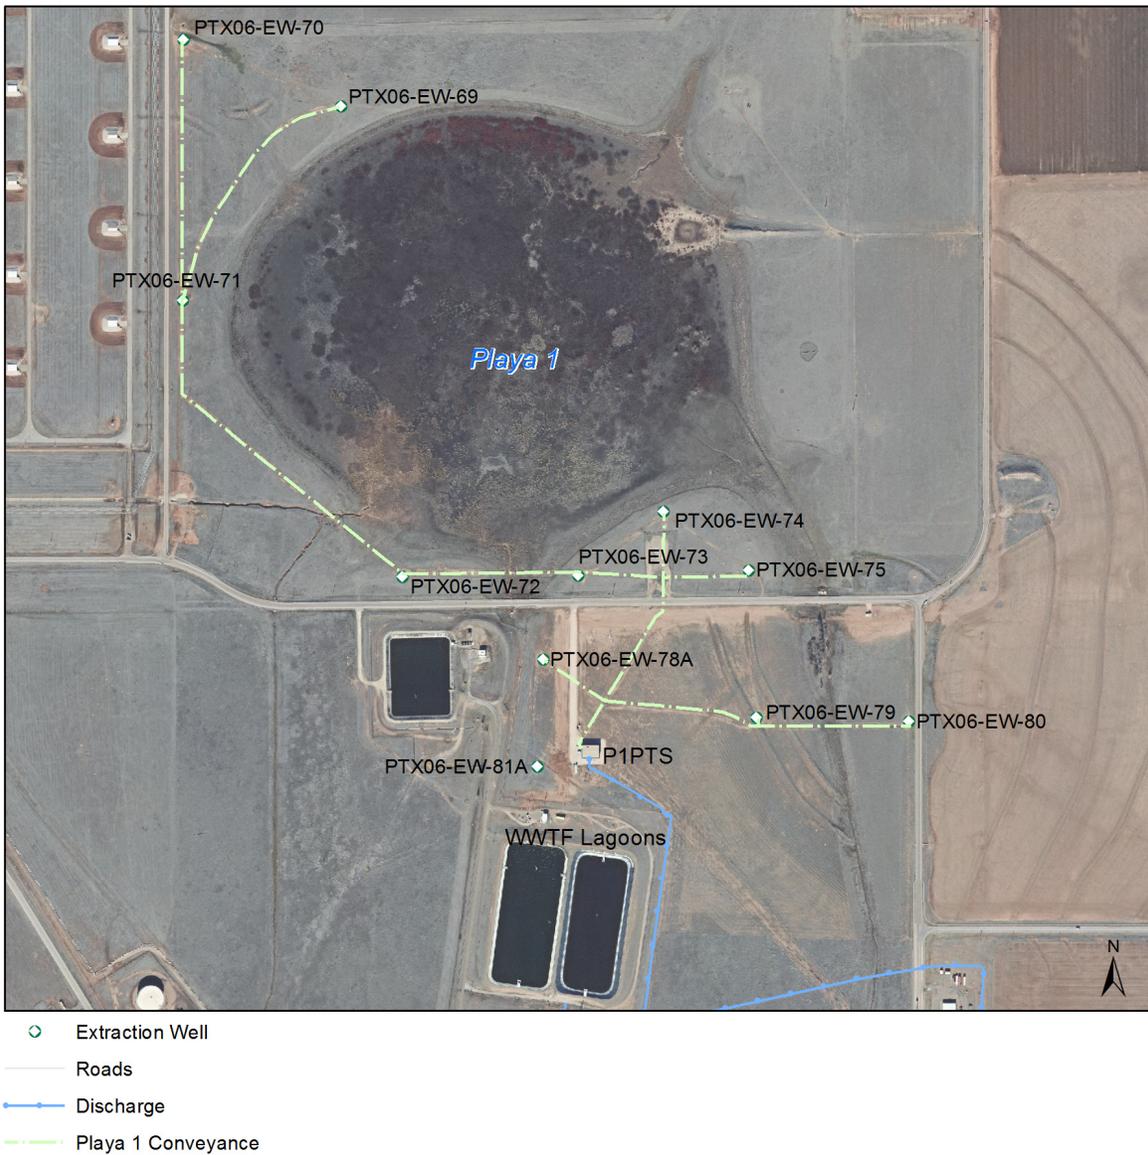
Figure 3-47. P1PTS Extraction Wells and Conveyance Lines

The P1PTS was completed during 2008 with operations starting in September 2008. This system extracts water from 10 wells near Playa 1 (see Figure 3-47) and treats the water through a series of GAC beds and ion exchange process units to reduce HEs and metals below the GWPS established in HW-50284 and the ROD. The objective of this system is to reduce the mound of perched groundwater associated with Playa 1, affecting the movement of the southeast plume by reducing the hydraulic head, as well as achieving mass removal.
