Pantex Plant

2017 Annual Progress Report

Remedial Action Progress

In Support of Hazardous Waste Permit 50284 and
Pantex Plant Interagency Agreement

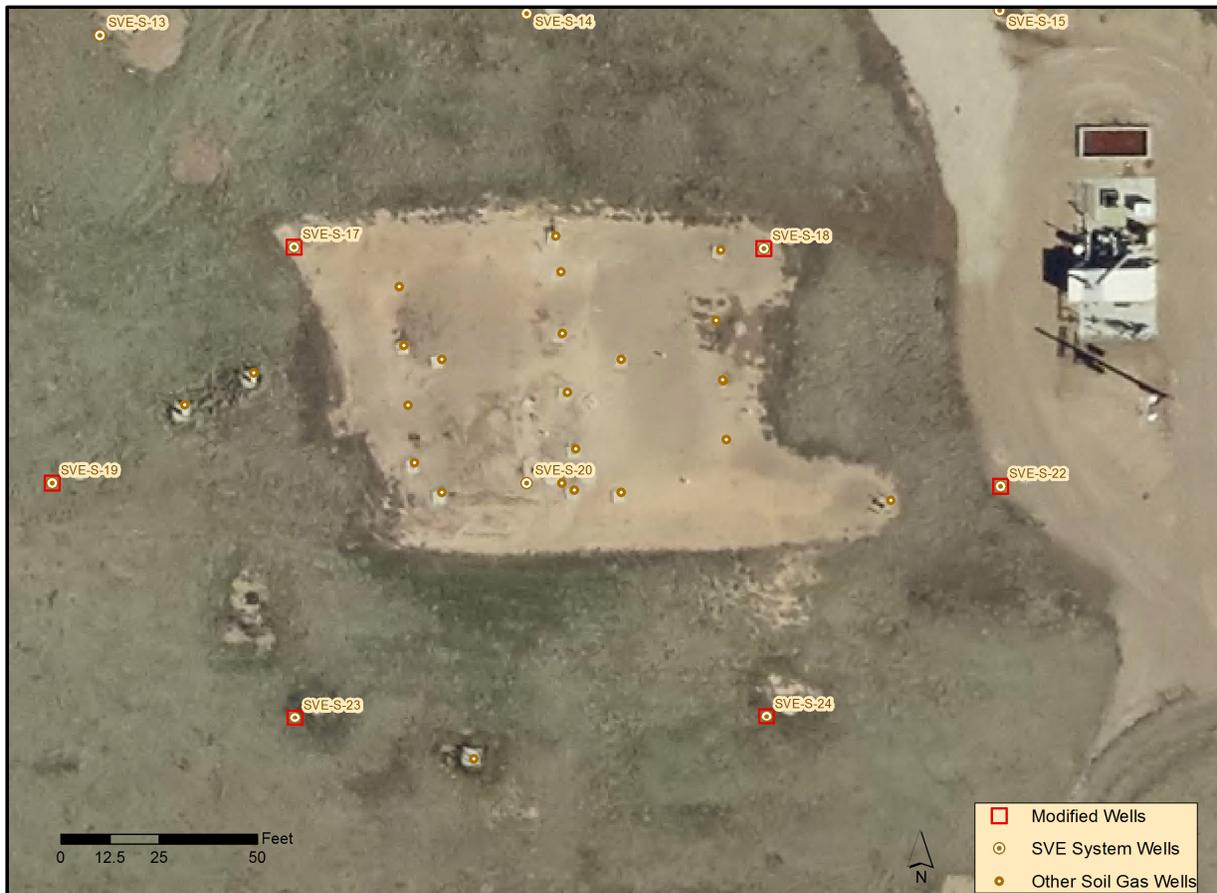
Figure 1-4. Burning Ground SVE System Wells and Modifications

The system was modified in May 2017 to increase air flow through the area surrounding SVE-S-20 to promote increased volatilization and bioremediation of the remaining soil NAPL. Six wells surrounding SVE-S-20 were modified to include above-ground piping that would allow air flow through the wells while the system is operating and pulling air from SVE-S-20 (see Figure 1-4). Pantex increased influent flow to the SVE by 40% (from 32 scfm to about 45 scfm), close to the maximum design flow of 50 scfm. Pantex also increased monitoring and evaluation of influent air to the SVE system and evaluation of the individual wells that were modified to gain baseline information as well as continued monitoring of changes. These evaluations will be used to help provide a path to closure of the Burning Ground SVE.

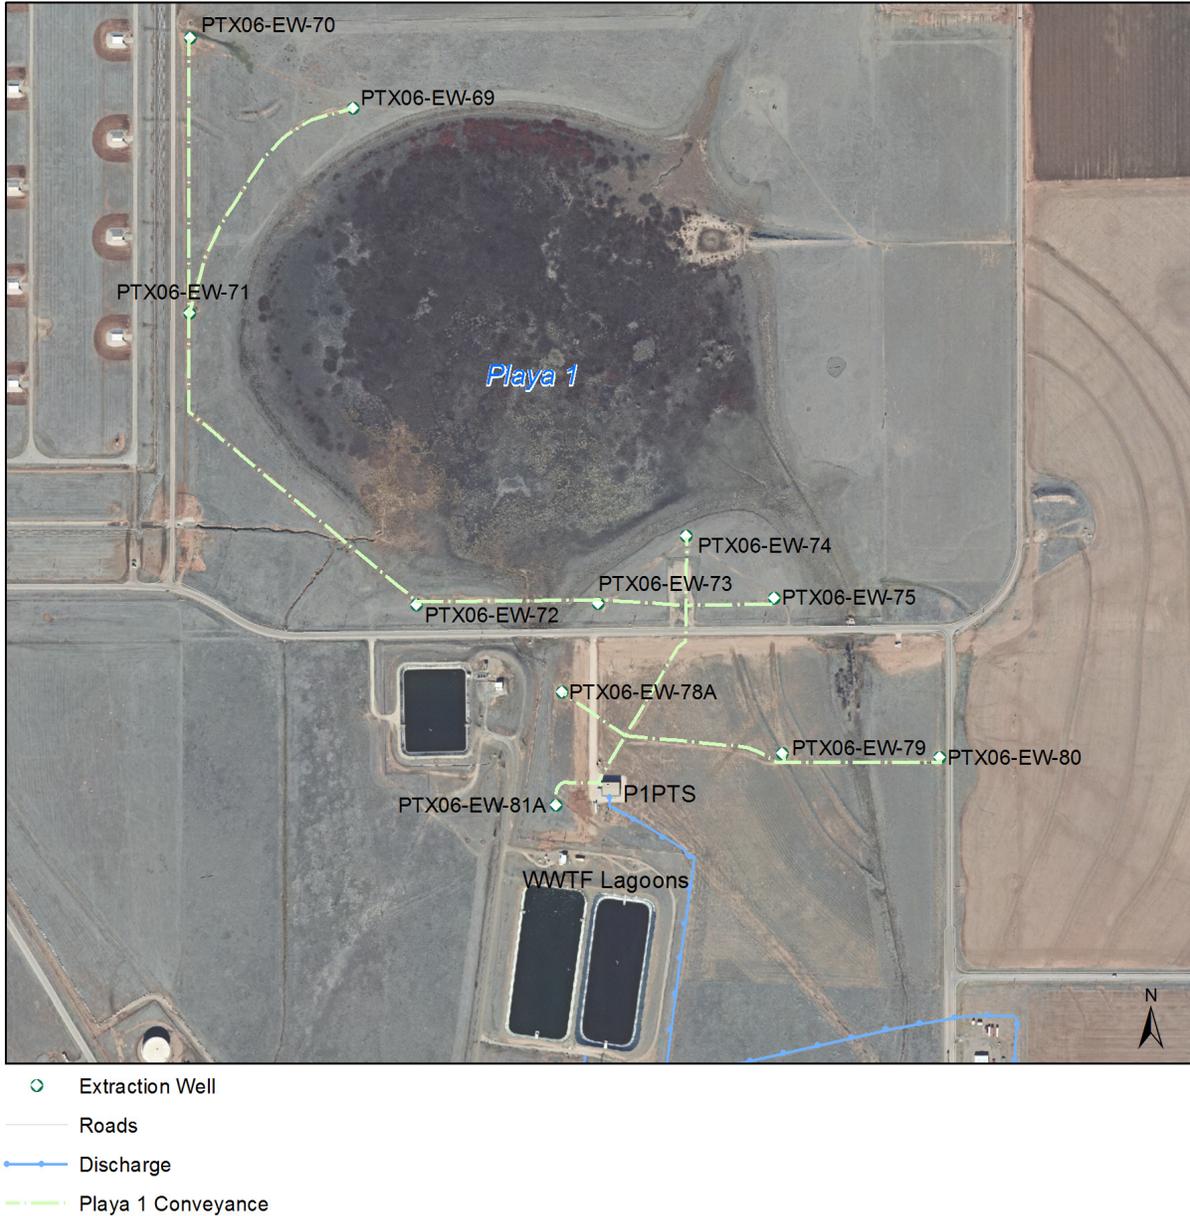
Figure 1-6. P1PTS Wells and Conveyance Lines

P1PTS beneficially uses all treated water by sending it through the WWTF to the irrigation system. Because this system does not have the capability to inject the treated water back into the perched aquifer, the treatment throughput must be temporarily adjusted or discontinued based on the demands of the WWTF or irrigation system. In 2017, a break occurred at the

irrigation system so all irrigation usage was discontinued. Pantex, operating under permit by the State of Texas, can release treated waste water to Playa 1. Pantex continues to release to Playa 1 while engineering studies, designs, and repairs are made. Pantex is also pursuing other reuse methods for the treated perched groundwater.

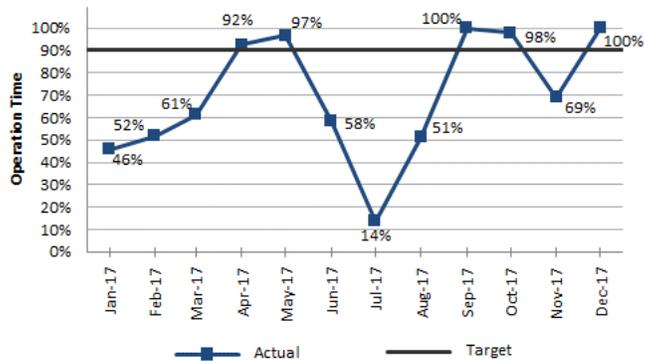
Figure 2-1. P1PTS Operation Time vs Target

The P1PTS operation was below the annual system operational goal by operating 277 days during 2017 with an average annual operational rate of 70%, based on total hours operated versus total possible operation time. The actual percentage monthly system operational time versus target is depicted in Figure 2-1.

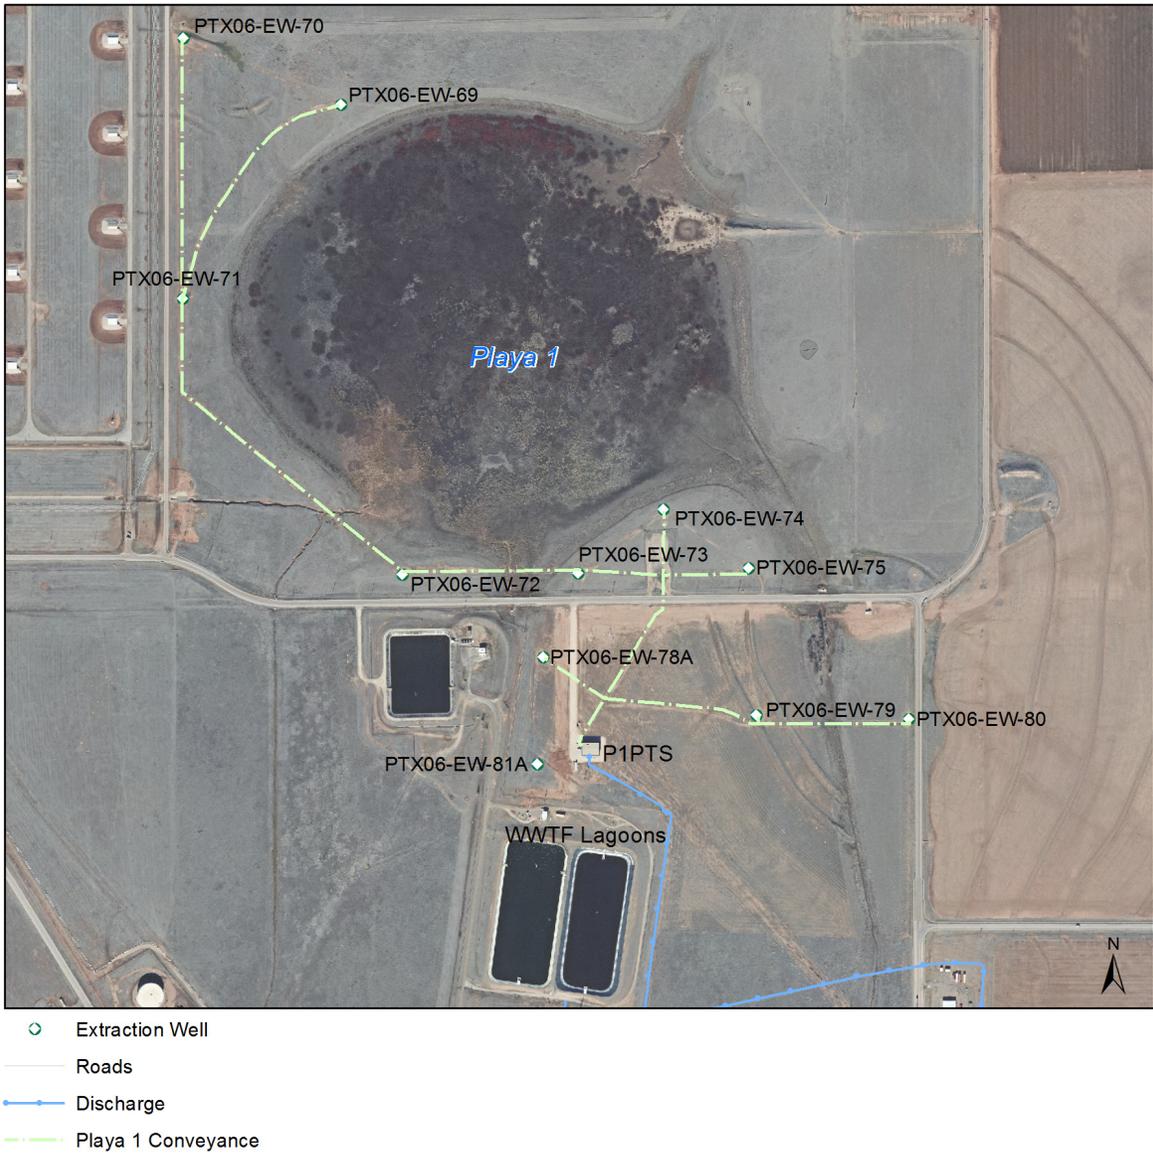
Figure 3-33. P1PTS Extraction Wells and Conveyance Lines

The P1PTS was completed during 2008 with operations starting in September 2008. This system extracts water from 10 wells near Playa 1 (see Figure 3-33) and treats the water through a series of GAC beds and ion exchange process units to reduce HEs and metals below the GWPS established in HW-50284 and the ROD. The objective of this system is to reduce the mound of perched groundwater associated with Playa 1, affecting the movement of the southeast plume by reducing the hydraulic head, as well as achieving mass removal.
