Pantex Plant

2020 Annual Progress Report

Remedial Action Progress

In Support of Hazardous Waste Permit 50284 and
Pantex Plant Interagency Agreement

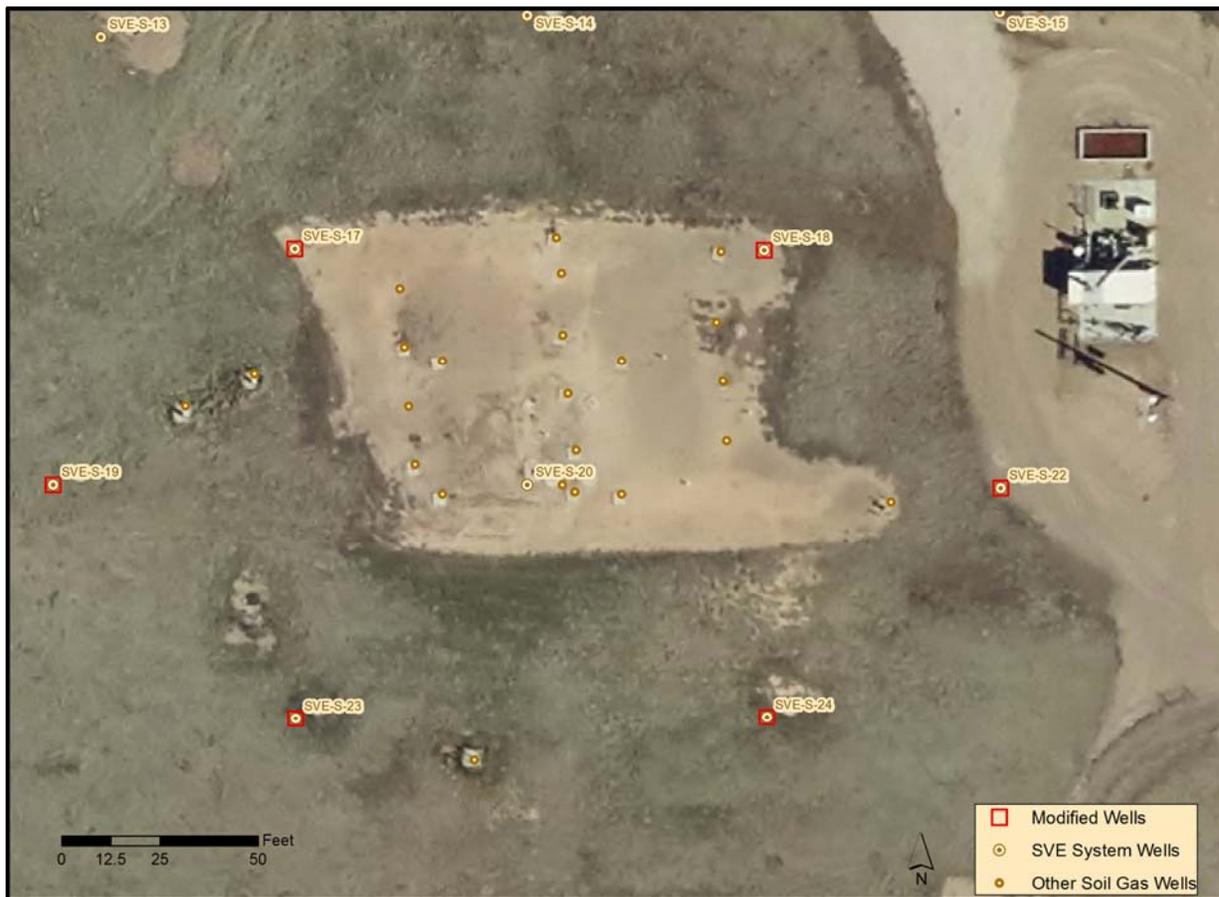
Figure 1-4. Burning Ground SVE System Wells and Modifications

The system was modified in May 2017 to increase air flow through the area surrounding SVE-S-20 and promote increased volatilization and bioremediation of the remaining soil NAPL. Six wells surrounding SVE-S-20 were modified to include aboveground piping that would allow airflow through the wells while the system is operating and pulling air from SVE-S-20 (see Figure 1-4). Pantex increased influent flow to the SVE by 40% from 32 standard cubic ft per minute (scfm) to approximately 45 scfm, close to the maximum design flow of 50 scfm. To gain baseline information, Pantex also increased monitoring and evaluation of influent air to the SVE system and of the individual wells that were modified. The evaluations, presented in Section 4, will be used to help provide a path to closure of the Burning Ground SVE.

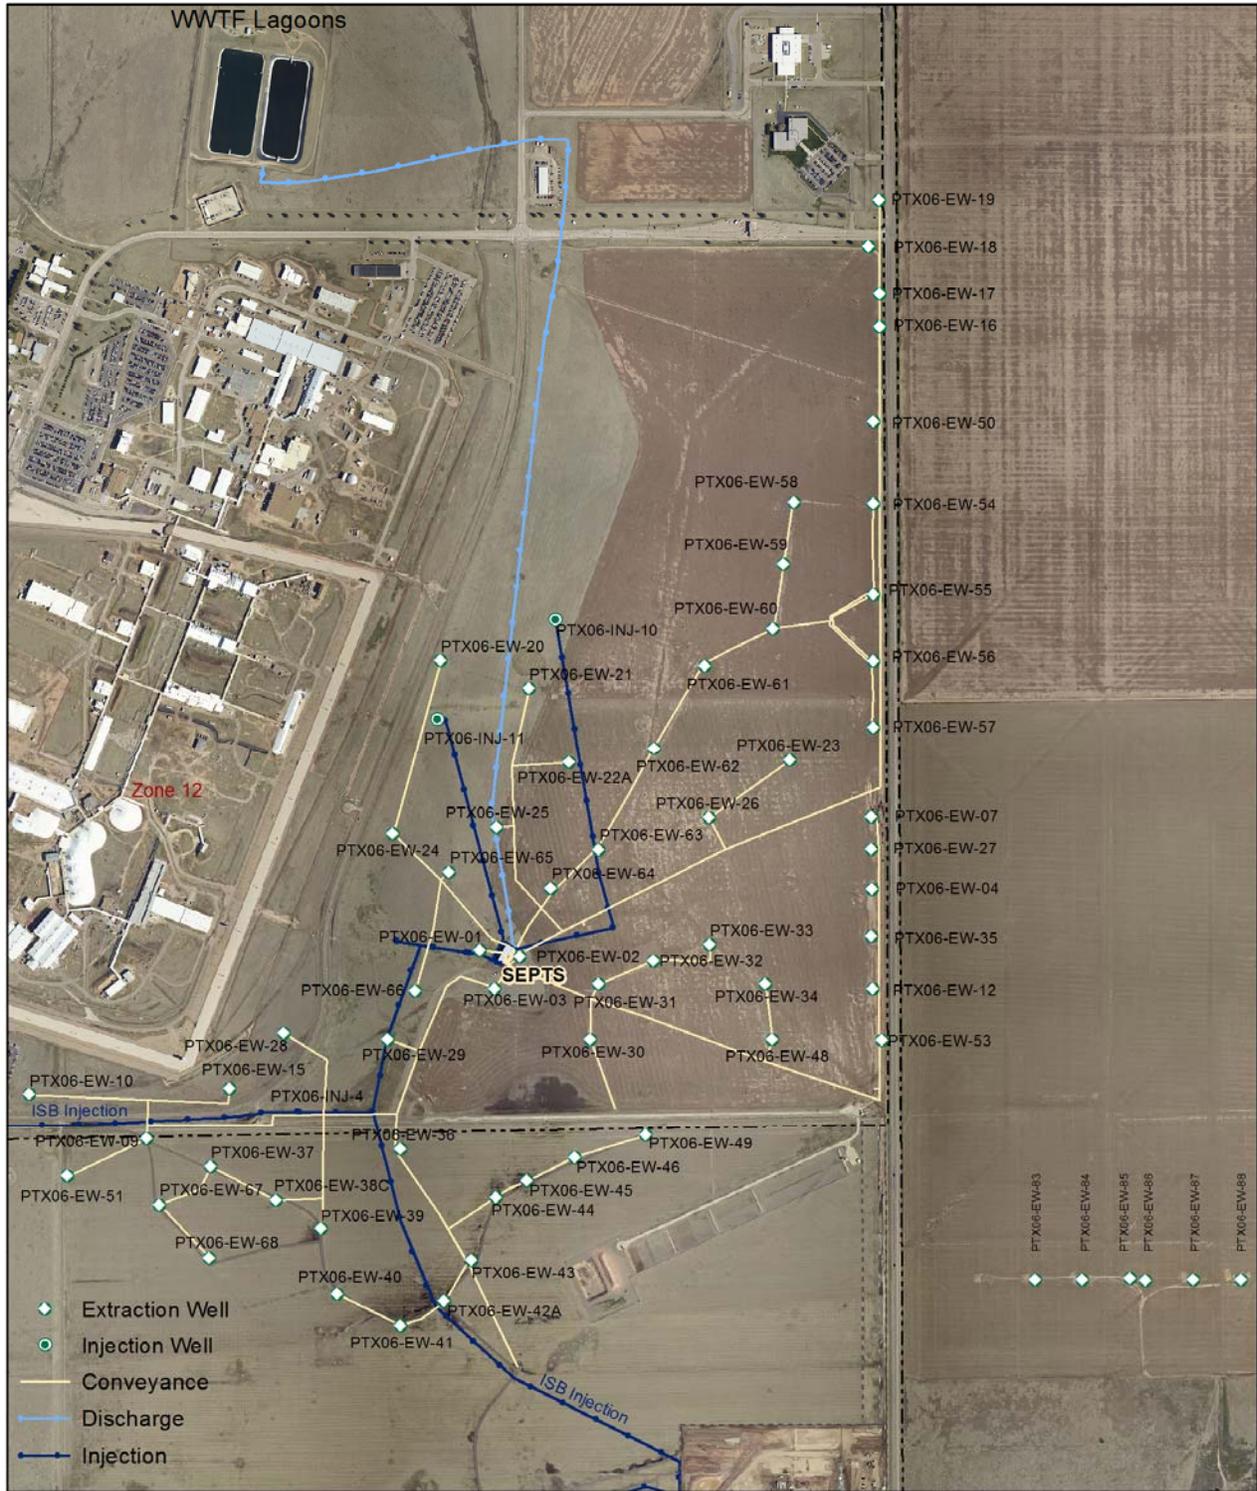
Figure 1-7. SEPTS Wells and Conveyance Lines

The SEPTS currently consists of a treatment building, 64 active extraction wells, and 1 injection well (see Figure 1-7). Six new extraction wells were drilled east of FM 2373 to provide additional control of plume movement to the southeast. The wells were tied-in to the SEPTS and started operating by May 2019.

The objective of the SEPTS (see Figure 1-7) is to remove contaminated perched groundwater and treat it for industrial and/or irrigation use. While the capability is being maintained for injection of treated water back into the perched zone, the intent is to permanently remove perched groundwater to gradually reduce the saturated thickness in this zone and to achieve the following two important goals:

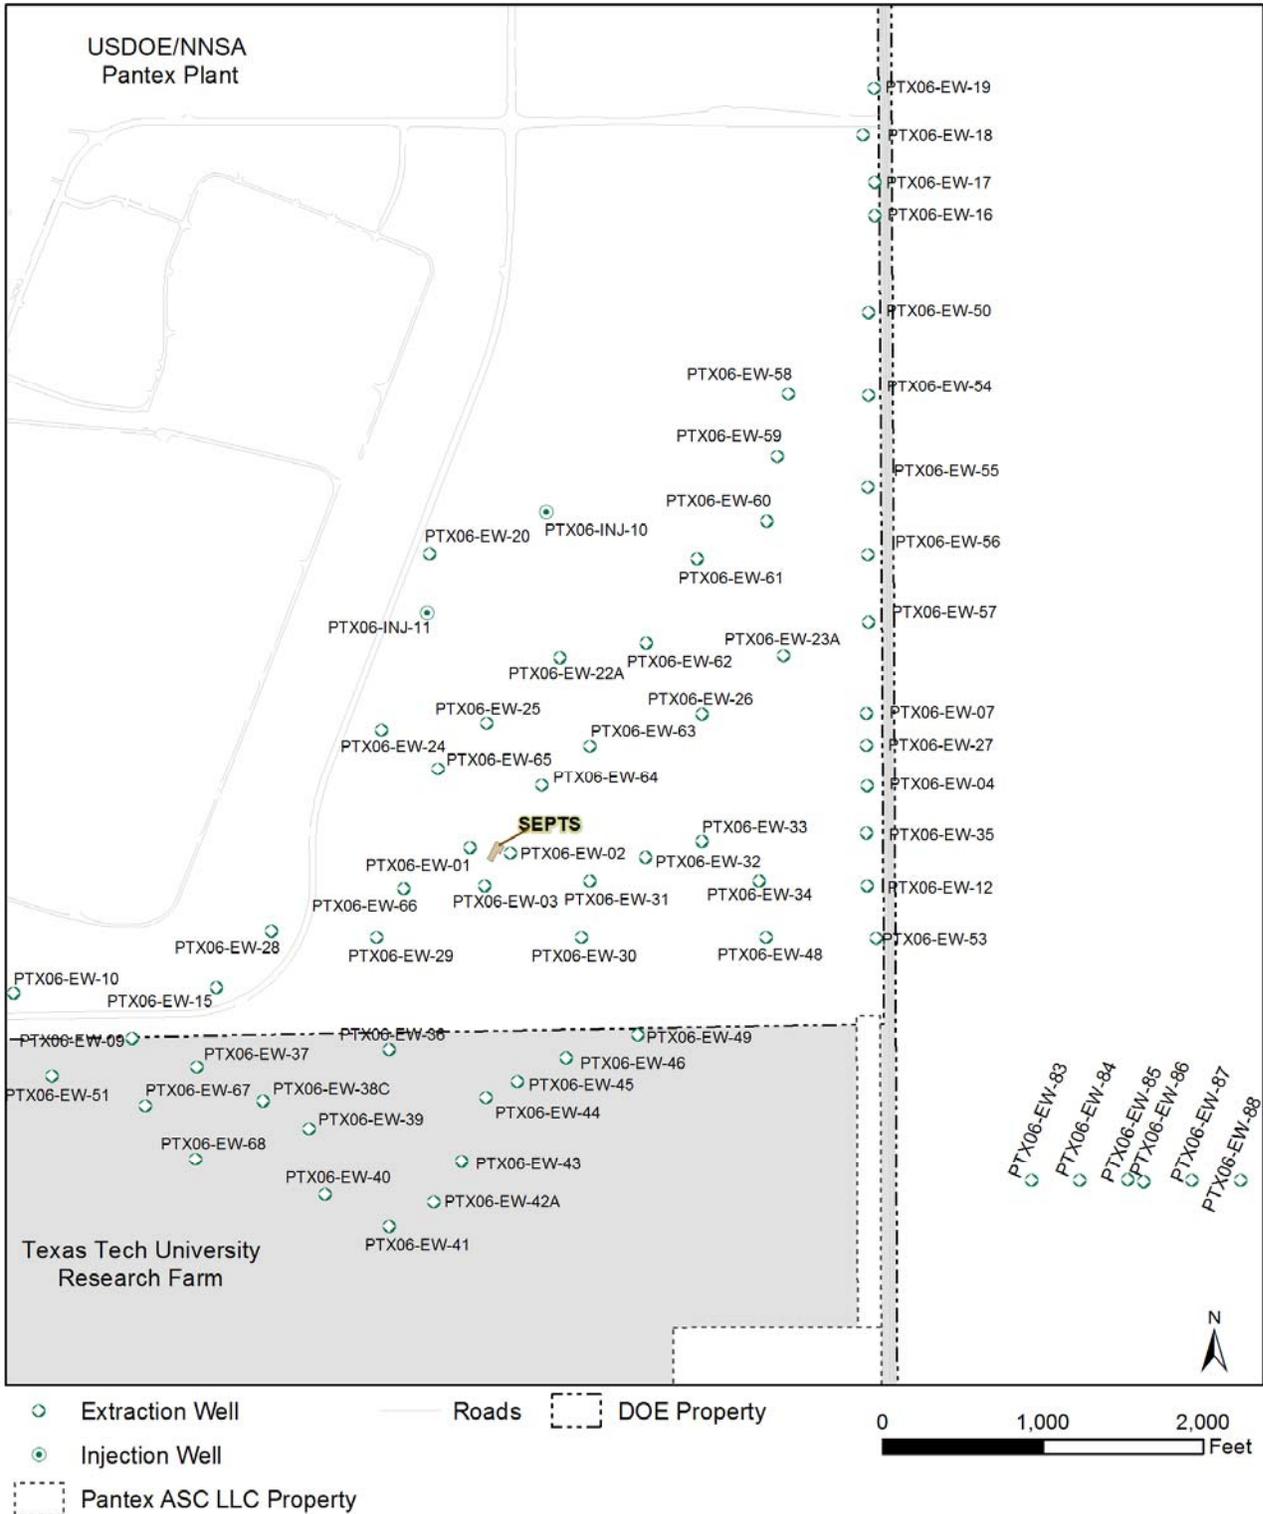
Figure 1-14. SEPTS Wells

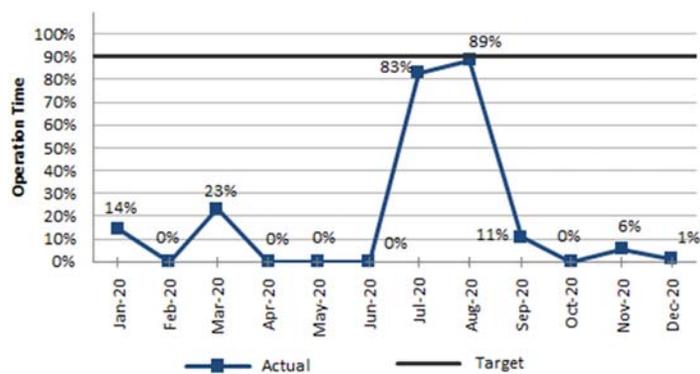
Figure 2-1. P1PTS Operation Time vs Target

The P1PTS operated 78 days during 2020 with an average annual operational rate of 22%, based on total hours operated versus total possible operation time. The actual percentage of monthly system operational time versus the target percentage is depicted in Figure 2-1.

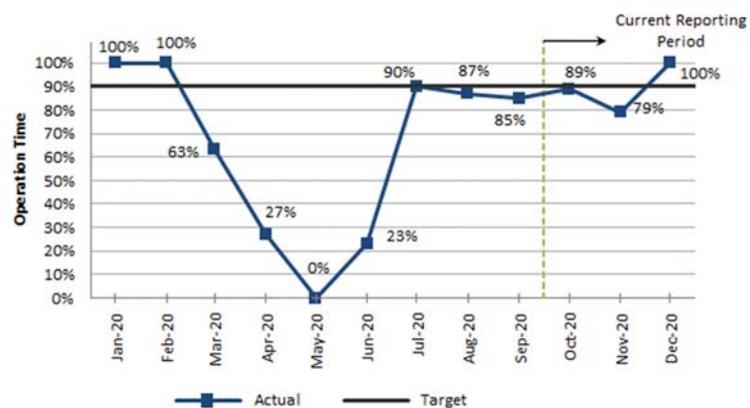
Figure 2-7. SEPTS Operation Time vs Target

During 2020, the SEPTS operated all or part of 264 days with an average operational rate of 70%, based on total hours operated versus total possible operation time. The percent operation time (i.e., hours per day) versus the target operation time is depicted in Figure 2-7.

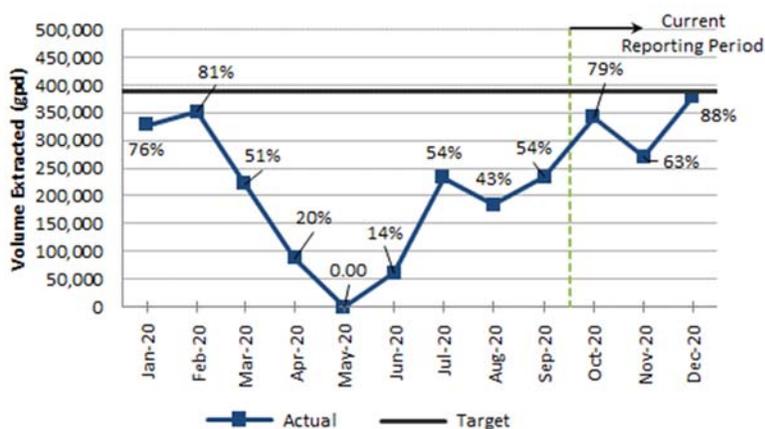
Figure 2-11. SEPTS Average GPD and % Capacity

Figure 2-11 reflects the SEPTS’s overall efficiency considering system and well operation. The figure depicts the average daily treatment rate in gpd by month, the target, and the percentage of total capacity achieved at the SEPTS. In 2020, the SEPTS treated an annual average of approximately 224,318 gpd (about 52% of design capacity), based on total possible hours of operation and total inflow from the well field.

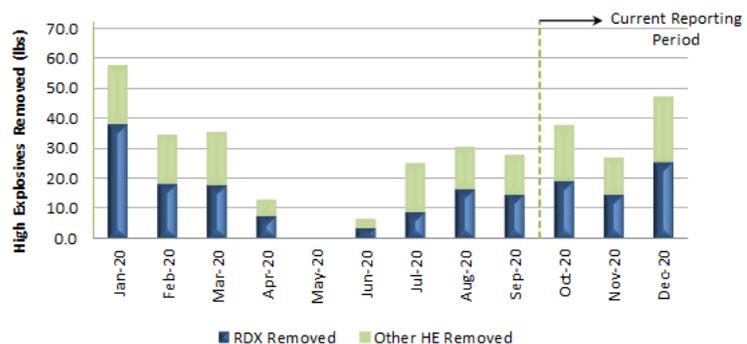
Figure 2-14. SEPTS High Explosive Mass Removed by Month

The total mass removed for hexavalent chromium and HEs, by month, is depicted in Figure 2-13 and Figure 2-14. The average removal rate of hexavalent chromium was 0.5 lbs/Mgal of water, and the average removal rate for HEs was 3.8 lbs/Mgal of water.
