Pantex Plant

2021 Annual Progress Report

Remedial Action Progress

In Support of Hazardous Waste Permit 50284 and
Pantex Plant Interagency Agreement

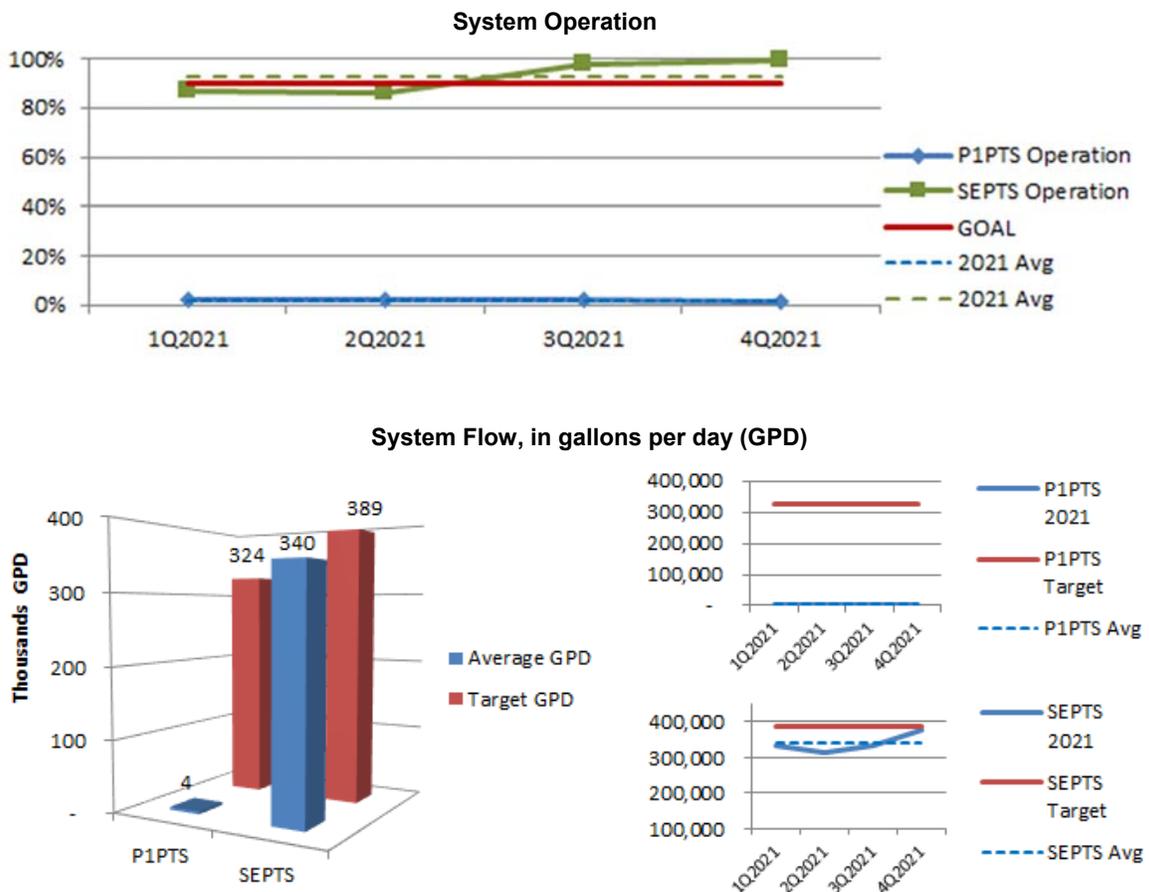
Figure E-1. Pump and Treat System Performance

Treatment throughput has not been a primary goal after the break at the irrigation system’s filter bank occurred in June 2017; however, the 90% goal is still depicted in the graphs and throughput is evaluated. When the systems operated, daily treatment throughput varied due to reduced flow to the Wastewater Treatment Facility (WWTF) and to Playa 1.

The P1PTS was heavily impacted by the irrigation system’s shutdown after the filter bank break. Treated water from P1PTS can only be released to the WWTF, so flows are impacted when the WWTF cannot receive the water. Treated water from the WWTF is now routed to Playa 1 until repairs at the irrigation system are complete. Since release to Playa 1 is limited by permit, the P1PTS was shut down. SEPTS remained operational with higher flows throughout most of 2021 due to the operation of P1PTS one week per quarter. The SEPTS operation focused on removing water in high-priority well locations to control plume movement to the southeast.

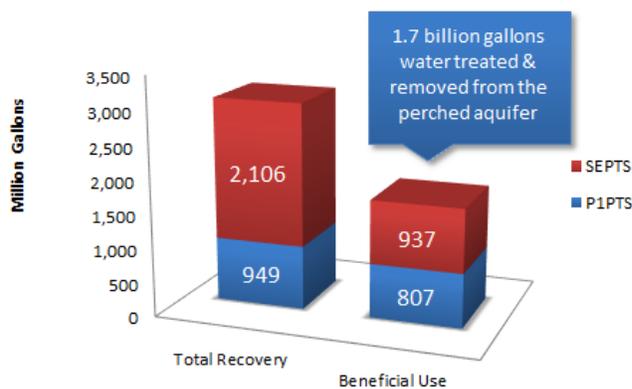
Figure E-2. Pump and Treat Recovery

Overall, the systems have operated efficiently to treat contamination and reduce saturated thickness. As depicted in Figure E-2, Pantex has treated over 3.0 billion gallons since the startup of the systems, with more than 1.7 billion gallons removed and beneficially used. Pantex continues to reduce reliance on the injection of treated water, where possible and as recommended in the first five-year review (FYR), Pantex has implemented

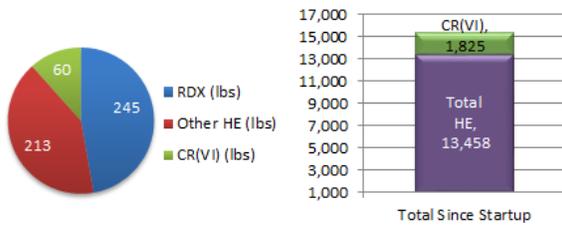
Figure E-3. SEPTS Mass Removal

The SEPTS has been operating longer than the P1PTS, and the greatest concentrations of HEs are found in the SEPTS's extraction well field, so mass removal is much higher at

that system. During 2021, the SEPTS removed approximately 518 pounds (lbs) of contaminants, and the P1PTS removed approximately 0.3 lbs of contaminants.

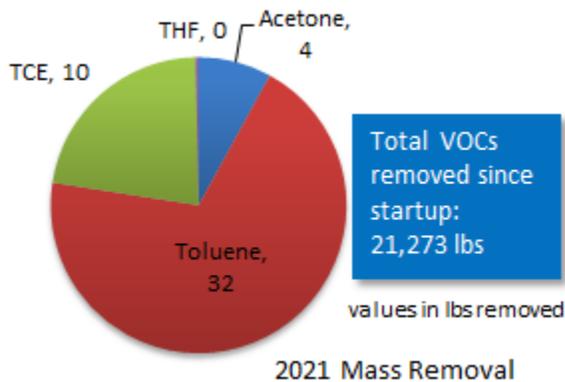
Figure E-5. Burning Ground SVE Mass Removal

In early 2012, a small-scale catalytic oxidation (CatOX) SVE system was installed at the Burning Ground to address the reduced soil gas plume at the Burning Ground. This small-scale system focuses on treating residual non-aqueous phase liquid (NAPL) and soil gas at soil gas well SVE-S-20.

The system was variably operated in 2021 due to shut down for repairs and planned

pulsing periods, with an overall operation of approximately 21%. The system was shut down in December 2020 for the first planned pulsing period and was restarted in April 2021. The system operated approximately four months due to shut down for repairs. The system was shut down again at the beginning of October for the next pulsing period. Figure E-5 presents the mass removal calculated

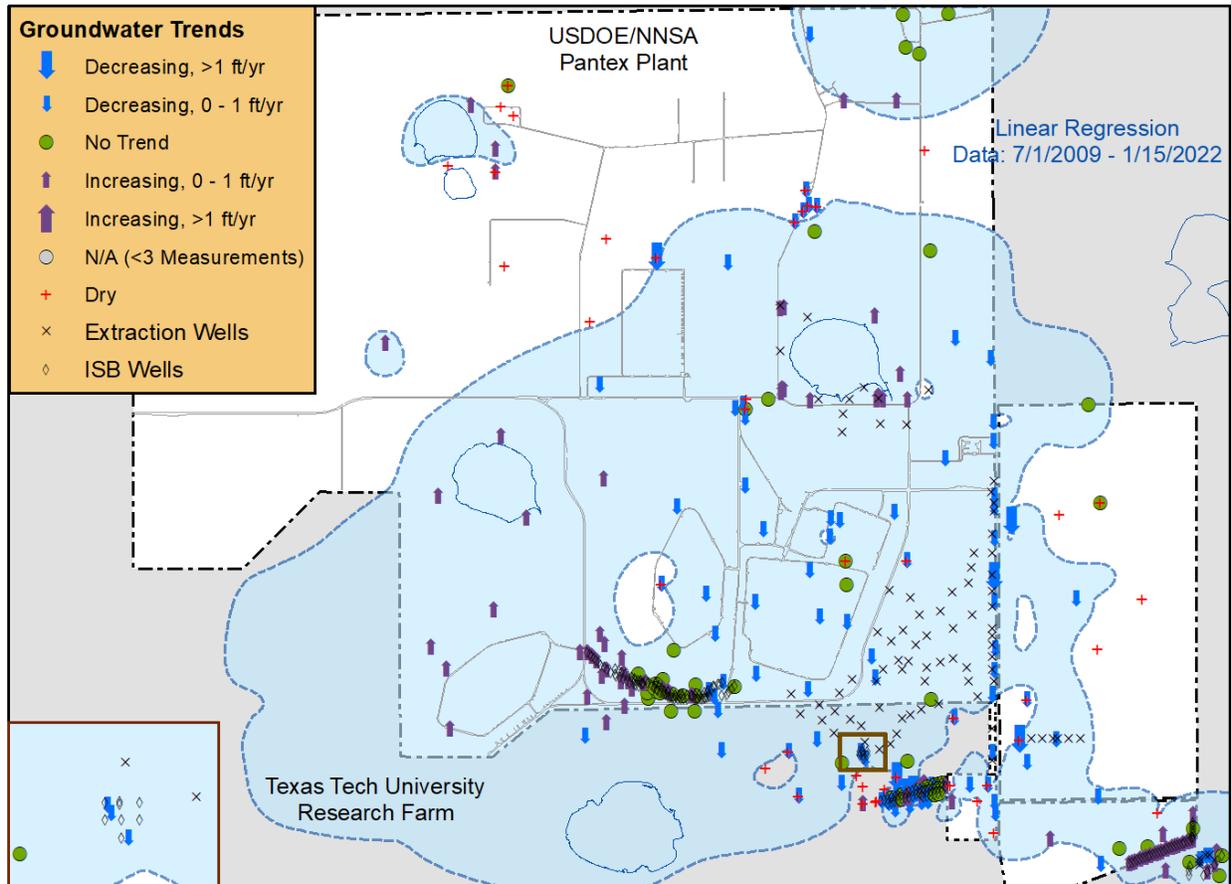
Figure E-6. Perched Aquifer Water Level Trends

Overall, calculated concentration and groundwater level trends were consistent with expected conditions defined in the LTM Design Report. Figure E-6 depicts recent water level trends in the perched aquifer long-term monitoring (LTM) wells.

A total of 46 monitoring wells were expected to have decreasing water level trends, limited water, or dry conditions, as defined in the LTM Design Report. Of these 46 wells, 23 exhibited conditions inconsistent with expected conditions or trends, including 13 wells with recently increasing trends and 8 wells with recent “no trend” conditions. In addition, seven wells are exhibiting apparent long-term increasing trends. Most of these wells exhibited recently increasing trends in response to increased precipitation and resulting recharge through unlined ditches and playas along with decreased extraction of perched groundwater. The long-term water level trend is decreasing or not trending for 21 of these wells, and water levels are expected to continue declining.

Four of the remaining wells that have been historically dry or had limited water are now showing fluctuating water levels. The appearance of water in these wells is associated with recharge of stormwater runoff and does not represent the movement of impacted perched groundwater into these areas.

The remaining three wells are located near Playa 1, where reduced extraction of perched groundwater by P1PTS combined with the release of treated water to the playa and increased recharge through the playa from above-normal precipitation, have collectively resulted in short-term increasing trends in these wells. These short-term trends are expected to reverse when the new irrigation system begins operation.

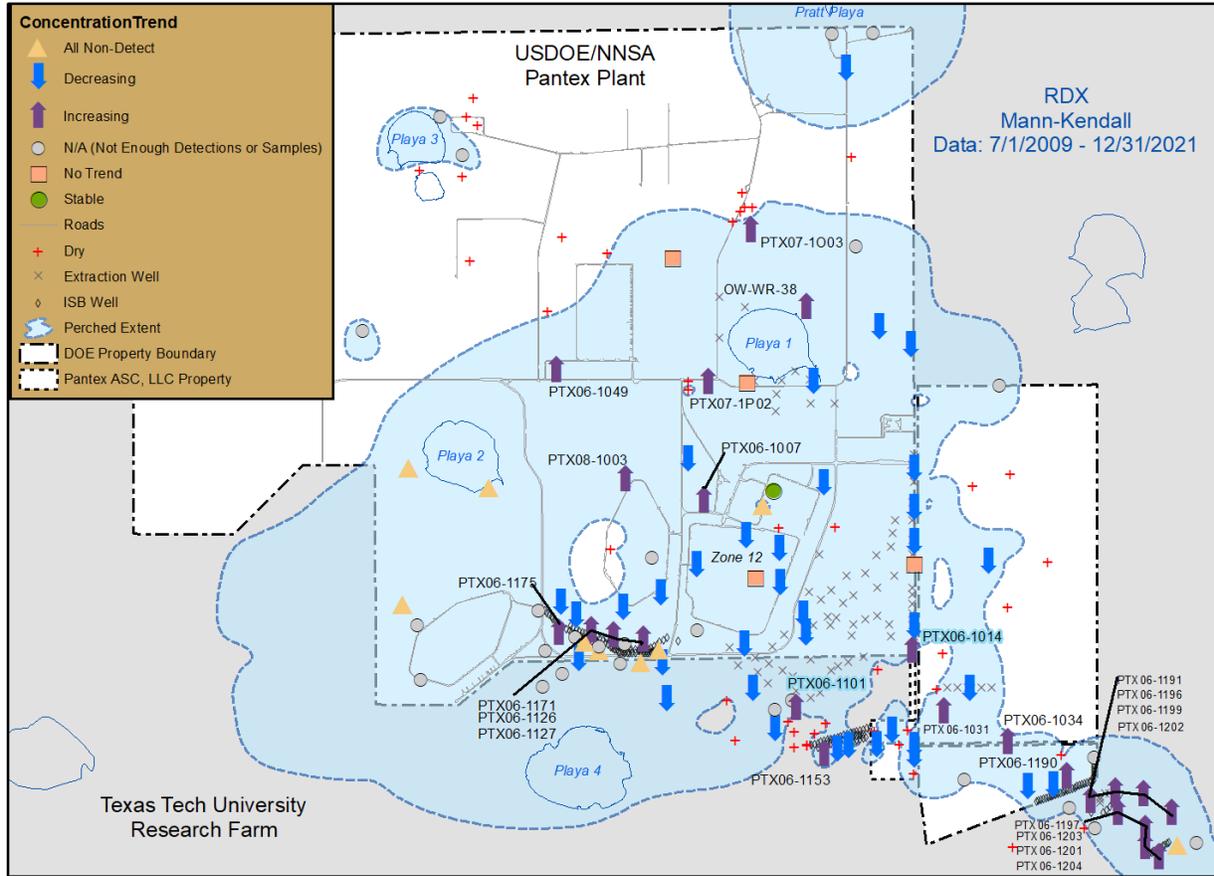
Figure E-7. RDX Trends in the Perched Aquifer

Of the 130 monitoring wells with expected COC concentration conditions defined in the LTM Design Report, 34 wells did not exhibit trends consistent with expected conditions for the four major COCs (i.e., RDX, hexavalent chromium, TCE, and perchlorate). These trends are anticipated to meet expected conditions as corrective actions continue to operate in the perched aquifer. Figure E-7 depicts RDX trends since the start of the full remedial action in the perched aquifer LTM wells. Wells in the southeast lobe of the perched aquifer are not yet under the influence of remedial action.

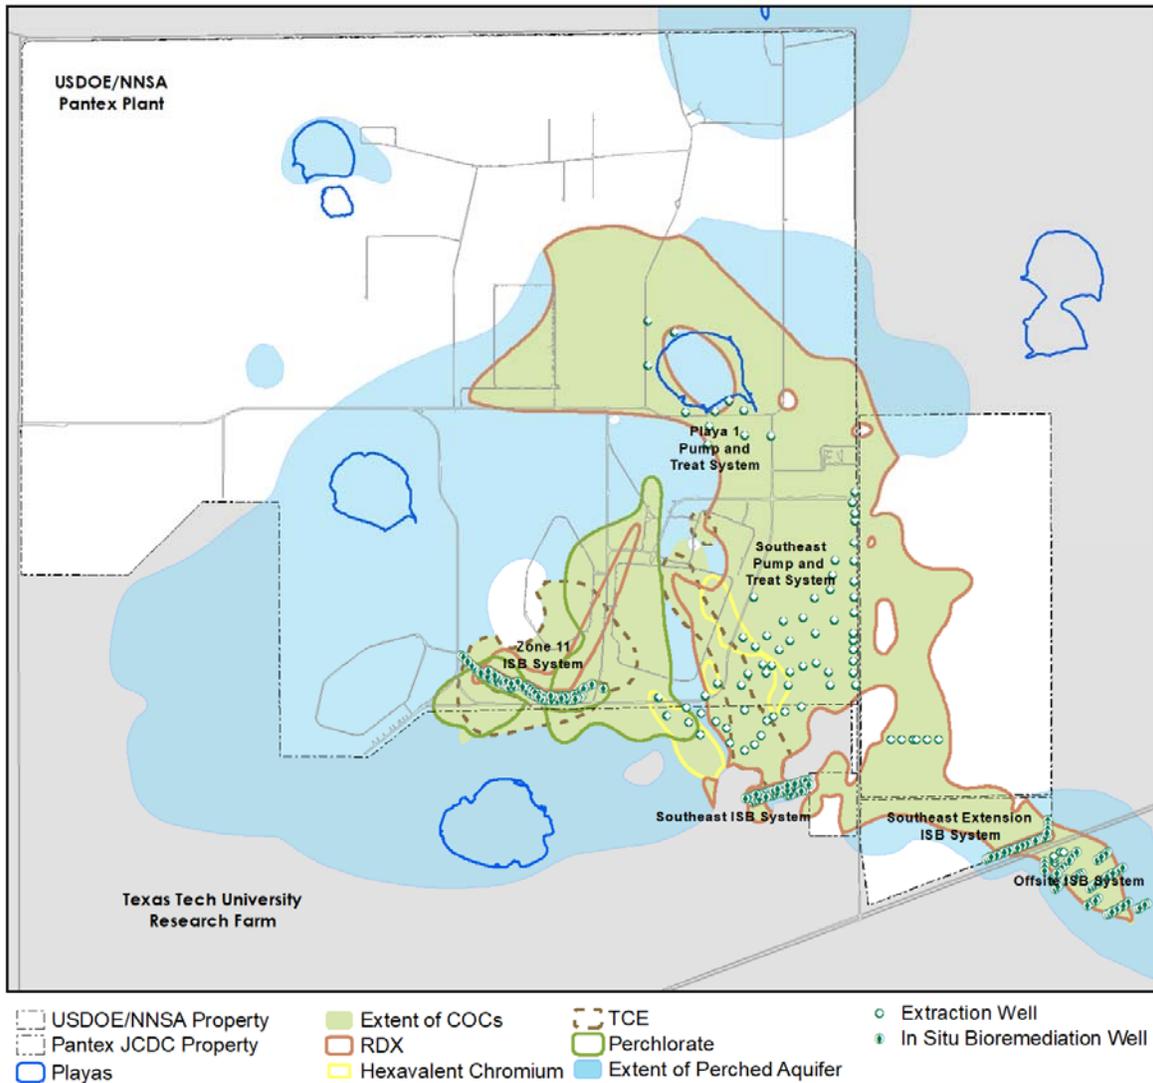
Figure E-8. Major COC Plumes in the Perched Aquifer

Generally, 2021’s plume shapes are similar to 2009’s COC plumes. The greatest differences between the shapes are due to changes in the extent of perched saturation in the perched groundwater’s extreme southeast lobe and HE plumes in that area because of the new information collected from recently drilled wells. A shift in the hydraulic gradient eastward in the area between the southern parts of Zones 11 and 12 has allowed perchlorate and TCE to migrate east and southeast towards the SEPTS well field; portions of the perchlorate plume are being actively remediated by the SEPTS at this time. Other changes in plume size and shape were caused by general plume movement downgradient, slight changes in concentrations that define the boundaries of the plumes, newly installed wells, or effects of the pump and treat systems.

Major COC plumes of interest are depicted in Figure E-8.

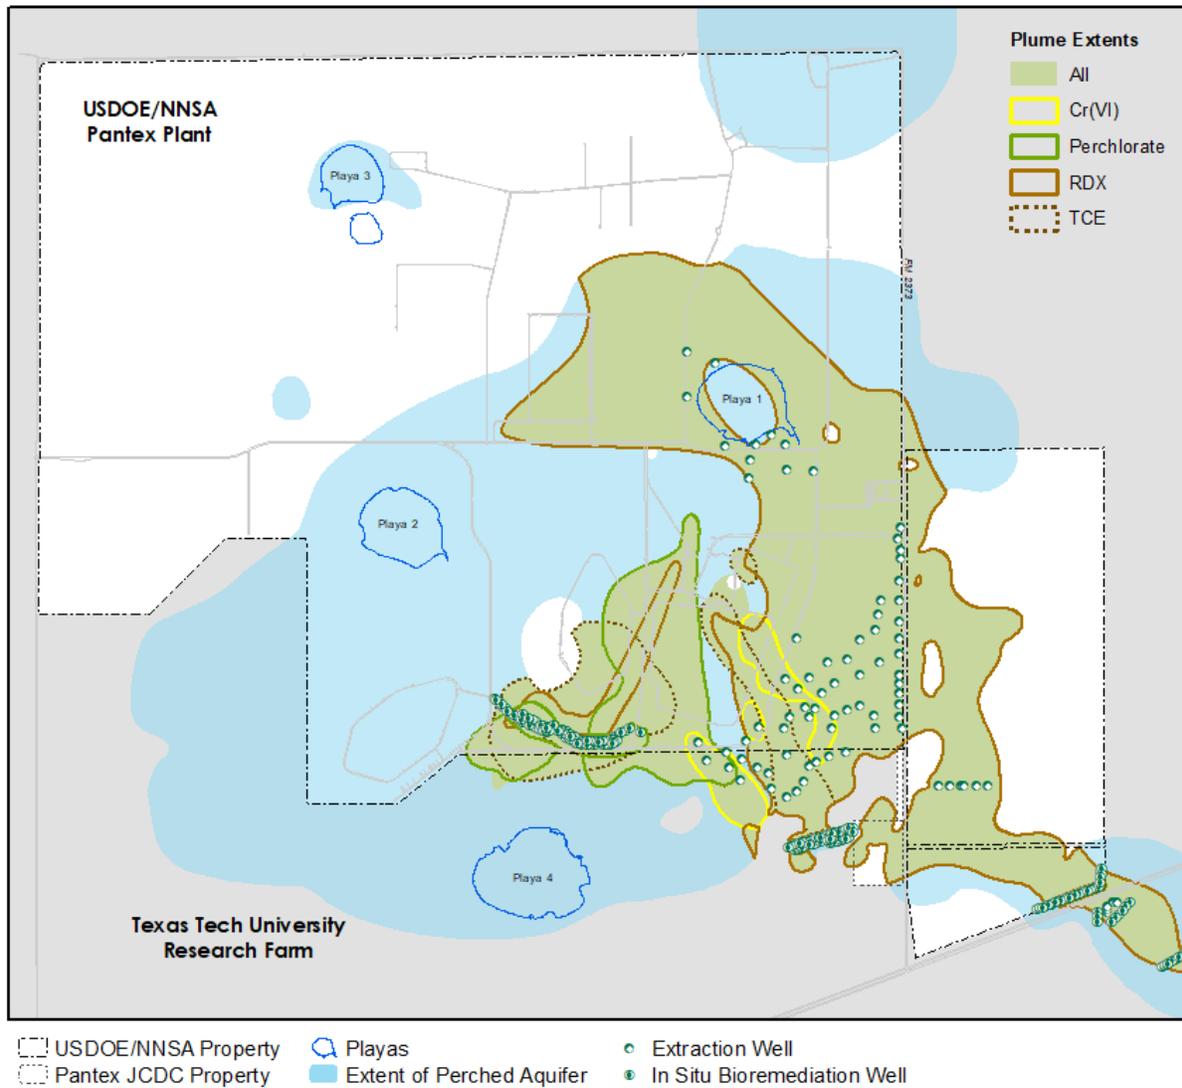
Figure 1-2. Extent of Perched Groundwater and Contaminant Plumes Exceeding the Groundwater Protection Standard

Historical waste management practices at Pantex resulted in the release of contaminants through various waste streams. Treated and untreated industrial wastewater released to the ditches and playas resulted in the contamination of perched groundwater beneath Playa 1, portions of Zone 11, Zone 12, TTU property to the south, and property east of FM 2373. The extent of perched groundwater and major contaminant plumes are depicted in Figure 1-2.

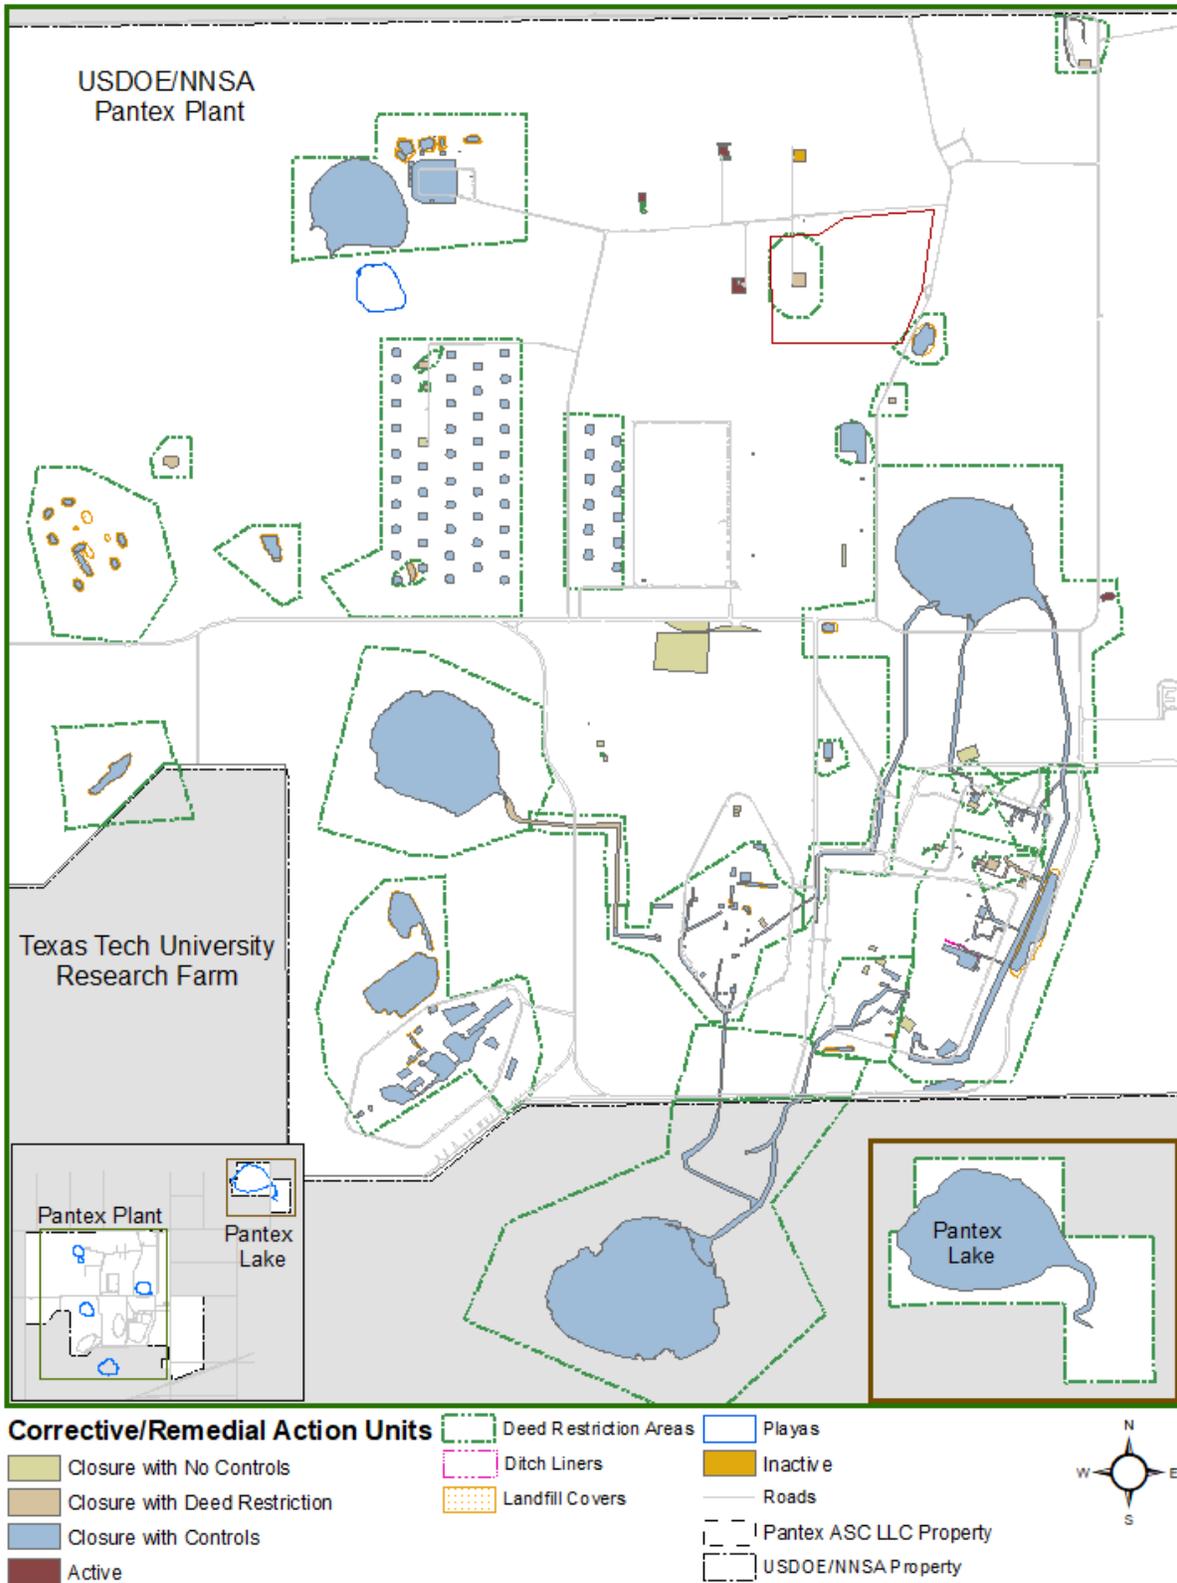
Figure 1-3. Status of Corrective/Remedial Action Units

In accordance with RCRA and CERCLA, Pantex and regulatory agencies identified 254 units at the Pantex Plant for further investigation and cleanup. Investigations that identified the nature and extent of contamination at solid waste management units (SWMUs) and associated groundwater were submitted to the TCEQ and EPA in the form of RCRA Facility Investigation Reports. Those investigation reports closed many units through interim remedial actions; therefore, no further controls other than deed recordation are necessary for those units. Other units were evaluated in human health and ecological risk assessments to identify units that required further remedial actions to protect human health and the environment. Figure 1-3 depicts the location and status of the 254 units.

The remedial action for landfills included installing and maintaining protective covers for the Former Burning Ground Ash Disposal Trench and SWMUs 14 through 24, the former operational area of FS-5, and 27 landfill units depicted in Figure 1-3. These protective covers were either placed after landfilling operations ceased or were installed as interim corrective measures (ICMs) under State RCRA Authority to prevent worker contact and the infiltration of water through landfill materials that could lead to migration of contaminants to the underlying aquifer without mitigation.

A total of five ditch sections representing SWMUs 2 and 5-05, with a total length of approximately 832 ft, were lined as an ICM in 2004 to prevent migration of vadose zone soil contamination to the perched groundwater. The ditch liner is depicted in Figure 1-3.

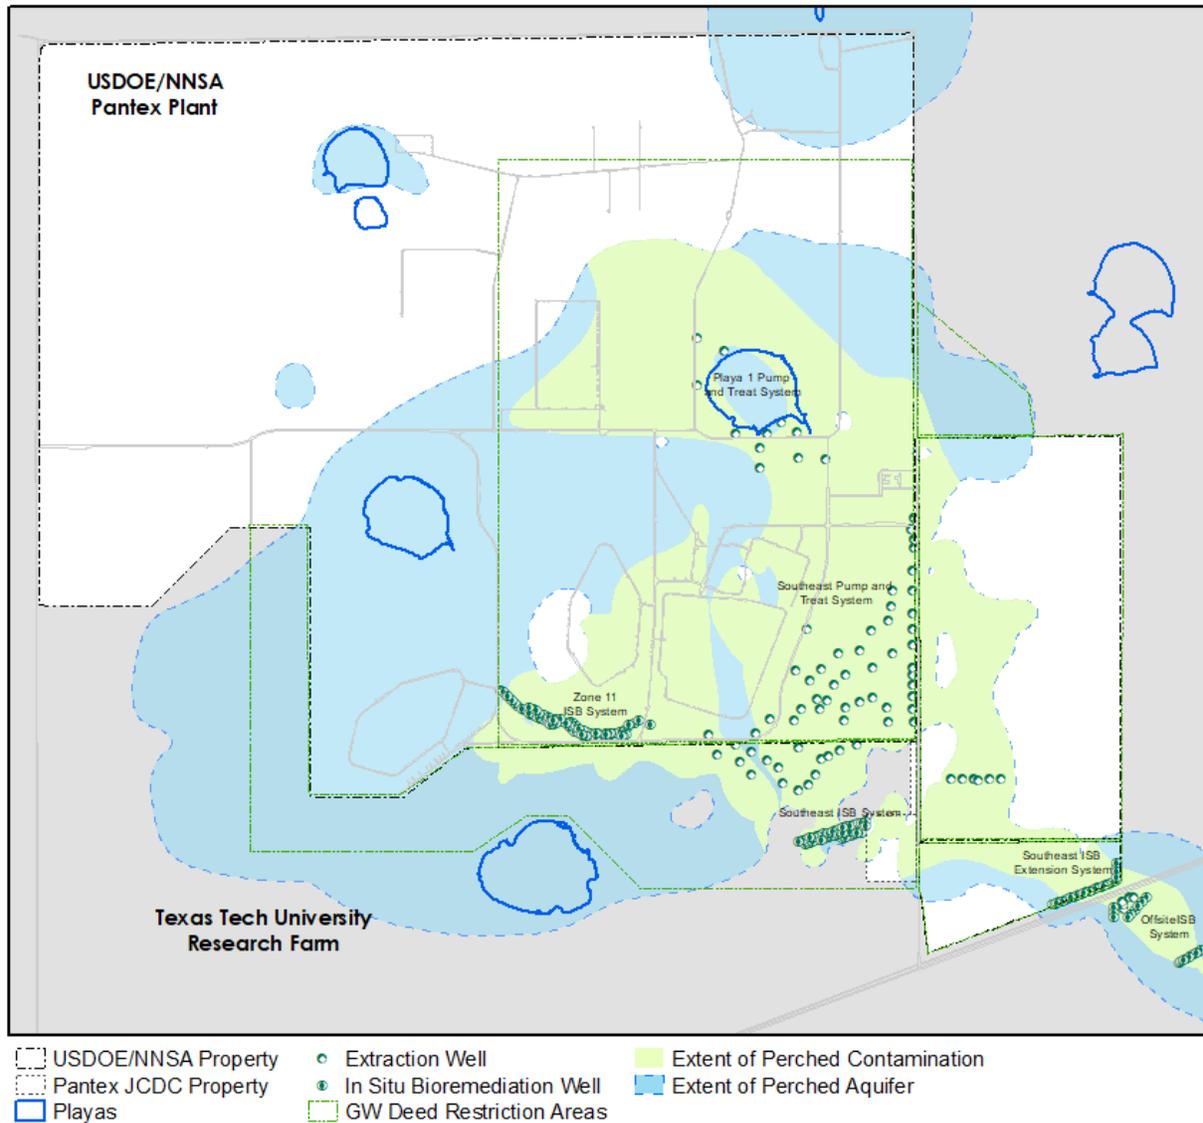
Figure 1-5. Groundwater Remedial Actions

In accordance with the IAG and HW-50284, Pantex has implemented actions to remediate the contaminated perched groundwater. Two types of active remediation systems (see Figure 1-5) were installed to address the contamination: Pump and treat

Pantex has installed ISBs to reduce the concentration of contaminants as they migrate through the remediation zone in targeted areas of the groundwater plumes. Currently, Pantex has four ISB systems, but two more are planned for the future to reduce risk to the offsite area to the southeast and to the Ogallala Aquifer that lies beneath the northeast TTU property.

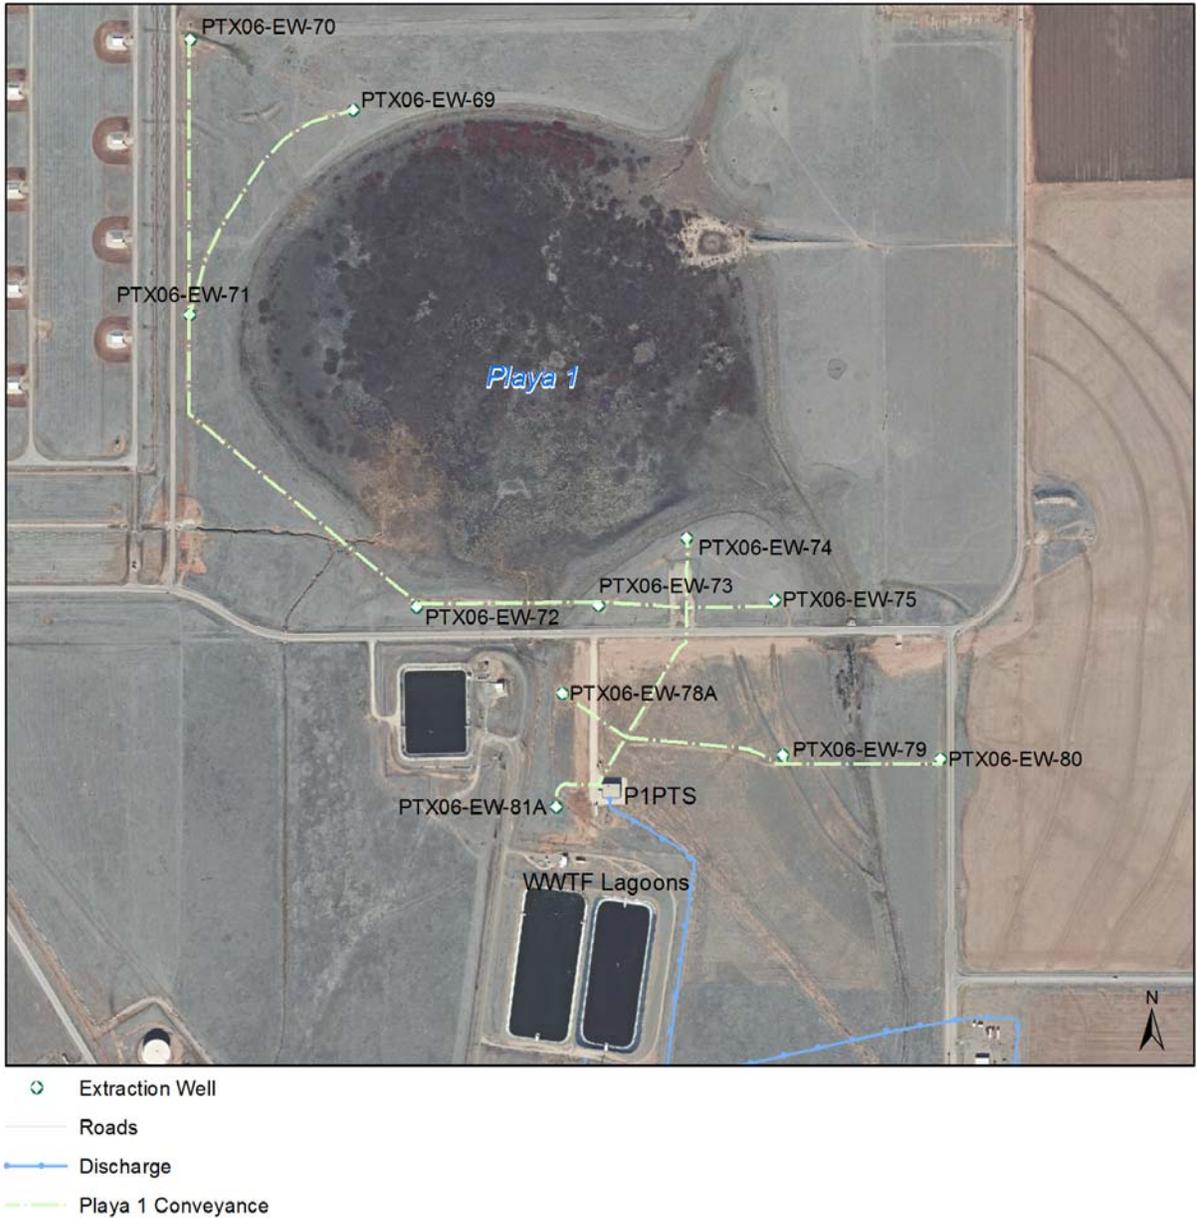
Figure 1-6. P1PTS Wells and Conveyance Lines

Operating under a permit issued by the State of Texas, Pantex can release treated wastewater to Playa 1. Pantex continued to release to Playa 1 into early 2022 while repairs were completed at the onsite irrigation system. Repairs were completed at the subsurface irrigation system in March 2022, but some release of water to Playa 1 continues due to the limited use of the onsite subsurface irrigation system at this time. Pantex has designed and is installing a second irrigation system east of FM 2373 to

allow beneficial use of water from both pump and treat systems. The new center pivot system is expected to be completed in 2022, with operation expected to begin in early 2023.

The P1PTS was completed in 2008 with operations starting in September 2008. This system extracts water from 11 wells near Playa 1 (see Figure 1-6) and treats the water through a series of GAC beds and ion exchange process units to reduce HEs and metals below the GWPS established in HW-50284 and the ROD. The objective of this system is to achieve mass removal and reduce the mound of perched groundwater associated with Playa 1, which affects the movement of the southeast plume by reducing the hydraulic head.

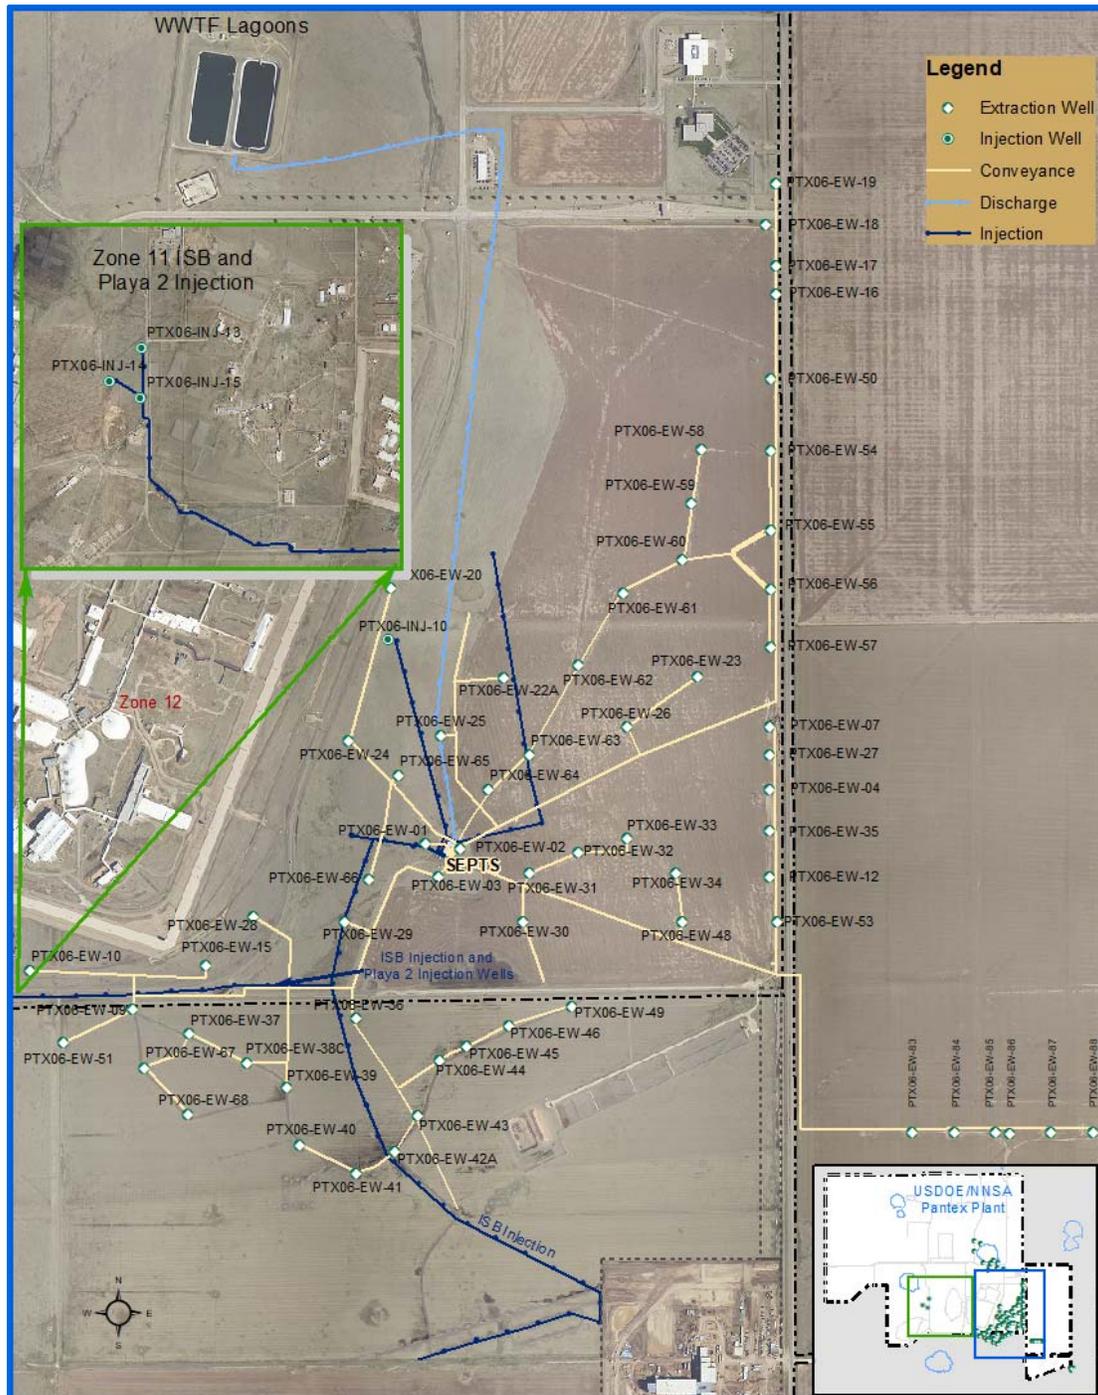
Figure 1-7. SEPTS Wells and Conveyance Lines

The SEPTS currently consists of a treatment building, 65 active extraction wells, and 4 injection wells (see Figure 1-7). Six new extraction wells were drilled east of FM 2373 to provide additional control of plume movement to the southeast. The wells were tied-in to the SEPTS and started operating by May 2019. Currently, only three of those wells remain operational due to the declining water levels in the area. This system is designed to treat up to 300 gpm.

The objective of the SEPTS (see Figure 1-7) is to remove contaminated perched groundwater and treat it for industrial and/or irrigation use. While the capability is being maintained for injection of treated water back into the perched zone, the intent is to permanently remove perched groundwater to gradually reduce the saturated thickness in this zone and to achieve the following two important goals:

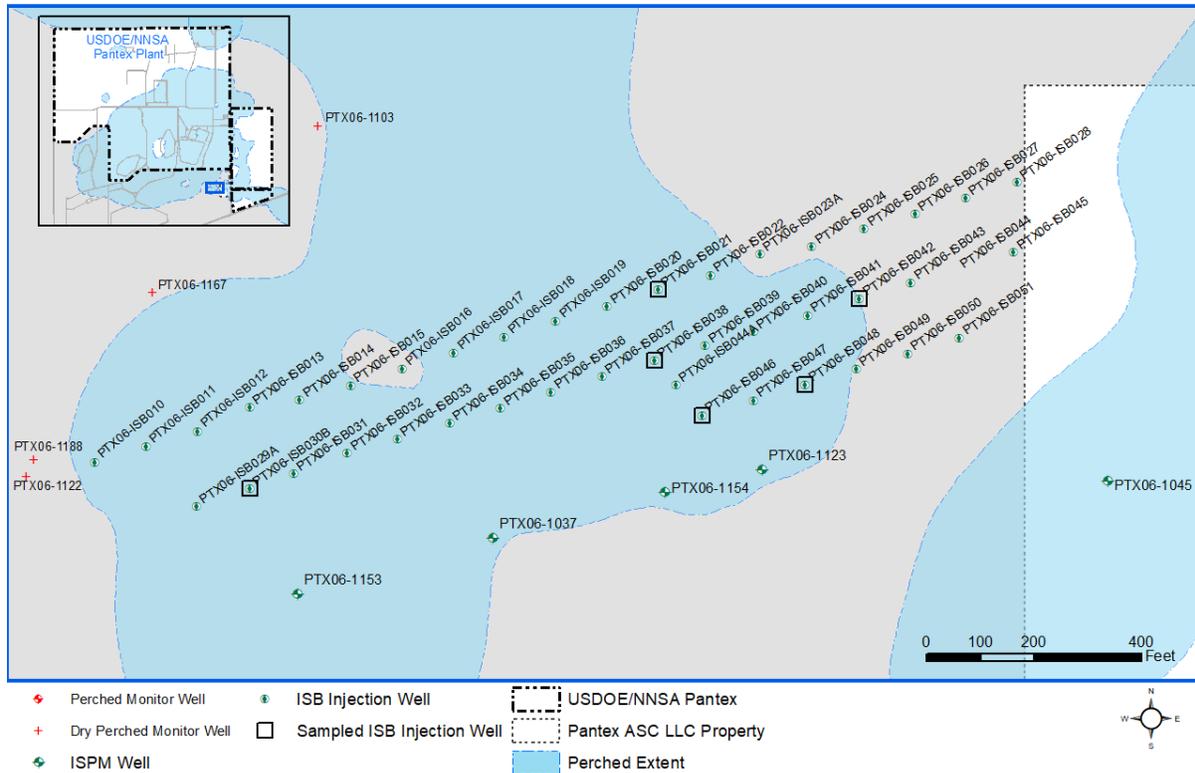
Figure 1-9. Southeast ISB Treatment Zone and Performance Monitoring Wells

Installed in 2007 as an early action, the Southeast ISB System is on TTU property south of Pantex and consists of 42 injection wells within the treatment zone and 5 ISPM wells (see Figure 1-9). The injection wells were drilled in a line perpendicular to the hydraulic gradient so the water flowing through the treatment zone will be treated before reaching the area beneath TTU property where the FGZ becomes less resistant to vertical migration. The system is designed to treat HEs and hexavalent chromium.

Based on the rate of perched groundwater flow and estimated longevity of the Newman Zone[®] soybean oil, injections were estimated to be necessary about every 12 to 24 months. Pantex has recently used molasses during injection events to more widely distribute the carbon source. However, recent injections at this ISB are now informed by data and the presence of water in the system.

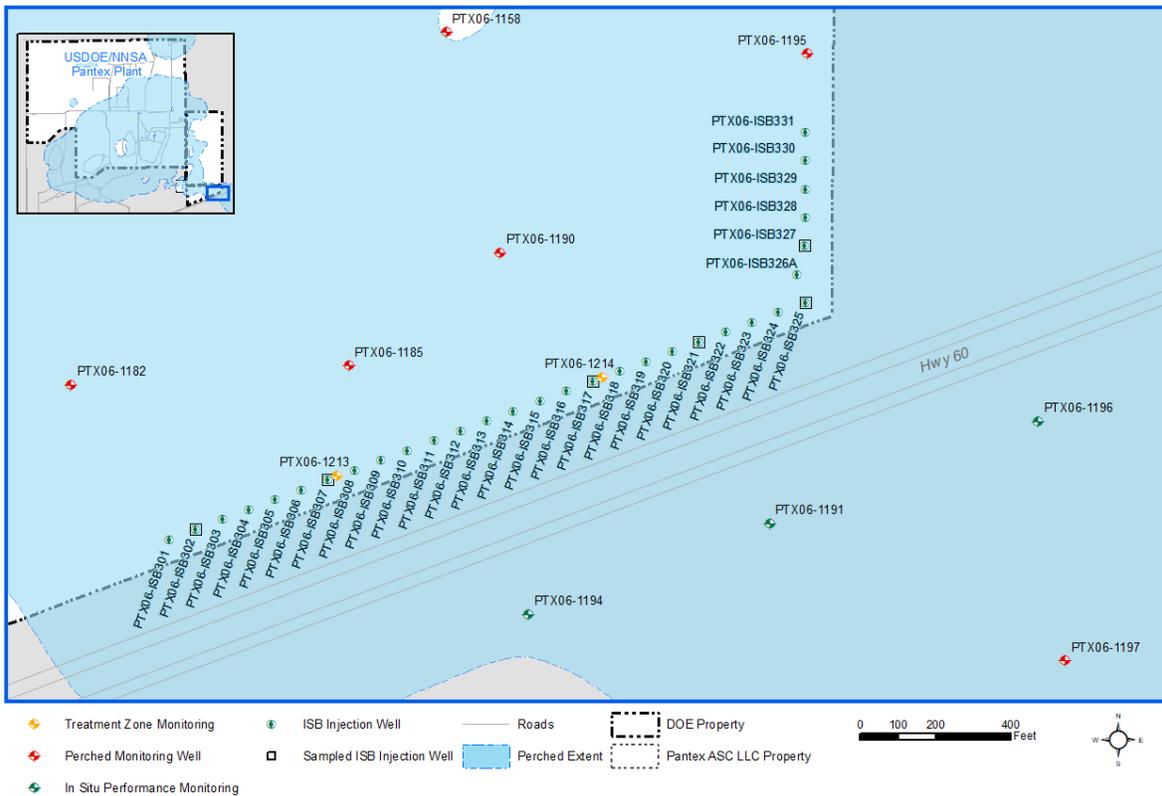
Figure 1-10. Southeast ISB Extension Treatment Zone and Performance Monitoring Wells

The system was positioned to treat HE contaminants, particularly RDX, that is moving to offsite landowner property. Due to the new extraction wells' upgradient removal of water, water levels are anticipated to decline in this system over time, and future injections will be unnecessary. Figure 1-10 depicts the Southeast ISB Extension.

Based on the rate of perched groundwater flow and estimated amendment longevity of molasses, injections are estimated to be necessary every six to nine months. As depicted in Table 1-5, five injection events have been completed at this system.

This system was installed using a similar design to the Southeast ISB. Wells were more closely spaced at 75 ft to ensure better distribution of amendment. The implementation of this system was documented in the *2018 Annual Progress Report* (Pantex, 2019d) as part of the implementation report for drilling. Wells drilled in the future will be added to the appropriate appendix in each year's annually progress report.

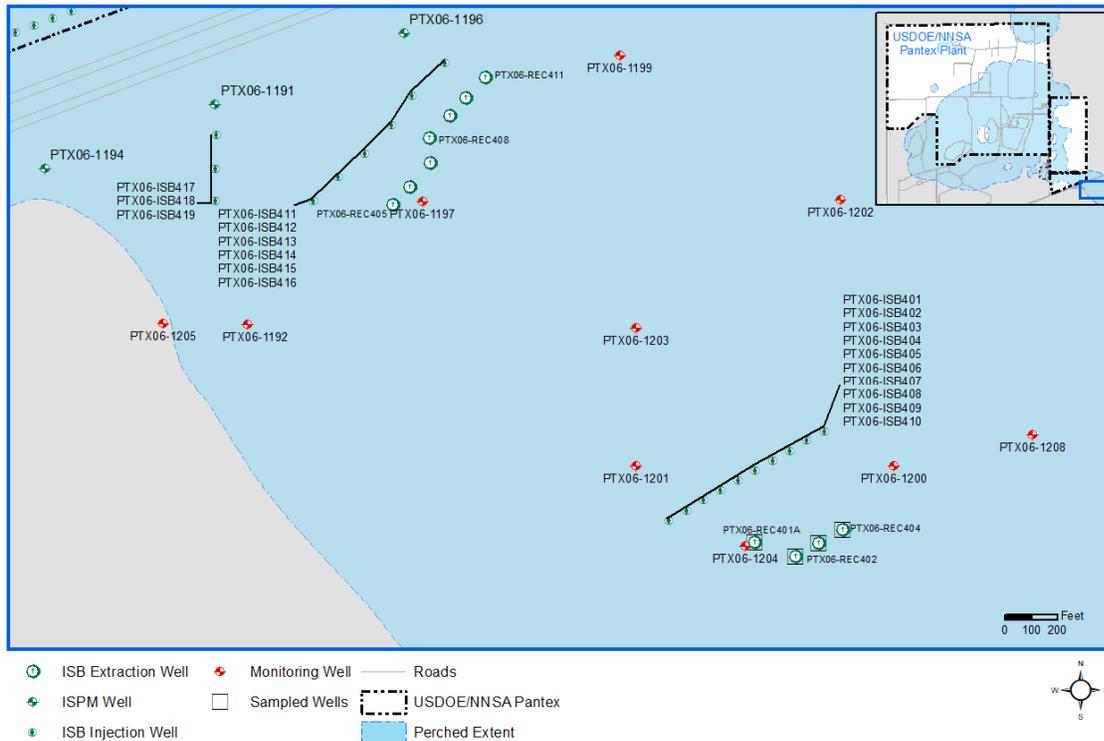
Figure 1-11. Offsite Treatment Zone and Performance Monitoring Wells

To address HE contamination that moved onto a neighboring property, Pantex began installing an offsite ISB system in 2020. This ISB is located to the southeast of Pantex-owned property, south of Highway 60, and currently consists of 19 new ISB injection wells and 11 extraction wells, as depicted in Figure 1-11. One ISPM well will be converted to injection in the near future to better treat a neighboring property where a

Designed to complete clean-up within 25 years at the offsite property, the system was developed using the updated perched groundwater fate and transport model (HGL, 2021b). The final placement of wells was driven by the data collected from new system wells installed in 2020, with modeling used to determine optimum placement and timing of injections to achieve clean-up.

Based on final analytical and aquifer data collected at the initial system wells installed in 2020, the system's final update and optimization occurred in 2021. That modeling effort has guided the plans for final placement of system wells in 2022 and 2023 as well as the future injection timing for the system wells. Based on the optimization modeling, all or portions of the injection wells are injected twice per year.

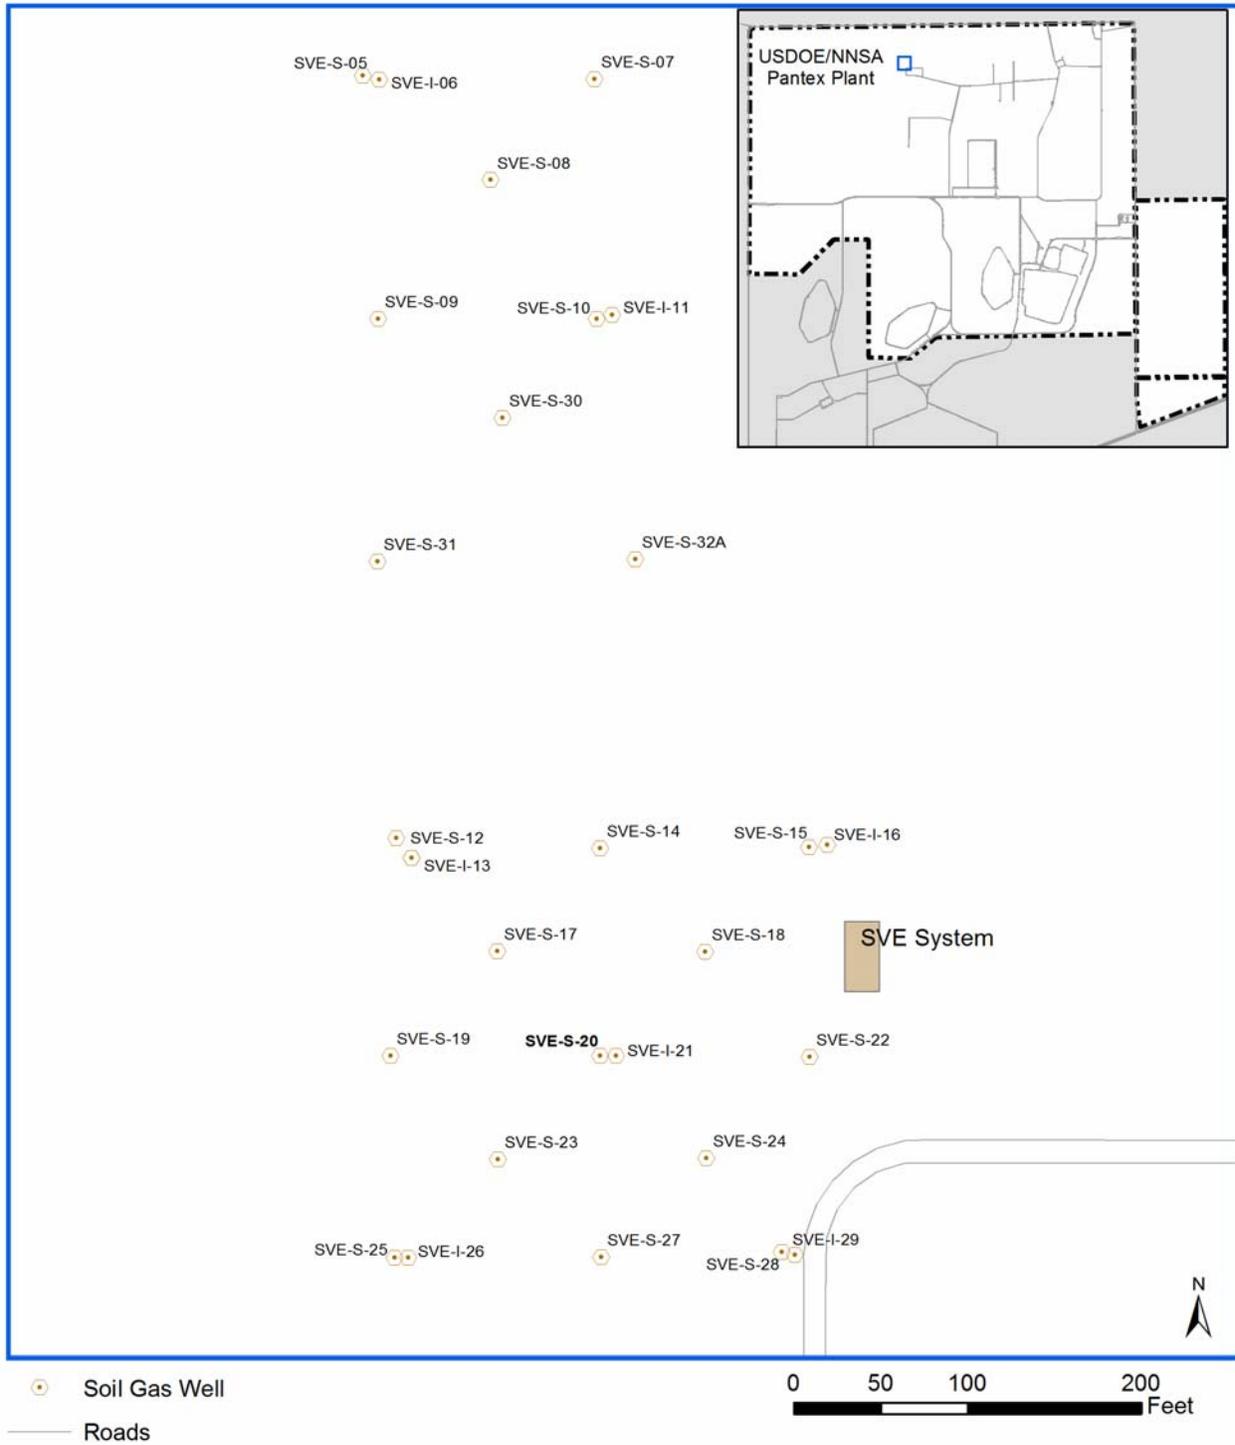
Figure 1-19. Burning Ground SVE Wells

¹The shallow depth wells are screened from 20 to 45 ft and 50 to 90 ft bgs. The intermediate depth wells are screened from 95 to 180 ft and 190 to 275 ft bgs.

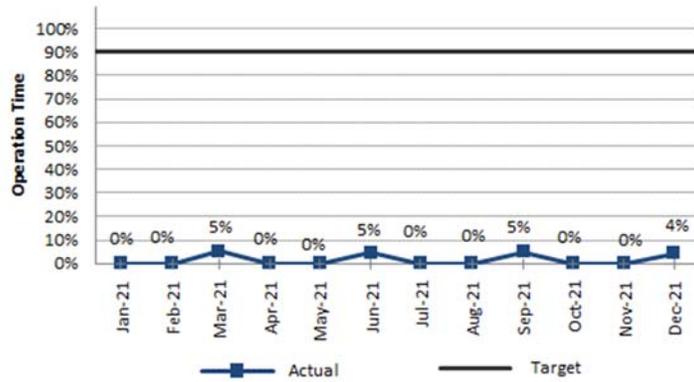
Figure 2-1. P1PTS Operation Time vs Target

The P1PTS operated 8 hours/day for 17 days during 2021 with an average annual operational rate of 2%, based on total hours operated versus total possible operation time. The actual percentage of monthly system operational time versus the target percentage is depicted in Figure 2-1.

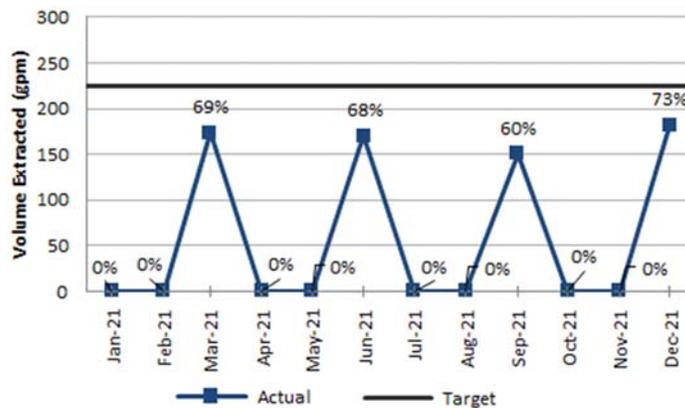
Figure 2-2. P1PTS Average GPM and % Capacity

Figure 2-2 depicts the average gpm extracted from all wells by month. The P1PTS system extracted an average of 169 gpm (about 68% of design throughput) from the well field while operating in 2021. The calculated gpm accounts for water extracted from the well field when the system operated and is affected by each well's yield, downtime, or reduced flow required by the WWTF/irrigation system.

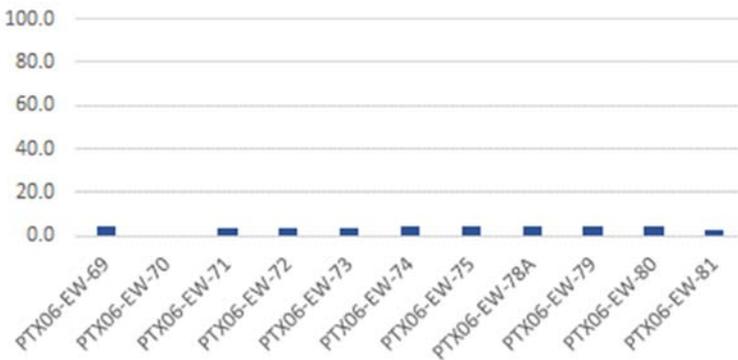
Figure 2-3. P1PTS Well Operation Time

Figure 2-3 reflects the operation time by well. PTX06-EW-70 was down most of last year and in need of repair. The repair was completed by the beginning of fourth quarter, but due to low flow requirements, the well was not operated in December during the quarterly operation. PTX06-EW-81 was not operated for a portion of the year due to communication problems causing potential leaks; the well was operating by the end of the year. Most other wells were running when the system was periodically operated, if flow was not restricted.

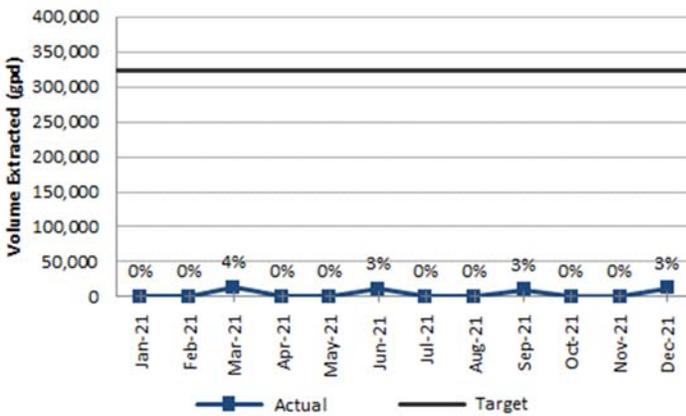
Figure 2-4. P1PTS Average GPD and % Capacity

Figure 2-4 reflects the P1PTS’s overall system efficiency considering system and well operation. The system treated an average of about 11,900
