Pantex Plant

2021 Annual Progress Report

Remedial Action Progress

In Support of Hazardous Waste Permit 50284 and
Pantex Plant Interagency Agreement

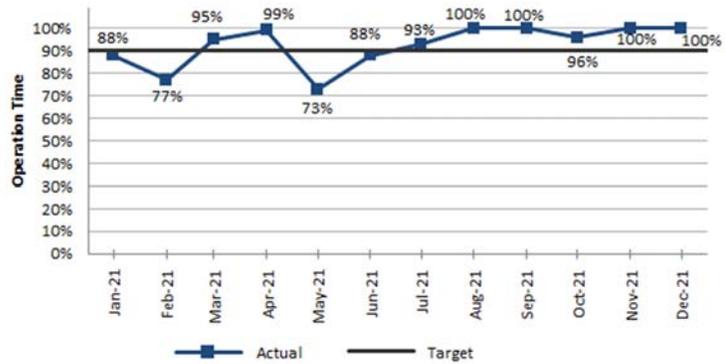
Figure 2-7. SEPTS Operation Time vs Target

During 2021, the SEPTS operated all or part of 346 days with an average operational rate of 93%, based on total hours operated versus total possible operation time. The percent operation time (i.e., hours per day) versus the target operation time is depicted in Figure 2-7.

System operation was affected by power outages, paging issues, weather conditions, and carbon/resin change-out. Operation was consistent at the SEPTS due to shutdown of P1PTS. When P1PTS was operating, flow was reduced at the SEPTS to meet discharge permit limits to Playa 1 and minimize injection into the perched aquifer.

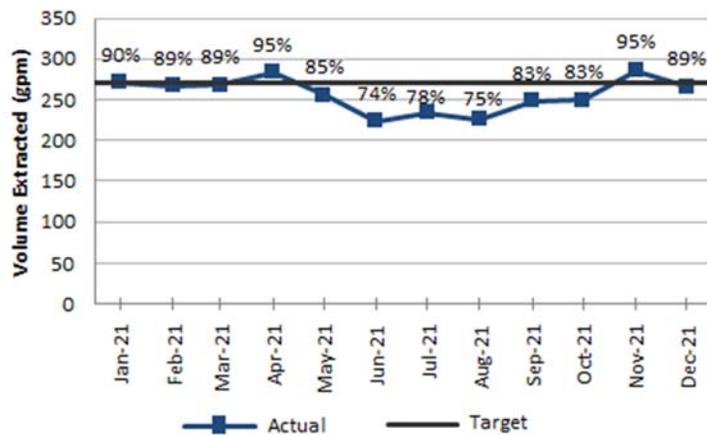
Figure 2-8. SEPTS Average GPM and % Capacity

As a measure of well operation efficiency, Figure 2-8 depicts the average gpm extracted from all wells by month, the percentage of design capacity achieved, and system goals. Unless flow is affected by the WWTF or other issues, the system’s operational rate has been the prioritized goal since June 2014. In 2021, the system was operated fully, except when P1PTS was operated. Even though the 90% throughput goal was not applicable during

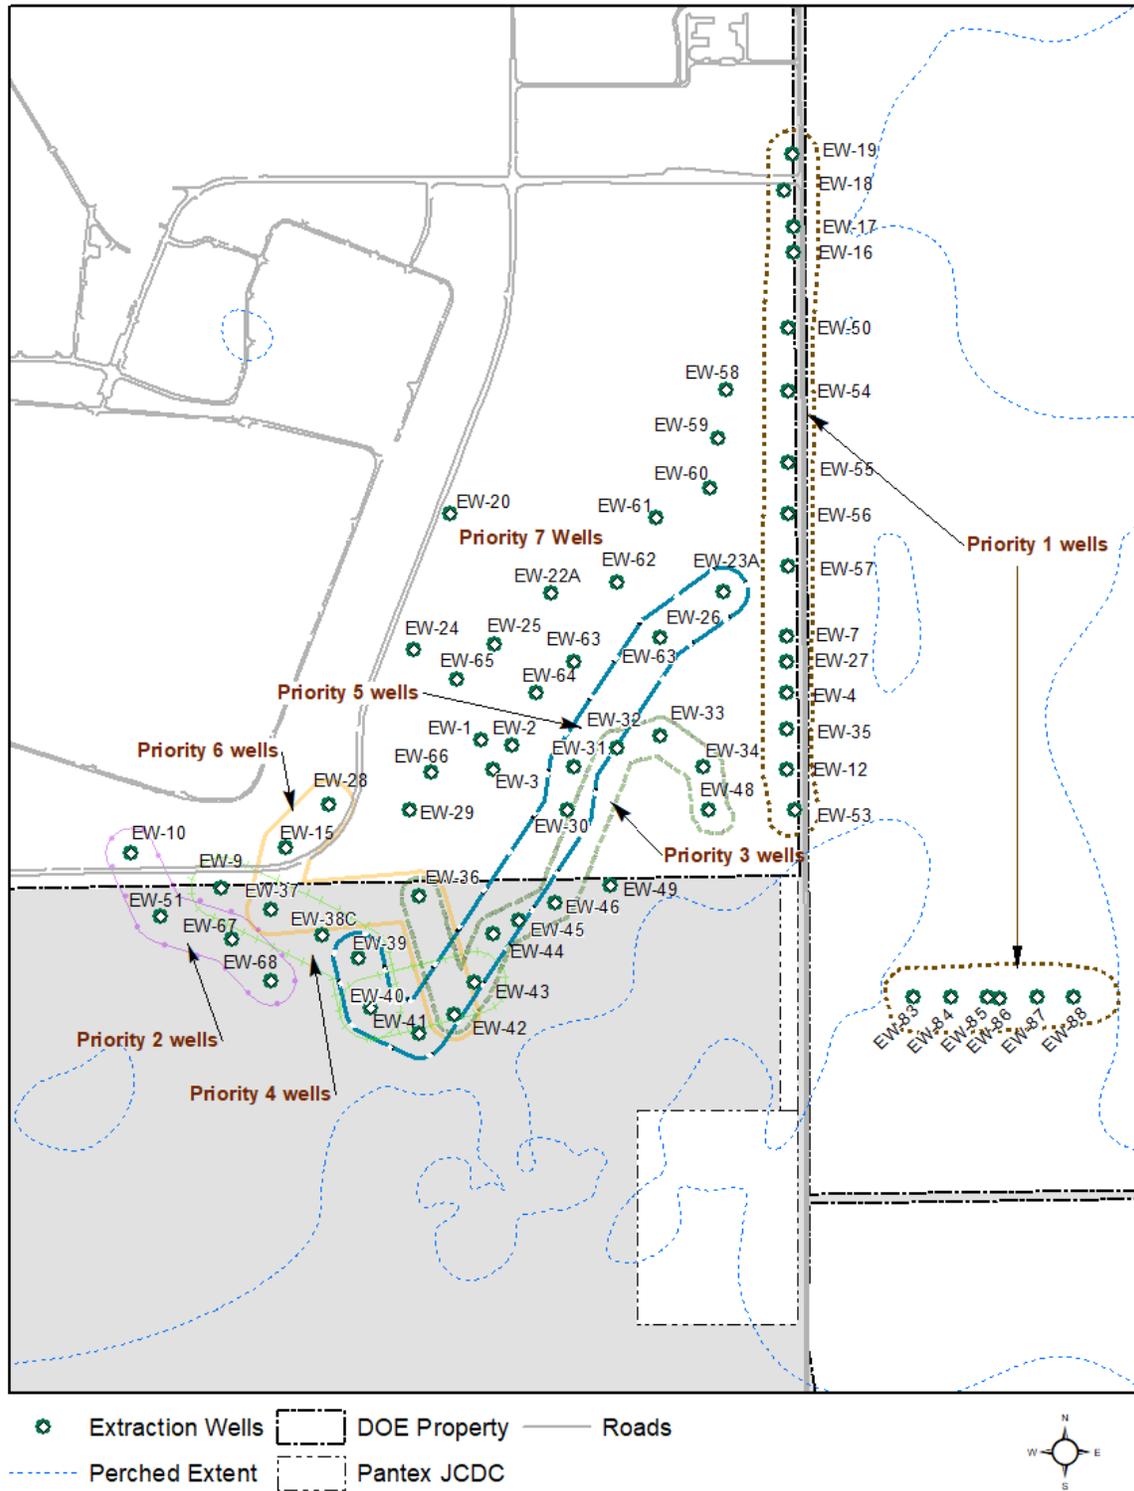
Figure 2-9. Extraction Well Prioritization

Although perched groundwater levels are declining, the extraction rates from the well field currently exceed the treatment system's capacity. Pantex extracts from the well field according to set priorities that best meet long-term objectives. The well-extraction priorities for operating wells are as follows and depicted in Figure 2-9:

- **Priority 4 wells:** Wells along the northern edge of the hexavalent chromium plume from the Zone 12 South area.
- **Priority 5 wells:** Wells close to the highest concentrations of RDX. These wells will continue to capture the RDX plume movement when the Priority 3 wells are not pumping.

- **Priority 6 wells:** Wells that capture the center of the hexavalent chromium plume from the former cooling tower on the eastern side of Zone 12.
- **Priority 7 wells:** All other wells in the SEPTS. With the exception of EW-49, these wells help reduce saturated thickness in the perched aquifer and remove head that pushes the groundwater horizontally and vertically but will not be as effective at controlling plume movement. EW-49 is in a low-transmissivity zone and, thus, is a very low-producing well. For this reason, it was not placed in a high priority for pumping.

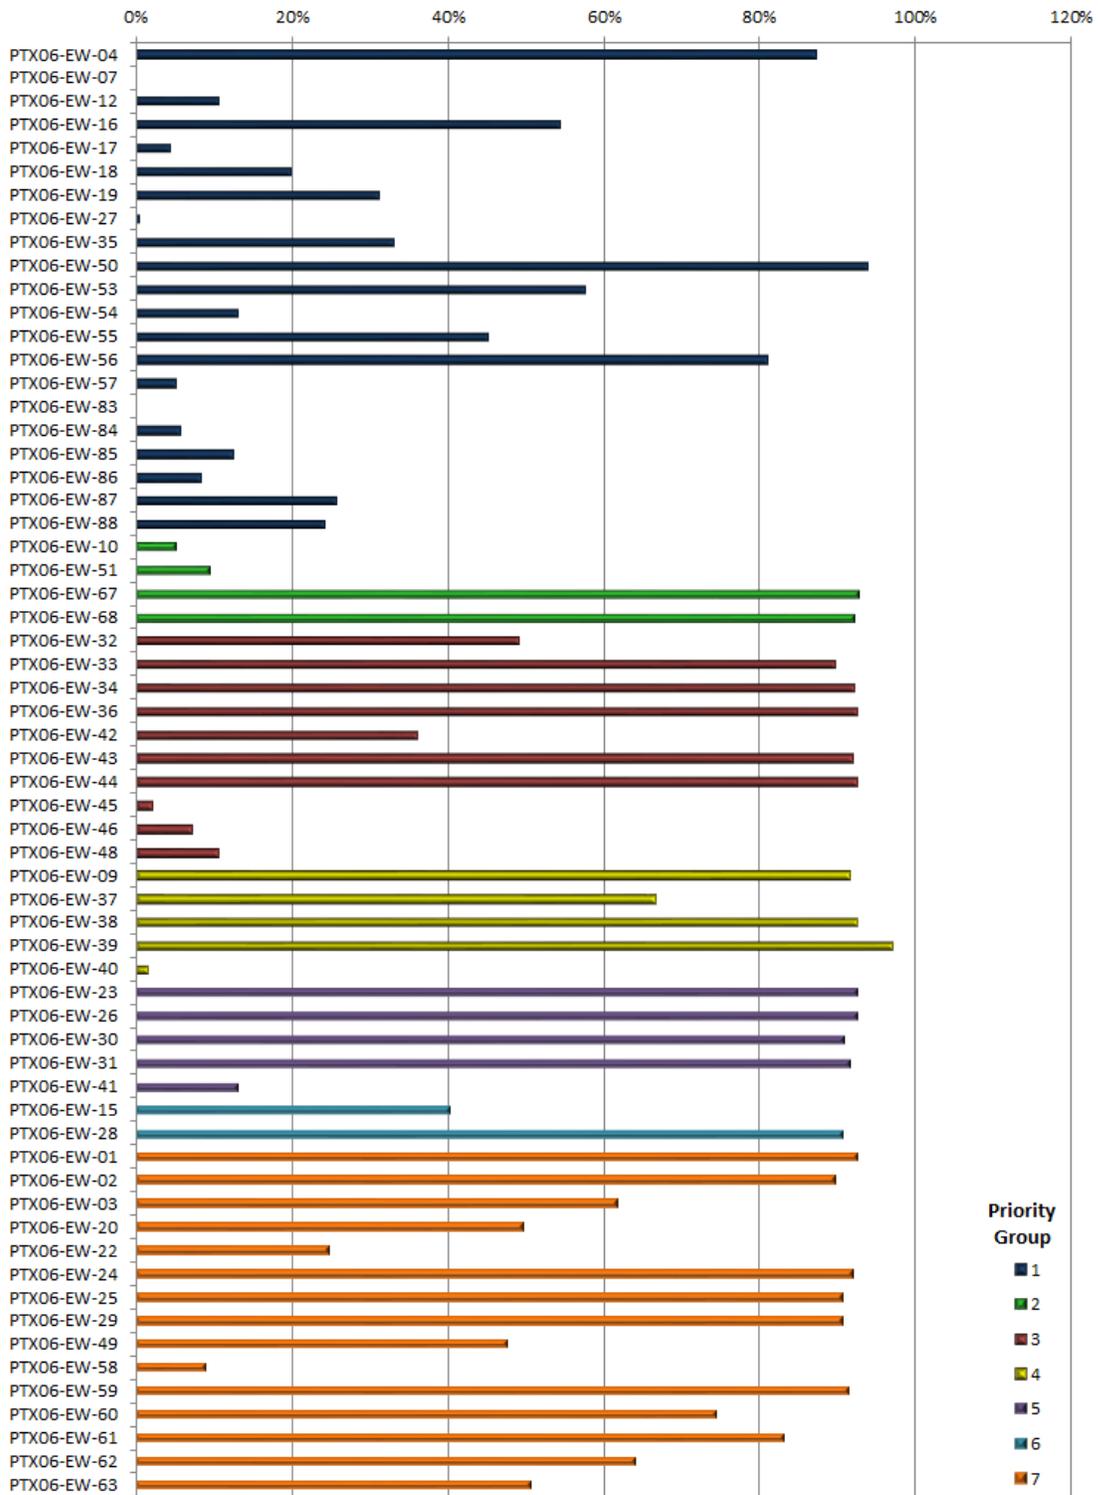
Figure 2-10. SEPTS Well Operation Time

This prioritization scheme was implemented in 2009 after the system was expanded. Figure 2-10 provides the percentage of days on which the wells were operated in the SEPTS. Priority 1 – Priority 5 wells were operated at higher frequencies with the exception of wells that had repair issues, were locked out due to repair issues with wells on the same line, or had low water levels that prevent them from operating properly. Two wells, PTX06-EW-10 and PTX06-EW-51, in the perchlorate plume were shut down while contracting for the design and installation of perchlorate pre-treatment.

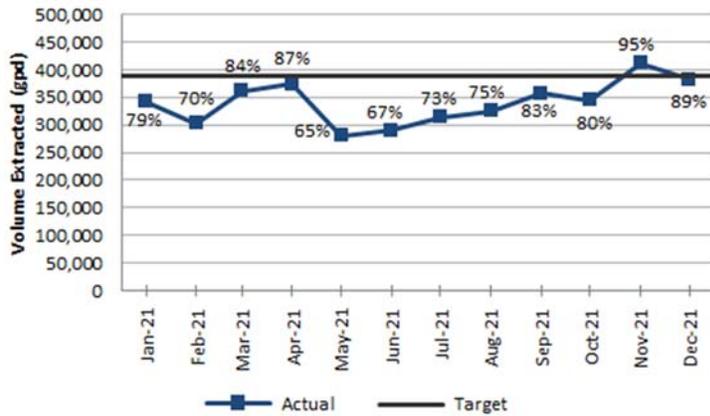
Figure 2-11. SEPTS Average GPD and % Capacity

Figure 2-11 reflects the SEPTS’s overall efficiency considering system and well operation. The figure depicts the average daily treatment rate in gpd by month, the target, and the percentage of total capacity achieved at the SEPTS. In 2021, the SEPTS treated an annual average of approximately 379,593 gpd (about 85% of design capacity), based on total possible hours of operation and total inflow from the well field.

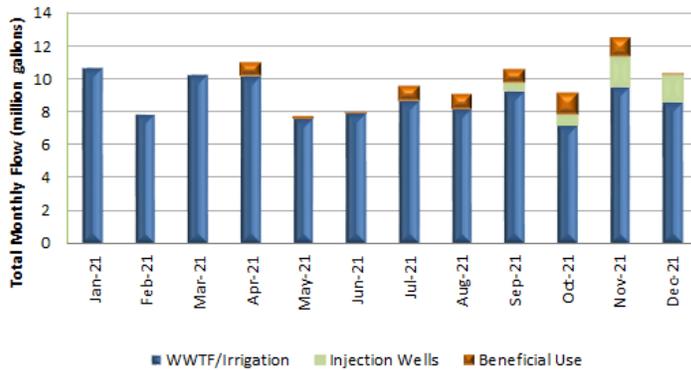
Figure 2-12. SEPTS Total Flow Volume and Disposition of Effluent

The system treated approximately 124.3 Mgal of extracted water during 2021. The total volume treated by month and the final disposition of the treated water are depicted in Figure 2-12. Approximately 4% of the treated water was injected into the perched aquifer, 5% was used beneficially for ISB injection, and the remainder was released to Playa 1 via the WWTF.

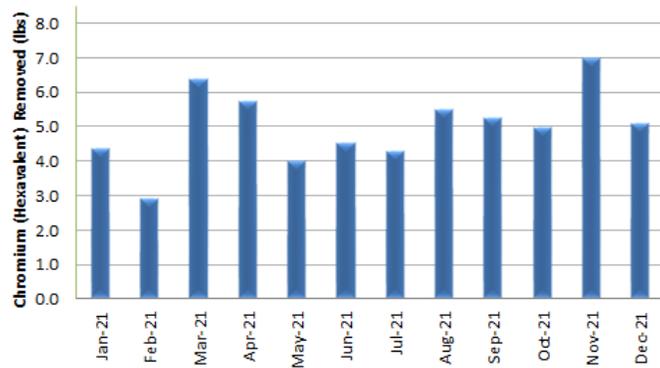
Figure 2-13. SEPTS Chromium Mass Removal by Month

The SEPTS primarily removes RDX and hexavalent chromium from the perched groundwater. The system removed approximately 60 lbs of hexavalent chromium, 245 lbs of RDX, and 213 lbs of all other HEs during 2021. The total mass removed for hexavalent chromium and HEs, by month, is depicted in Figure 2-13 and Figure 2-14. The average removal rate of hexavalent chromium was 0.48 lbs/Mgal of water, and the average removal rate for HEs was 3.5 lbs/Mgal of water.

Hexavalent chromium mass removal is declining because concentrations in PTX06-EW-51 and nearby extraction wells continue to decline. PTX06-EW-51 was located in the heart of the hexavalent chromium plume south of Zone 12 and contributed heavily to the hexavalent chromium influent concentrations at the SEPTS. The plume has moved downgradient, and other extraction wells now capture portions of it even though concentrations are much lower at these wells. HE mass removal is affected by wells that operate in higher-concentration portions of the RDX plume. Overall, average concentrations of RDX in the SEPTS influent have declined with average concentrations about 570 ug/L in 2009, the first year of the full remedial action, to about 230 ug/L in 2021. Average influent concentrations of hexavalent chromium were approximately 214 ug/L in 2009 and approximately 73 ug/L in 2021.

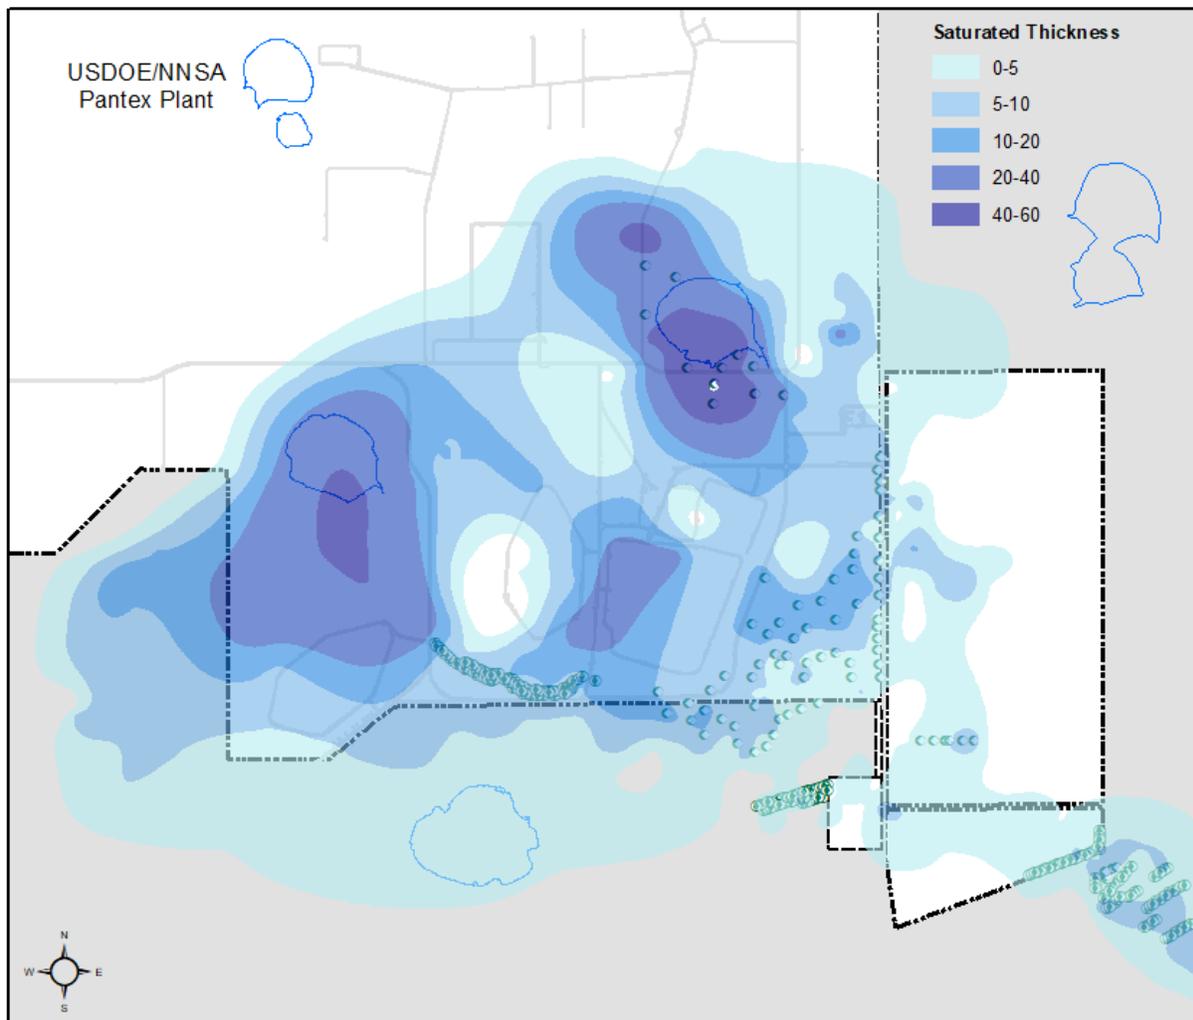
Figure 2-15. Perched Aquifer Saturated Thickness, 2021

saturated thickness (i.e., <10 ft of water), as shown in Figure 2-15. About 29% of wells inside the treatment zone demonstrate greater than 5 ft of water, with all downgradient wells having less than 5 ft of water.

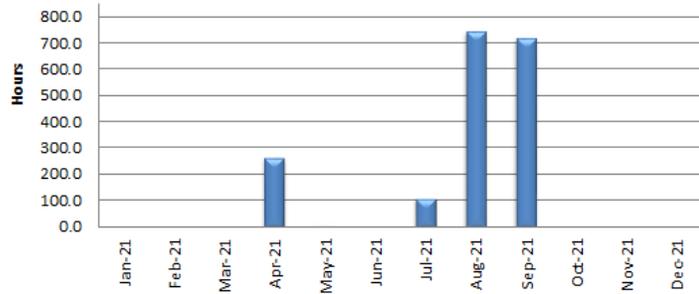
Figure 2-16. SVE System Operation

Figure 2-16 depicts the SVE system's operation for 2021. The system was down from January to March and October to December for a planned pause in operation as part of a pulsing plan. The system was down from May to June due to necessary repairs that required replacement parts to be ordered and replacement services to be contracted. Overall, the system operated approximately 21% of the year.

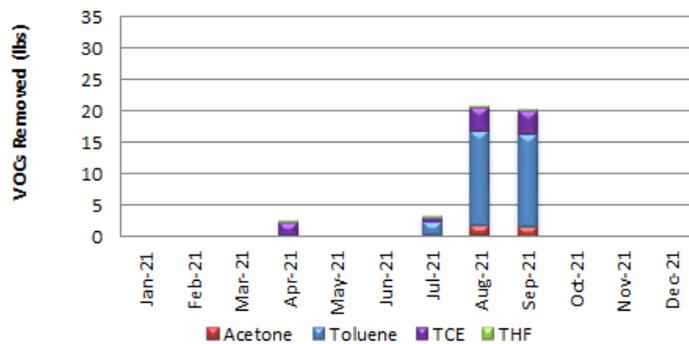
Figure 2-17. Burning Ground SVE Mass Removal

Calculated mass removal for 2021 is presented in Figure 2-17. Mass removal was estimated based on concentrations reported from analytical sampling, system operation time, and system flow rates. VOC constituents contributing to the majority of the total VOC concentration were included in the calculation. The system removed approximately 46.2 lbs of VOCs during 2021, and since its inception, the SVE system has removed about 21,273 lbs of VOCs. Trends of removal rates, concentrations, and general effectiveness of the SVE are provided in Section 4.

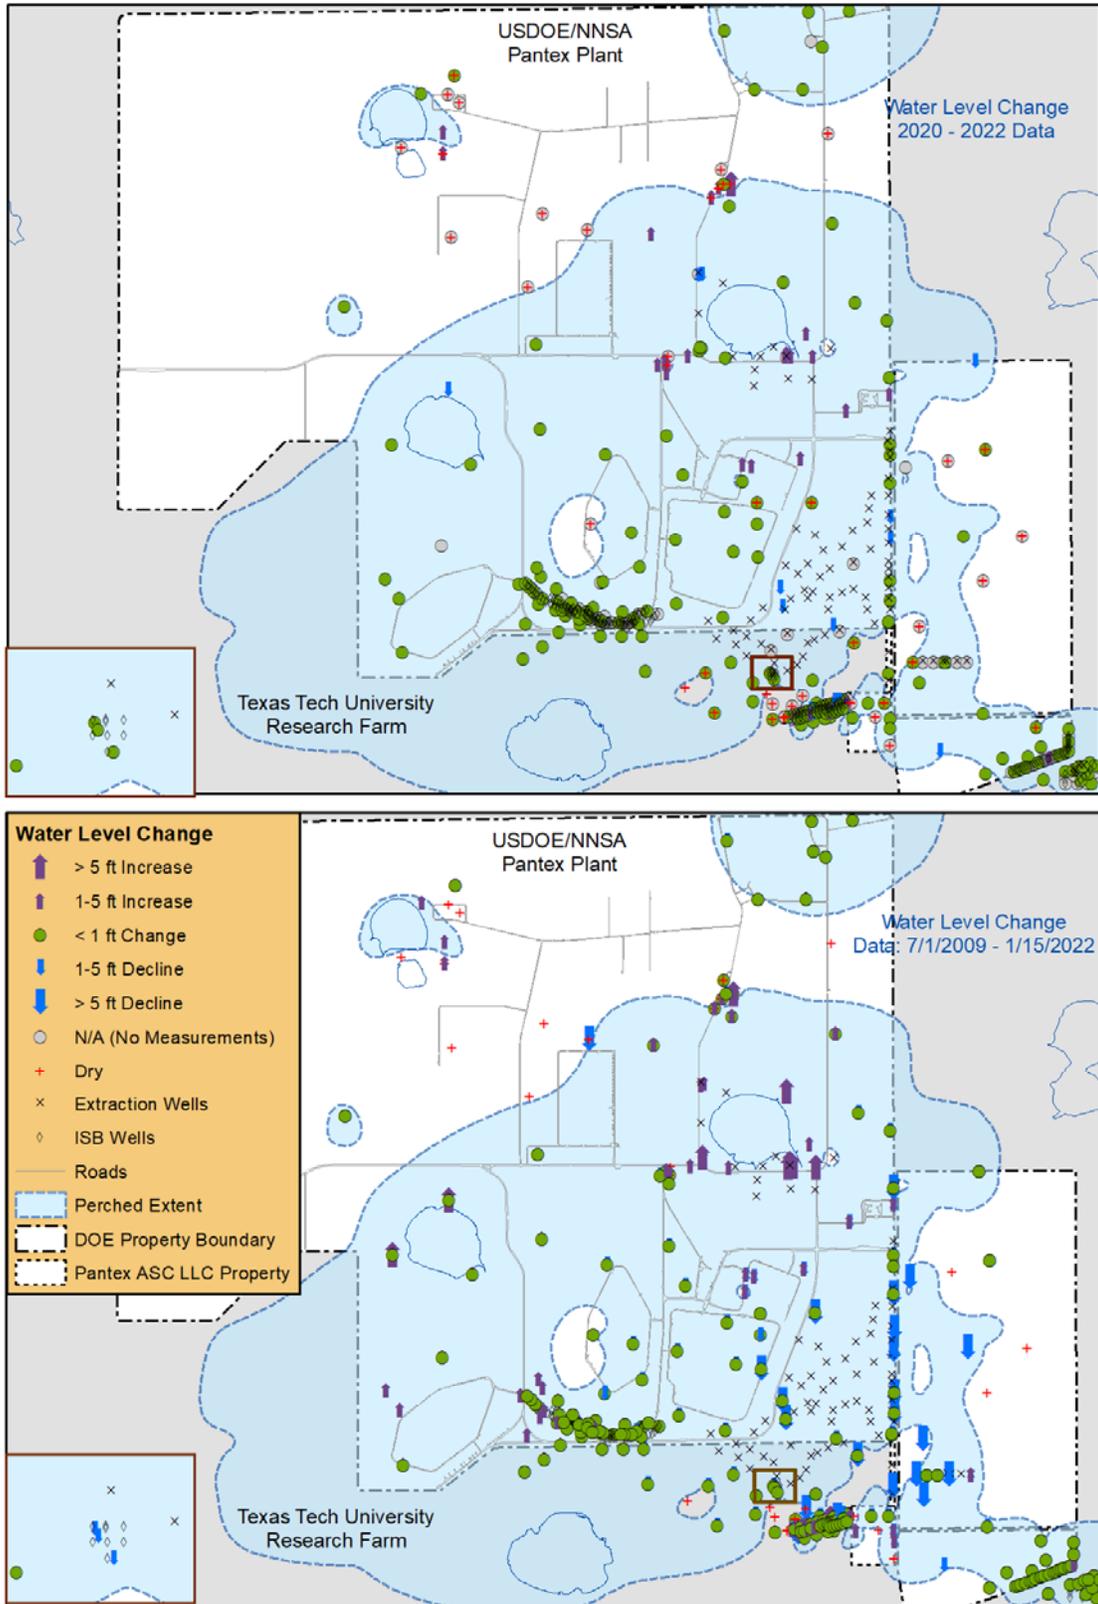
Figure 3-5. Water Level Trends in the Perched Aquifer

Figure 3-5 depicts the water level trends in all LTM perched aquifer wells. Well hydrographs are included in Appendix F.

A recent increasing trend was observed at five wells near Playa 1 (PTX06-1013, PTX06-1023, PTX06-1050, PTX08-1001, and PTX08-1002). These trends are associated with a combination of increased recharge through the playa resulting from the discharge of treated wastewater effluent and treated perched groundwater to the playa along with decreased extraction of perched groundwater from the P1PTS. The long-term water level trend is decreasing for all of the wells near Playa 1 except OW-WR-38, PTX08-1001, and PTX08-1002, which are increasing but remain below historically observed high levels.

A recent increasing trend was observed in three wells in the southeast area (PTX06-1002A, PTX06-1038, and PTX06-1039A), and recent “No Trend” conditions were observed at PTX06-1098, PTX06-1100, and PTX06-1101. Most of these wells exhibited a marked increase in 2017 water levels, a response to above-normal precipitation, followed by less varied increasing trends or declines through 2021, due to the release of water to Playa 1. The hydrographs for all of these wells show that water levels have fluctuated in recent data and the long-term water level trend is decreasing. Hydrographs for all active perched wells are found in Appendix E. The observed fluctuations may be associated with recharge to the ditches and areas that pond in Zone 12 as well as reduced extraction of perched groundwater from the SEPTS.

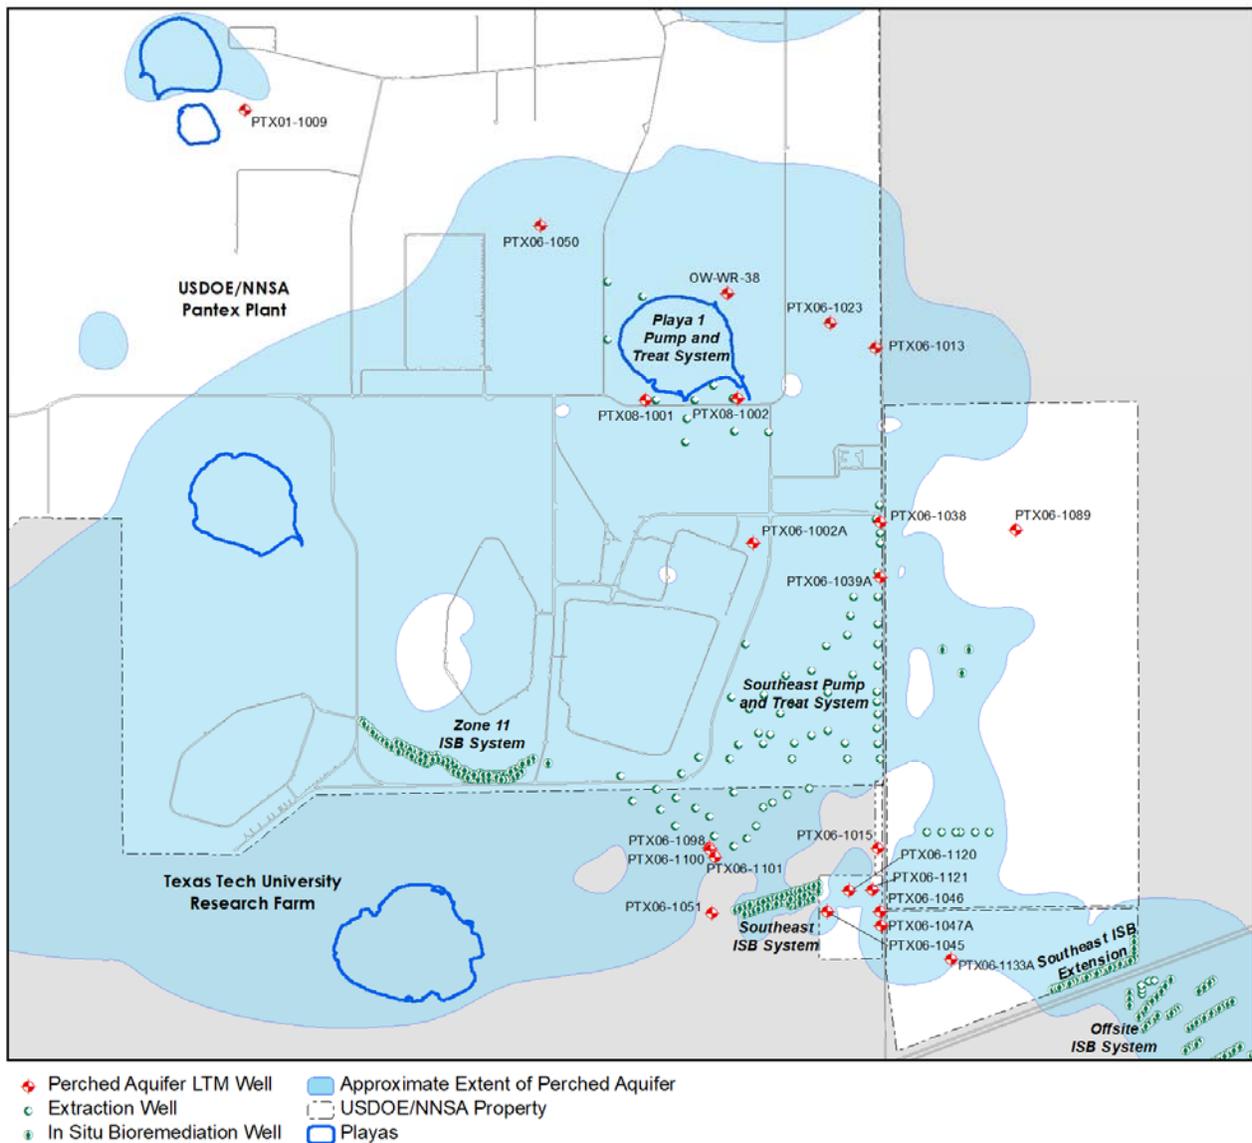
Figure 3-6. Perched Wells with Unexpected Water Level Trends

Increasing water levels have been observed at PTX01-1009 near Playa 3. This well has historically been dry, but water was first measured in the screen in June 2019. The subsequent December water level measurement was dry, but water has been observed in the screen in both measurements in 2021. These recent increased water levels may be associated with above-normal precipitation in recent years and increased recharge through the playa.

Overall, calculated groundwater level trends are consistent with expected conditions defined in the LTM Design Report, which is summarized in Appendix E. Of the 46 monitoring wells with expected decreasing water level trends, limited water, or dry conditions defined in the *Update to the Long Term Monitoring System Design Report* (Pantex, 2019a), 23 wells, depicted in Figure 3-6, exhibited conditions inconsistent with current expected conditions or trends. These include 13 wells with recent increasing trends and 8 wells with recent “No Trend” conditions. In addition, seven wells are exhibiting apparent long-term increasing trends.

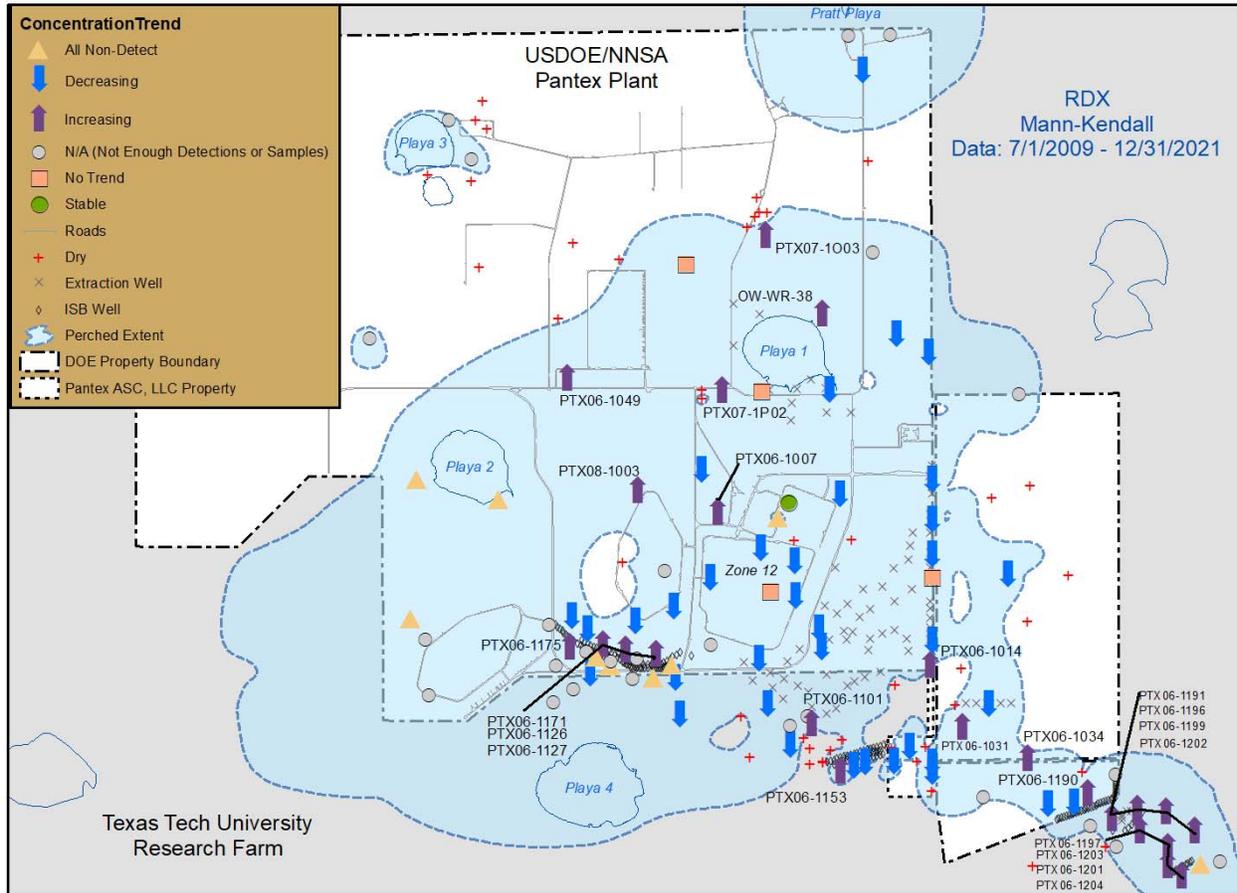
Figure 3-7. RDX Trends in the Perched Aquifer

of the well field. The Southeast ISB has had some effect on wells to the south on TTU property, exemplified by stable or declining concentrations in downgradient wells, including the trend of recent data at PTX06-1153. This is a key area for declining concentrations because portions of that area are potentially more sensitive to vertical migration to the deeper drinking water aquifer. The trends are depicted in Figure 3-7.

According to data collected since the start of remedial actions, the following 24 monitoring wells exhibited increasing trends in RDX, as depicted in Figure 3-7:

- OW-WR-38, located north of Playa 1, is exhibiting an increasing trend in RDX. RDX concentrations have been fluctuating near the GWPS since 2009 but increased to 52.3 ug/L in the most recent sample collected in 2021. Although elevated RDX has not been previously observed at this well, other wells north of Playa 1 (e.g., PTX06-1050 and PTX07-1003) have exhibited higher concentrations of RDX in the past. The trend may be due to the P1PTS's effect or recent changes

- PTX06-1007, located between and north of Zones 11 and 12, is exhibiting an increasing trend in RDX. Since 2002, RDX has been detected at levels near the PQL in this well with only one detection of 5 ug/L above the GWPS in 2017. However, in 2020 and 2021, RDX increased from near the PQL to 26 ug/L. This increase could be caused by changes in flow gradients and plume movement from the SWMU 5-13C ditch.

- PTX06-1014 is exhibiting an increasing trend, although data for the last two years shows a decreasing trend. This well is within the influence of the SEPTS well field. Recently observed concentrations are similar to levels observed since 2009 and remain below this well's historical maximums.

- Two wells located in the far southeast lobe of perched groundwater (PTX06-1031 and PTX06-1034) are exhibiting increasing trends in RDX, likely due to plume movement into these wells. However, recent data indicate "No Trend" conditions.

- RDX was first observed at low concentrations in PTX06-1049 in 2011 and has since fluctuated at levels slightly above the GWPS. This well is located on the far western side of the perched aquifer, which is outside the influence of remedial action. These trends are likely due to groundwater flow from the Playa 1 vicinity.

- PTX06-1101 is located immediately downgradient of the Southeast ISB pilot study well field. RDX had been non-detect in this well since its installation in 2007 until 2014 and has been increasing since then. The increasing trend results from loss of treatment effectiveness in the ISB pilot area and concentrations returning to baseline conditions.

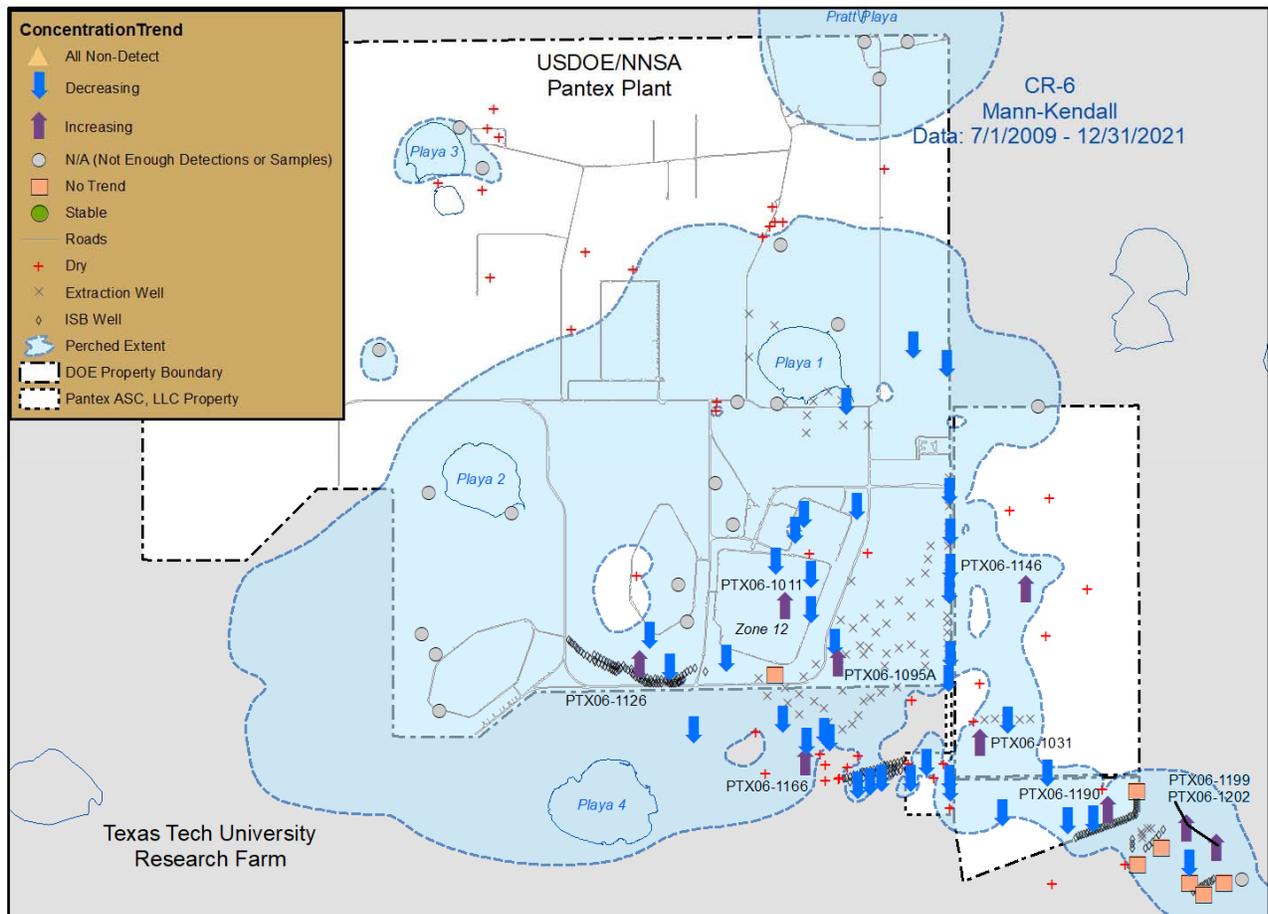
Figure 3-8. Hexavalent Chromium Trends in the Perched Aquifer

As depicted in Figure 3-8, the following nine perched aquifer wells are exhibiting increasing trends in hexavalent chromium below the GWPS since remedial actions began:

- An increasing trend was identified for PTX06-1011. This well is located within Zone 12, southwest of one of the hexavalent chromium source areas, at the former cooling tower. Historical concentrations in this well have fluctuated from slightly above the GWPS in the mid-1990s to less than the PQL. Concentrations in this well likely decreased after the SEPTS came online and, as flow conditions changed with the decline in saturated thickness in the perched groundwater, concentrations have fluctuated. The long-term trend for this well is decreasing, and recent concentrations remain below the GWPS. The identified increasing trend is partially the result of low-level detections and the use of one-half the detection limit in the trending but may also reflect the variable influence of the remedial actions and general plume movement in this area. Data for the last four samples indicate a decreasing trend.

- An increasing trend was identified for PTX06-1031, but concentrations remain far below the GWPS. Concentrations of total chromium, molybdenum, and nickel in this well have also fluctuated over the past several years; therefore, observed fluctuations in hexavalent chromium may be due to corrosion of the well's stainless-steel screen.

- PTX06-1095A is within the influence of the SEPTS well field but is also located less than 50 ft downgradient of the permeable reactive barrier (PRB) pilot study wells PTX06-PRB01A and PTX06-PRB02. Since 2013, detections have been highly variable. The increasing trend is likely due to the PRB losing treatment effectiveness and concentrations returning to baseline conditions. A decreasing trend was exhibited in the last four samples.

- An apparent increasing trend was identified for PTX06-1146; however, no trend was identified for the last four samples. Concentrations of total chromium in this well have also fluctuated over the past several years; therefore, observed fluctuations in hexavalent chromium may be due to corrosion of the stainless-steel screen of the well.

- An apparent increasing trend was identified for PTX06-1199; however, a decreasing trend was identified for the last four samples. All concentrations remain far below the GWPS.

- A probably increasing trend was identified for PTX06-1202; however, no trend was identified for the last four samples. All concentrations remain far below the GWPS.

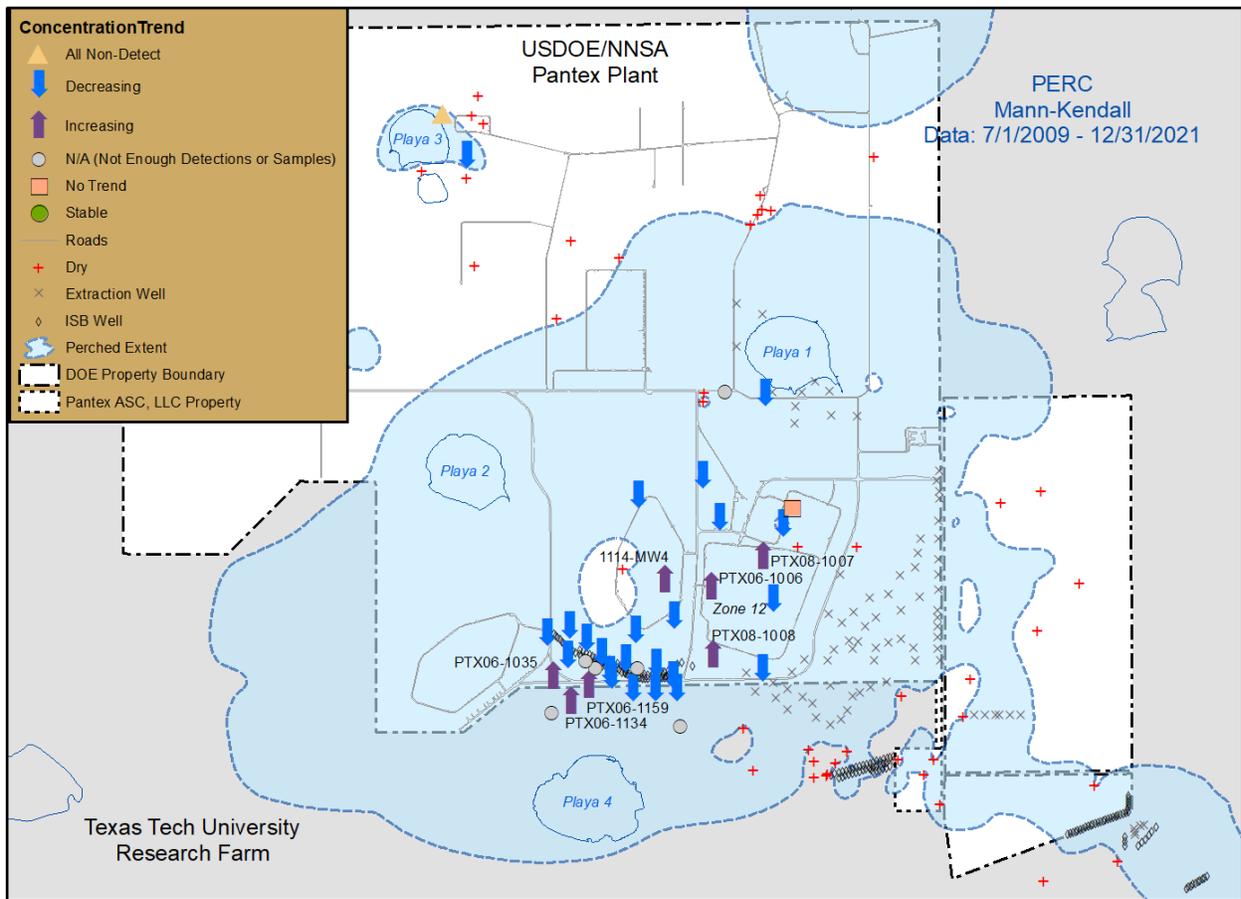
Figure 3-9. Perchlorate Trends in the Perched Aquifer

As depicted in Figure 3-9, seven monitoring wells are exhibiting increasing trends in perchlorate concentration:

- PTX08-1007 is exhibiting an increasing trend in perchlorate. Perchlorate has been detected below the PQL since 2014, and recent data do not indicate a trend.

- Perchlorate increased in PTX08-1008 from 2014 into 2017; however, perchlorate has been decreasing with fluctuations in this well since 2017. The variation in perchlorate in this well may be due to general plume movement to the southeast in this area, which may also be influenced by the SEPTS's operations.

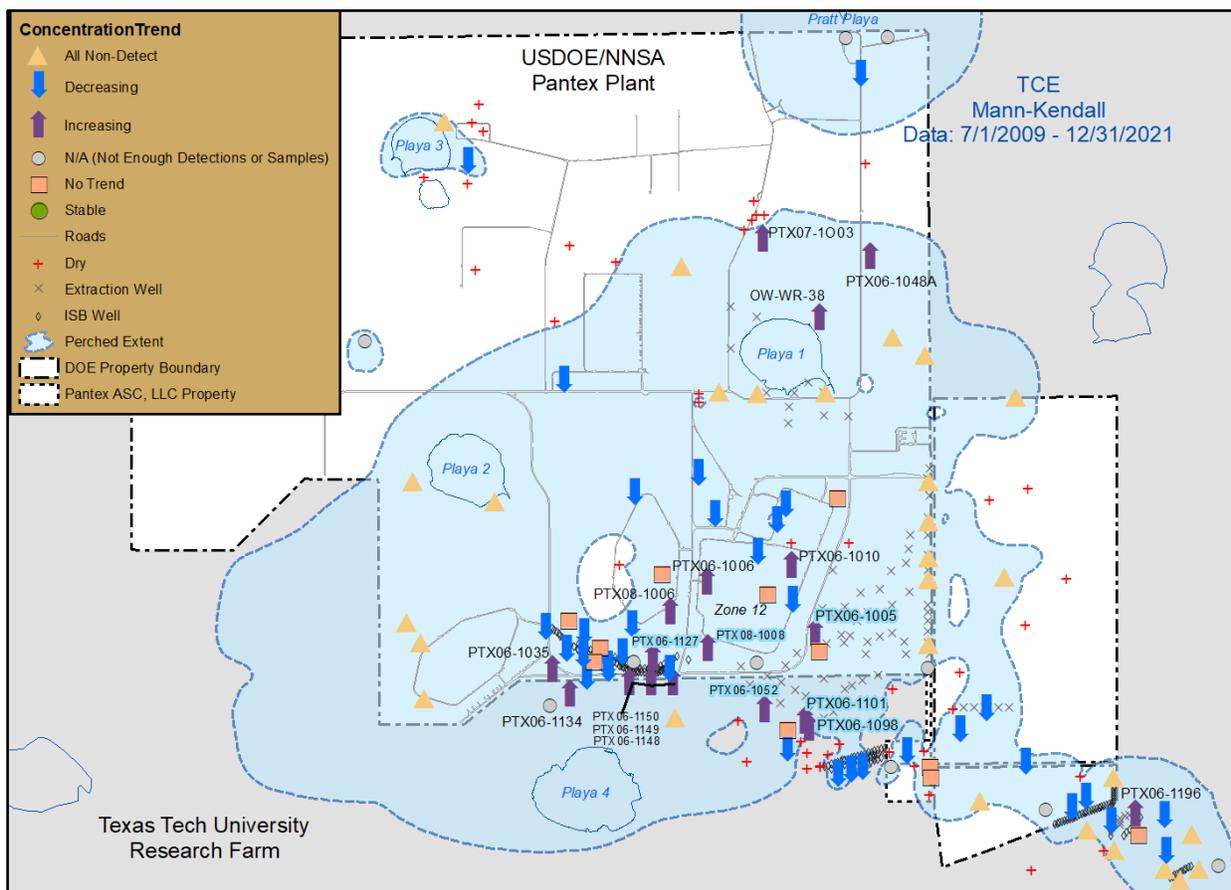
Figure 3-10. TCE Trends in the Perched Aquifer

As depicted in Figure 3-10, the following 18 monitoring wells are exhibiting increasing trends in TCE concentration since the start of remedial actions:

- TCE was below the GWPS in 2021 at PTX06-1196, downgradient of the Southeast ISB Extension. TCE has been detected below the PQL since 2018 and concentrations remain stable. Recent data do not indicate a trend.
- An increasing trend was identified for PTX07-1003, located north of Playa 1. This well has consistently measured values of TCE below the PQL since 2018. When trending all historical data, it exhibits a decreasing trend.
- TCE was above the GWPS in 2021 at PTX08-1008, located southwest of Zone 12. TCE has been detected above the PQL for a number of years, and recent data do not indicate a trend.

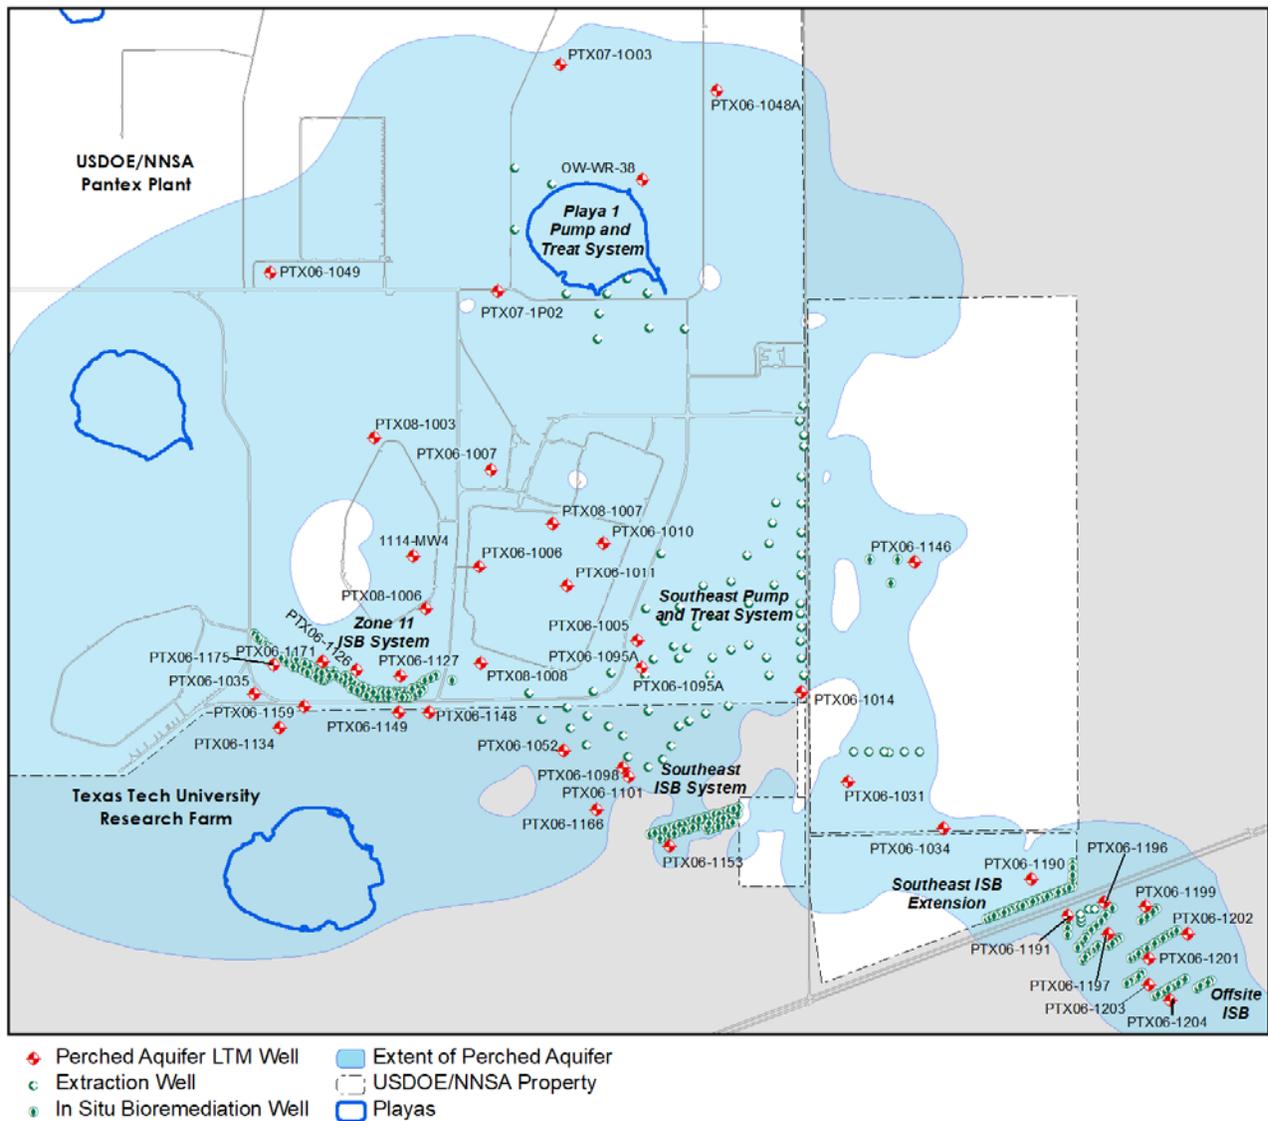
Figure 3-11. Perched Wells with Unexpected COC Trends

Of the 117 monitor wells with expected COC concentration conditions defined in the LTM Design Report, the 44 wells depicted in Figure 3-11 did not exhibit trends consistent with the expected conditions since the start of remedial actions. These wells were discussed in Section 3.1.4. Additional detail on all LTM wells is located in Appendix E, Table E-1.

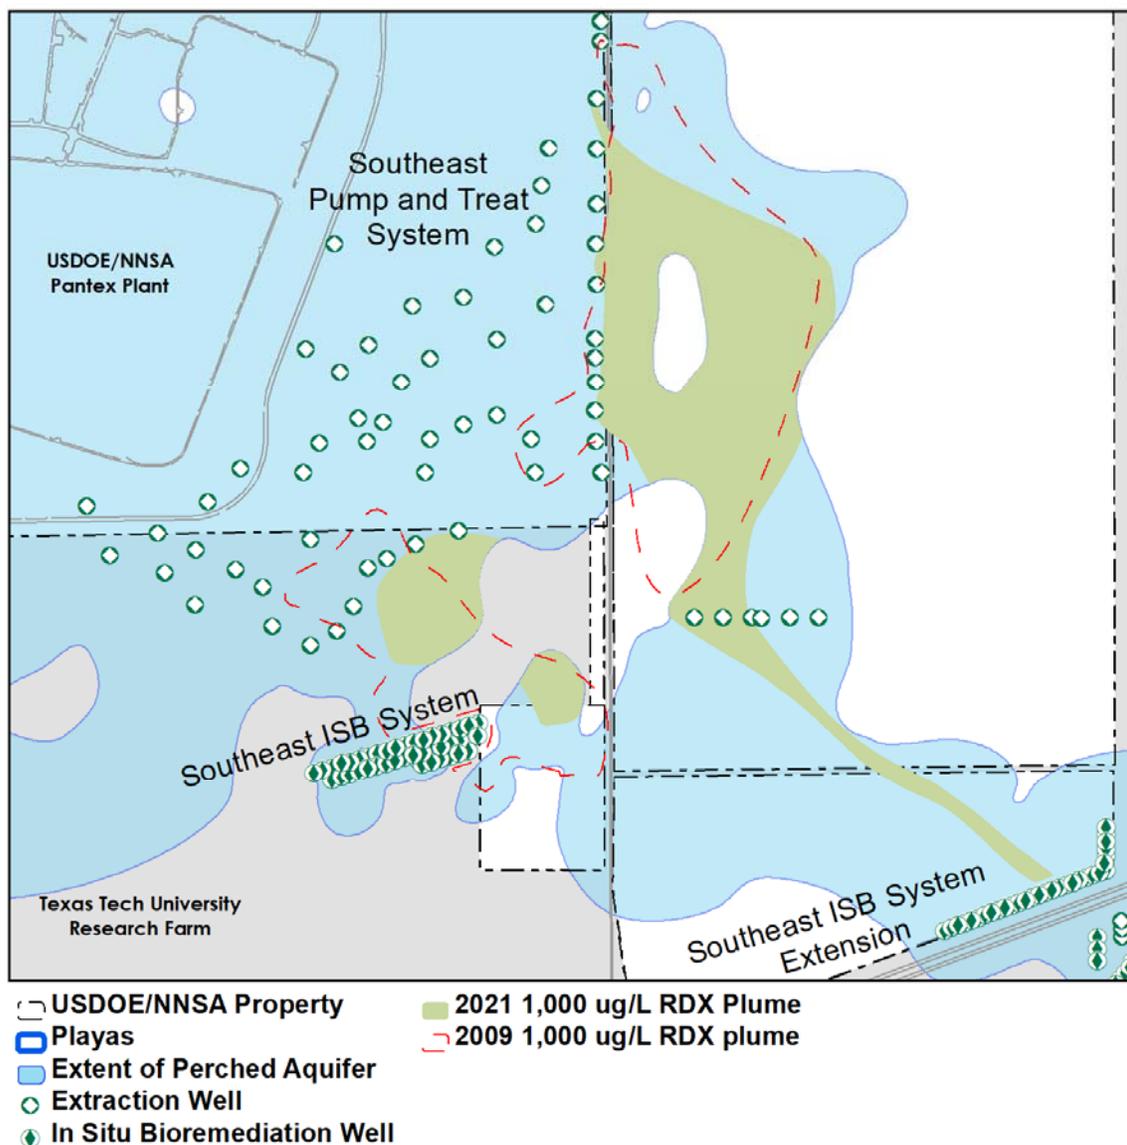
Figure 3-27. RDX Plume Movement, 2009-2021

As depicted in Figure 3-27, the 1,000-ug/L plume outlines have slightly shifted in the SEPTS well field and shifted to the southern and eastern edge of the perched aquifer extent. This is likely due to a combination of the SEPTS's operations and general plume movement in areas that are not under the SEPTS influence. For 2021, the RDX contour

has extended into the far eastern and southern lobe of the perched groundwater. This shift is the result of increases in RDX to above 1,000 ug/L at PTX06-1034, PTX06-1041, PTX06-1146, and PTX06-1190 coupled with recent additional investigation of the perched groundwater in this area. Movement of the plume in this area appears to be associated with faster groundwater flow paths along channel-type features on the top of the FGZ. Pantex determined the downgradient extent of the plume in early 2019 with the installation of six new wells to the southeast and, to intercept this plume as it migrates to the southeast, has completed a line of injection wells as part of an extension of the Southeast ISB remedy.
