Pantex Plant

2021 Annual Progress Report

Remedial Action Progress

In Support of Hazardous Waste Permit 50284 and
Pantex Plant Interagency Agreement

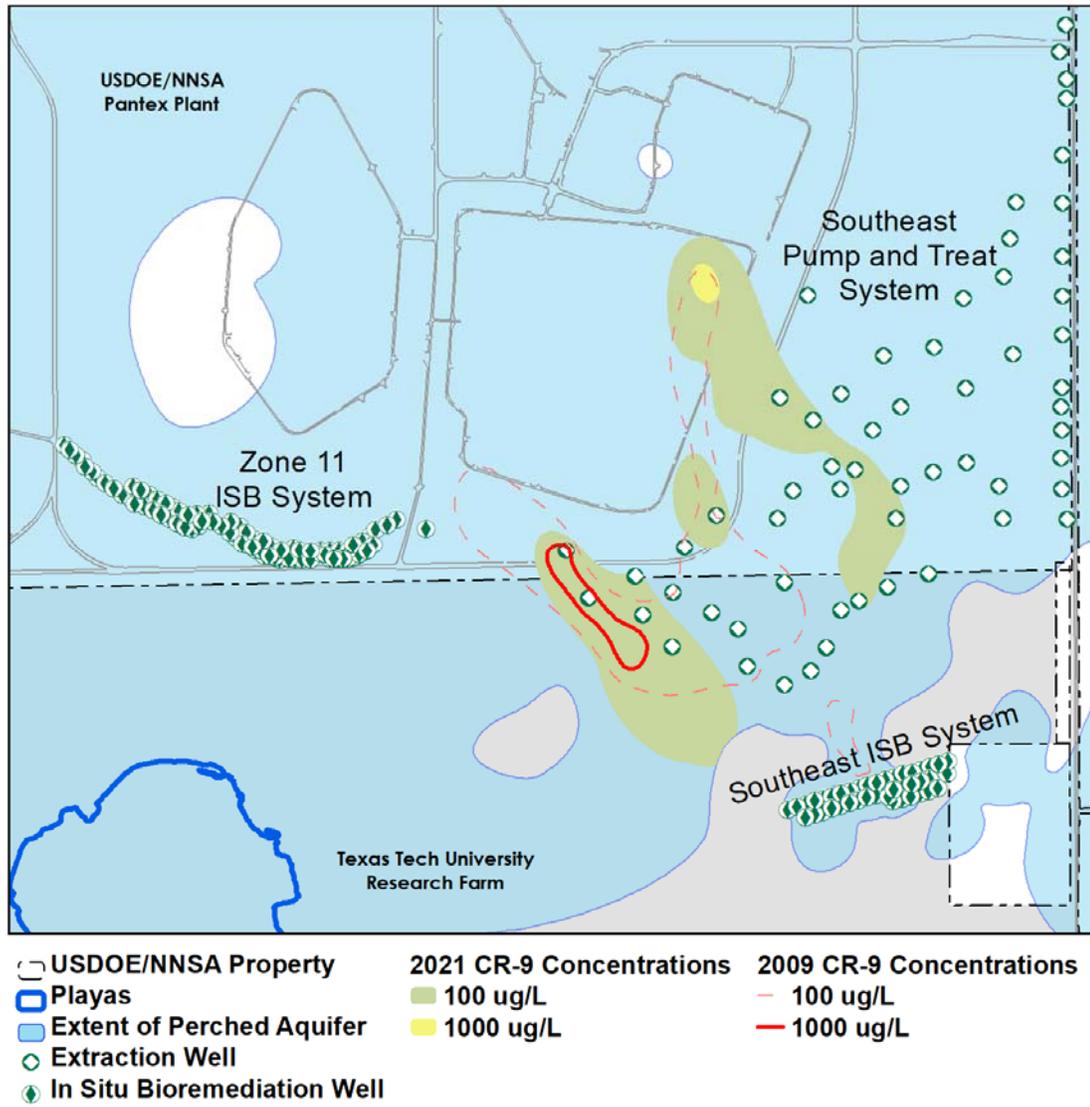
Figure 3-28. Hexavalent Chromium Plume Movement, 2009–2021

When compared with the 2009 hexavalent chromium maps (see Figure 3-28), the shapes are similar, with the following exceptions:

- The northern lobe of the plume has apparently shifted to the east, likely due to a combination of the SEPTS's extraction well pumping and reduction of injection in the area.
- The southern portion of the plume has apparently shifted southwest because of downgradient movement of chromium beyond the influence of the SEPTS.
- The smaller middle plume is a result of historical high injection rates that have pushed the plume to the southwest. This portion of the plume is expected to be captured by SEPTS.

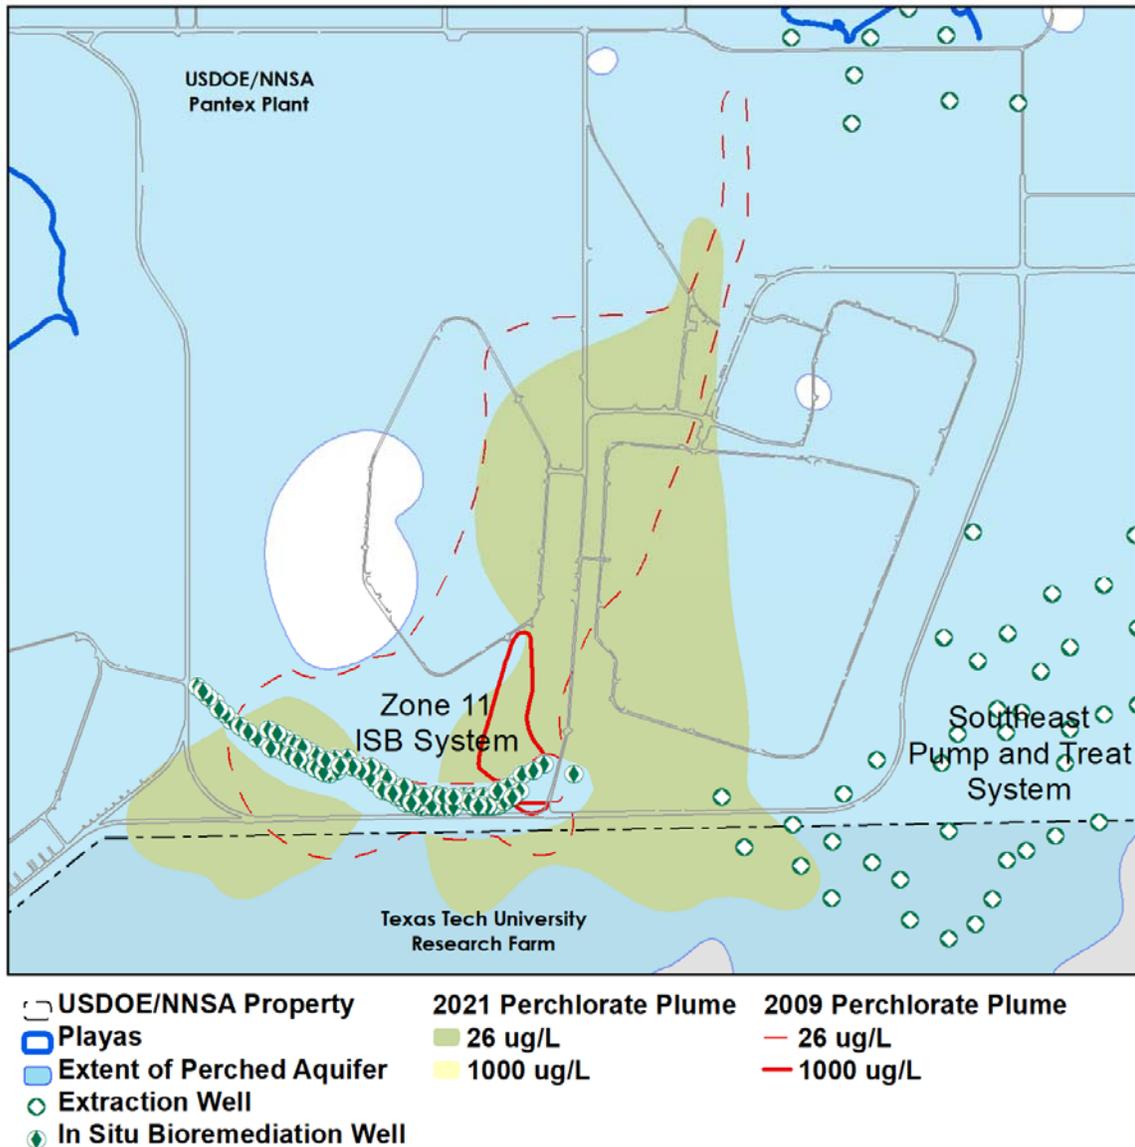
Figure 3-29. Perchlorate Plume Movement, 2009-2021

As depicted in Figure 3-29, the perchlorate plume shape is similar to the 2009 plume map, with the following notable exceptions:

The hydraulic gradient in the area between the southern parts of Zones 11 and 12 has shifted more eastward because of the influence of the SEPTS and the decline in perched water levels. This shift in the hydraulic gradient has allowed perchlorate to migrate east and southeast, with perchlorate moving into the SEPTS well field.

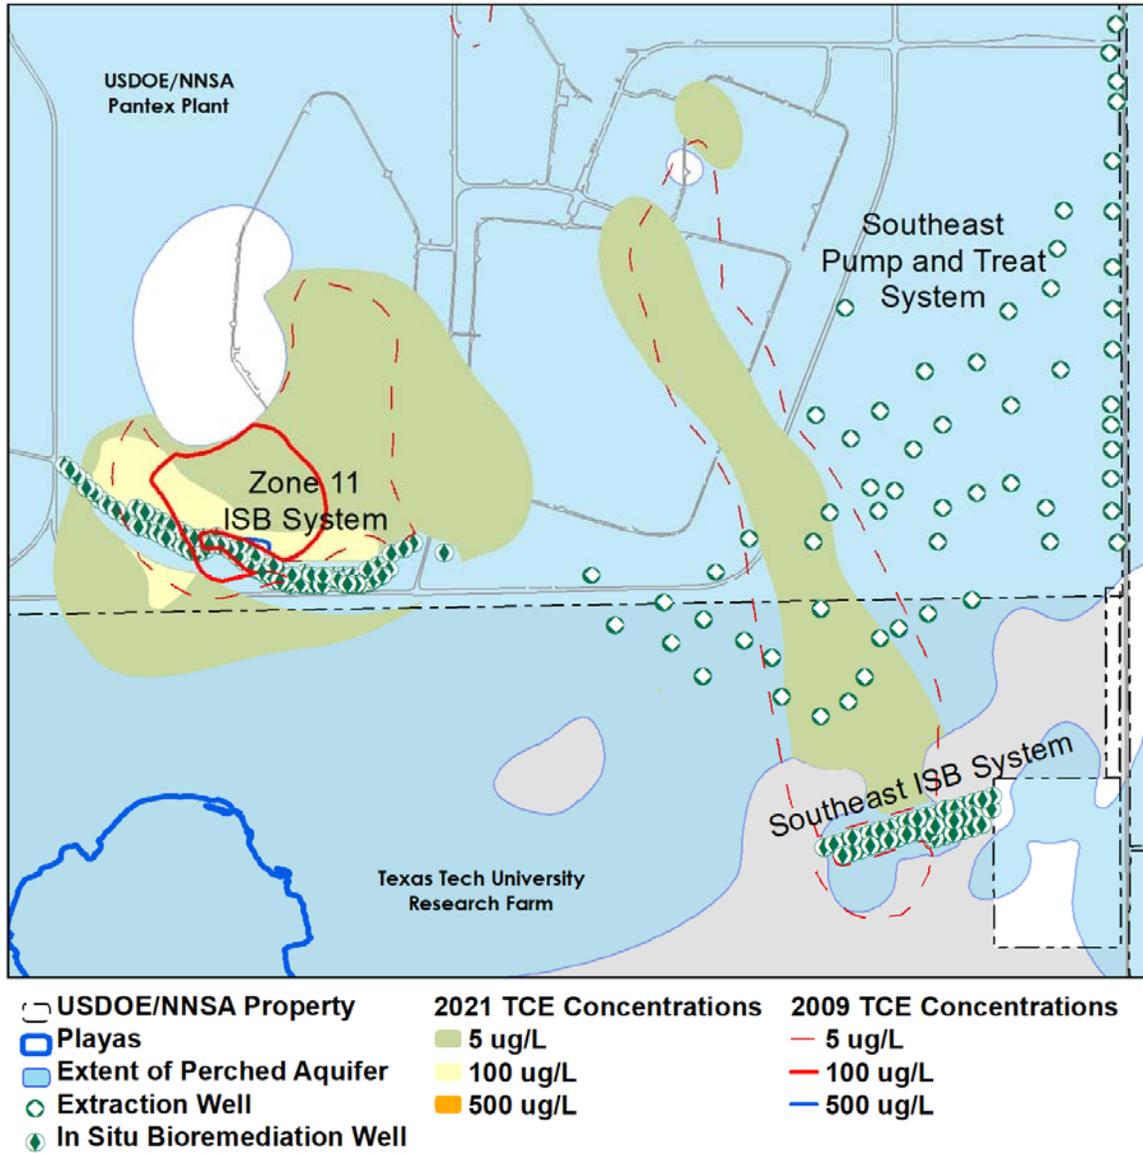
Figure 3-30. TCE Plume Movement, 2009-2021

As depicted in Figure 3-30, the 2009 and 2021 TCE plume shapes are similar, with the following notable exceptions:

- The plume originating from Zone 12 has contracted near this zone's source areas. However, the southern edge of the plume has shifted to the west due to data collected at monitoring well PTX06-1166 and decreasing TCE concentrations in the Southeast ISB's ISPM wells.
- The plume originating from Zone 11 has shifted to the south and west due to the area's general gradient and recently installed wells to the west. The TCE plume beneath Zone 11 continues to expand to the east as a result of the shifting flow gradients in perched groundwater.

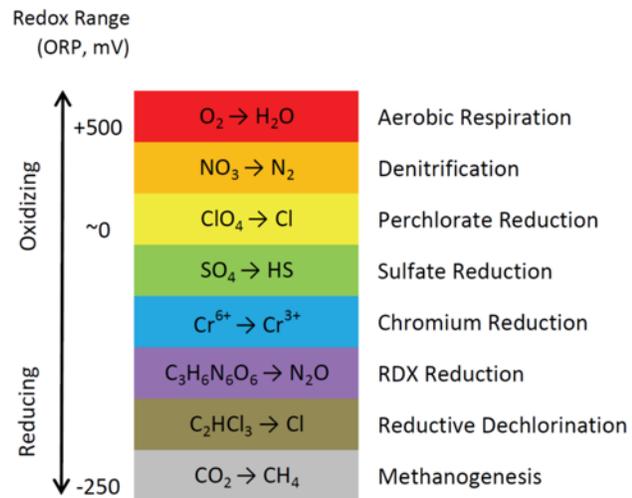
Figure 3-32. Typical Geochemical Redox Ranges

Geochemical conditions can be evaluated to determine if adequate reducing conditions exist to achieve reduction. Figure 3-32 presents the redox ranges for the reduction of various COCs. TCE and perchlorate are the primary COCs in the Zone 11 area while HEs, primarily RDX, and hexavalent chromium are the primary COCs in the southeast area. Perchlorate degradation does not require as strongly reduced conditions as RDX or TCE.

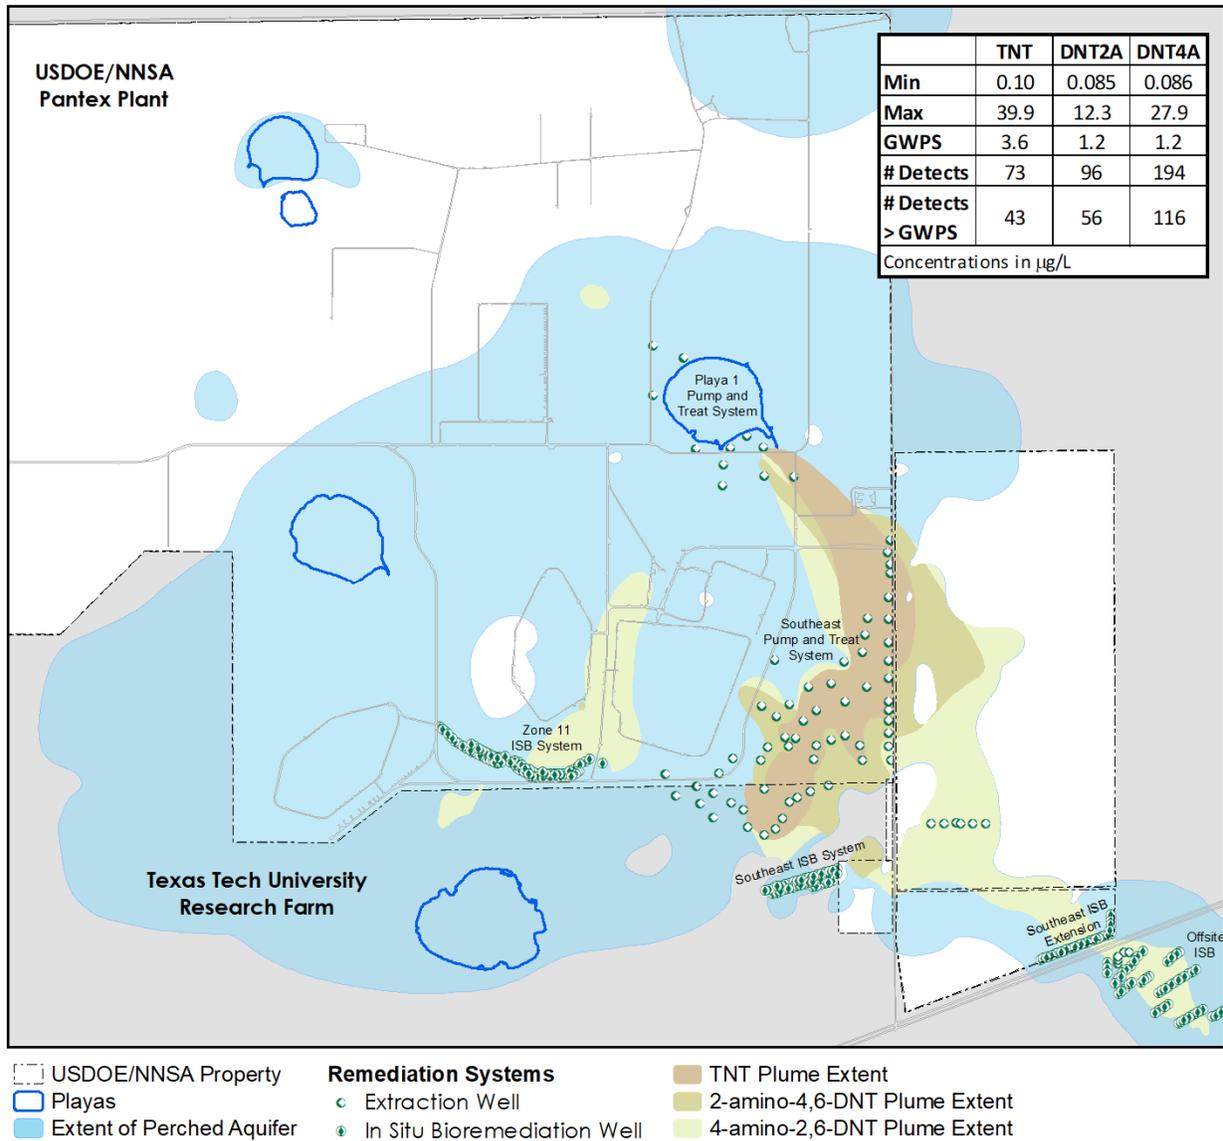
Figure 3-33. TNT and Degradation Product Plumes

Based on monitoring results for TNT and its breakdown products, DNT2A and DNT4A, TNT has naturally attenuated over time (see Figure 3-33). TNT has been manufactured at Pantex since the 1950s and, yet, is only present in the central portion of the overall southeastern plume, within the SEPTS well field and near Playa 1. The first TNT breakdown product, DNT2A, occurs near the TNT plume and extends slightly beyond.

The final monitored breakdown product, DNT4A, extends out to the edges of the perched aquifer saturation at low concentrations. Only TNT breakdown products are present in perched groundwater beneath Zone 11 and north of Playa 1. Concentrations of the breakdown products are still above the GWPS, but most wells with detections have recently shown decreasing or stable trends. A table of natural concentration ranges for wells outside the influence of the ISB systems is included in Figure 3-33.

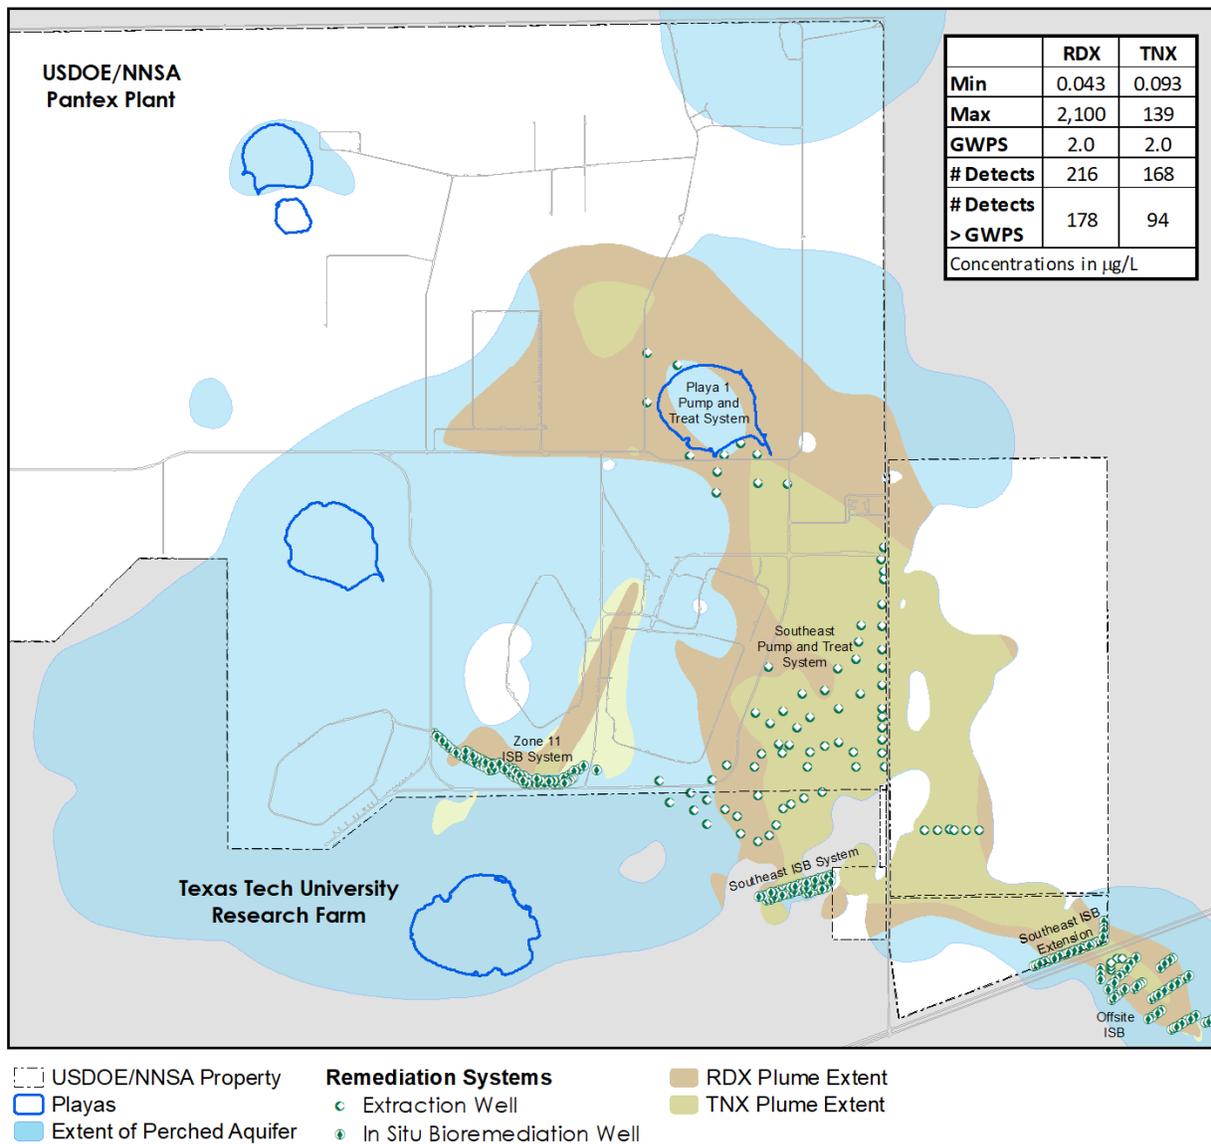
Figure 3-34. RDX and Degradation Product Plumes

Perched aquifer sampling results for RDX and breakdown products (i.e., MNX, DNX, and TNX) indicate that the breakdown products are present throughout most of the RDX plume, with TNX, the final degradation product, being the most widespread. If complete biodegradation of RDX were occurring, RDX and all breakdown products would be expected to decrease over time. Figure 3-34 depicts the overall RDX and TNX plume as well as a table of concentration ranges for wells outside the influence of the ISB systems.

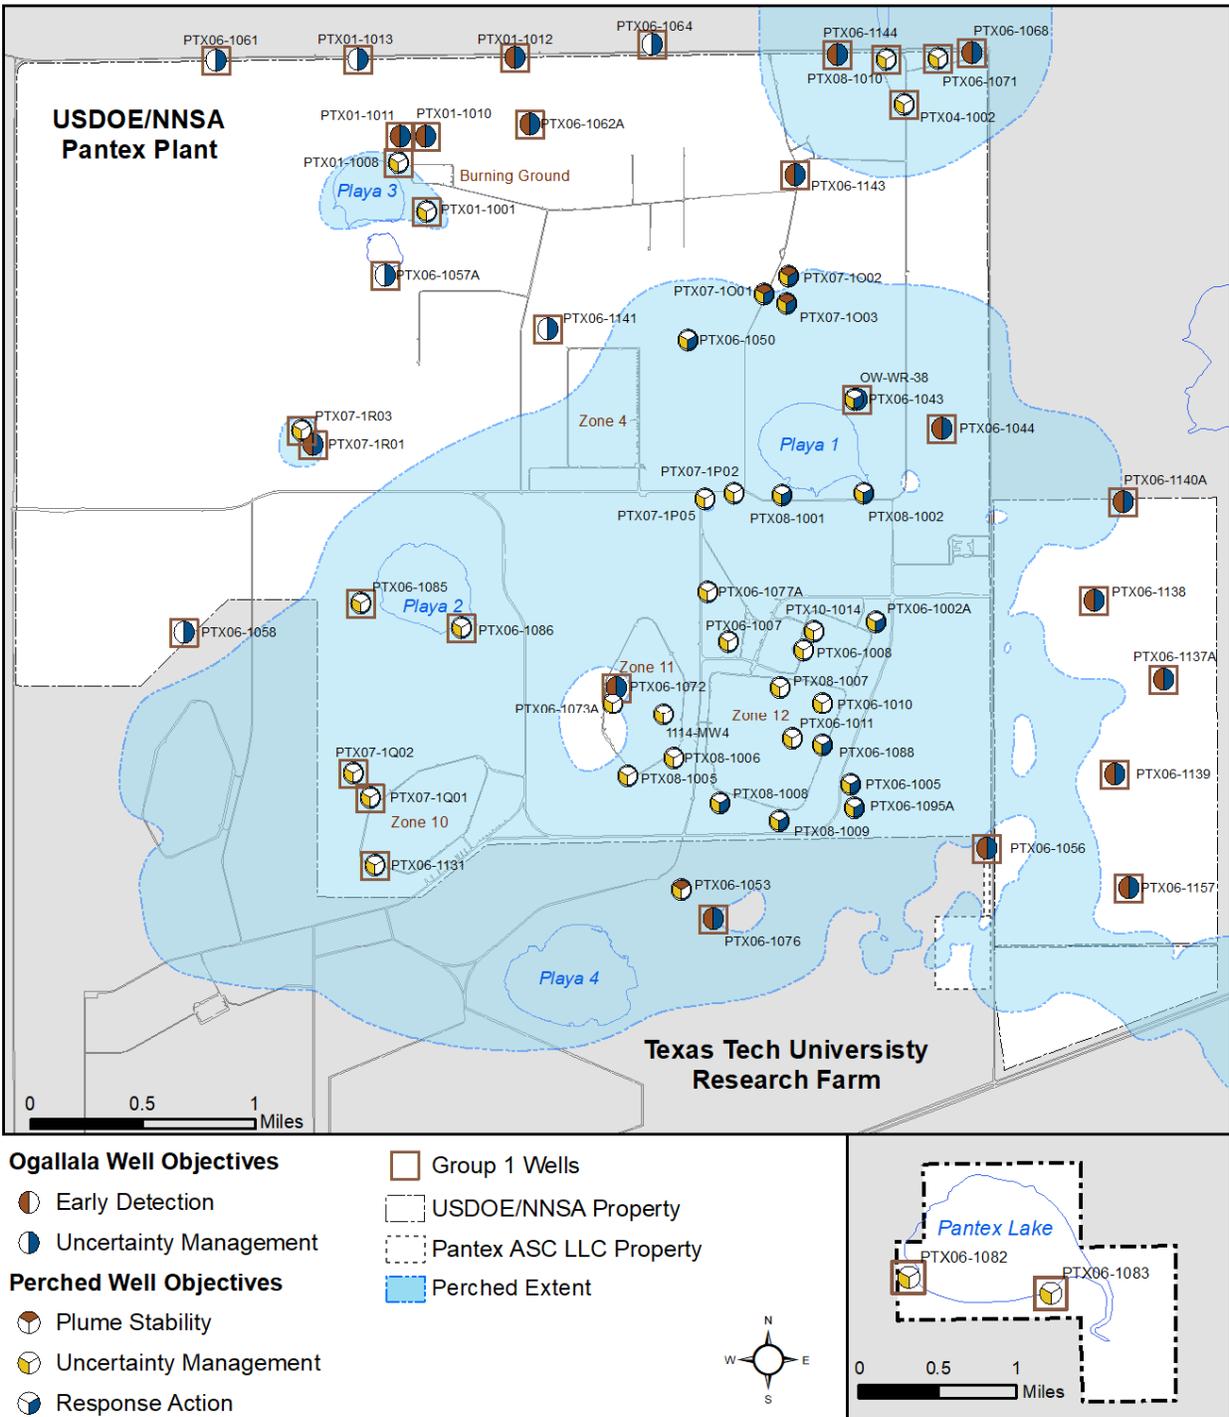
Figure 3-35. Uncertainty Management and Early Detection Wells

This report focuses on subsets of the uncertainty management/early detection wells, as depicted in Figure 3-35. The wells are evaluated with respect to the following groups:

- **Group 1:** 37 locations (designated by boxes in Figure 3-35) where contamination has not been detected or confirmed, or previous plume locations where concentrations have fallen below the GWPS, background, or PQL (e.g., Burning Ground and OSTP areas). These are typically Ogallala Aquifer wells, although some perched aquifer wells are located in areas without active groundwater remedial actions. These wells were evaluated in the quarterly reports.
- **Group 2:** 27 uncertainty management wells (all other wells in Figure 3-35) near groundwater contamination source areas. This group is established to confirm that source strength and mass flux are decreasing over time. Every five years, these wells are also evaluated for new COCs from source areas.

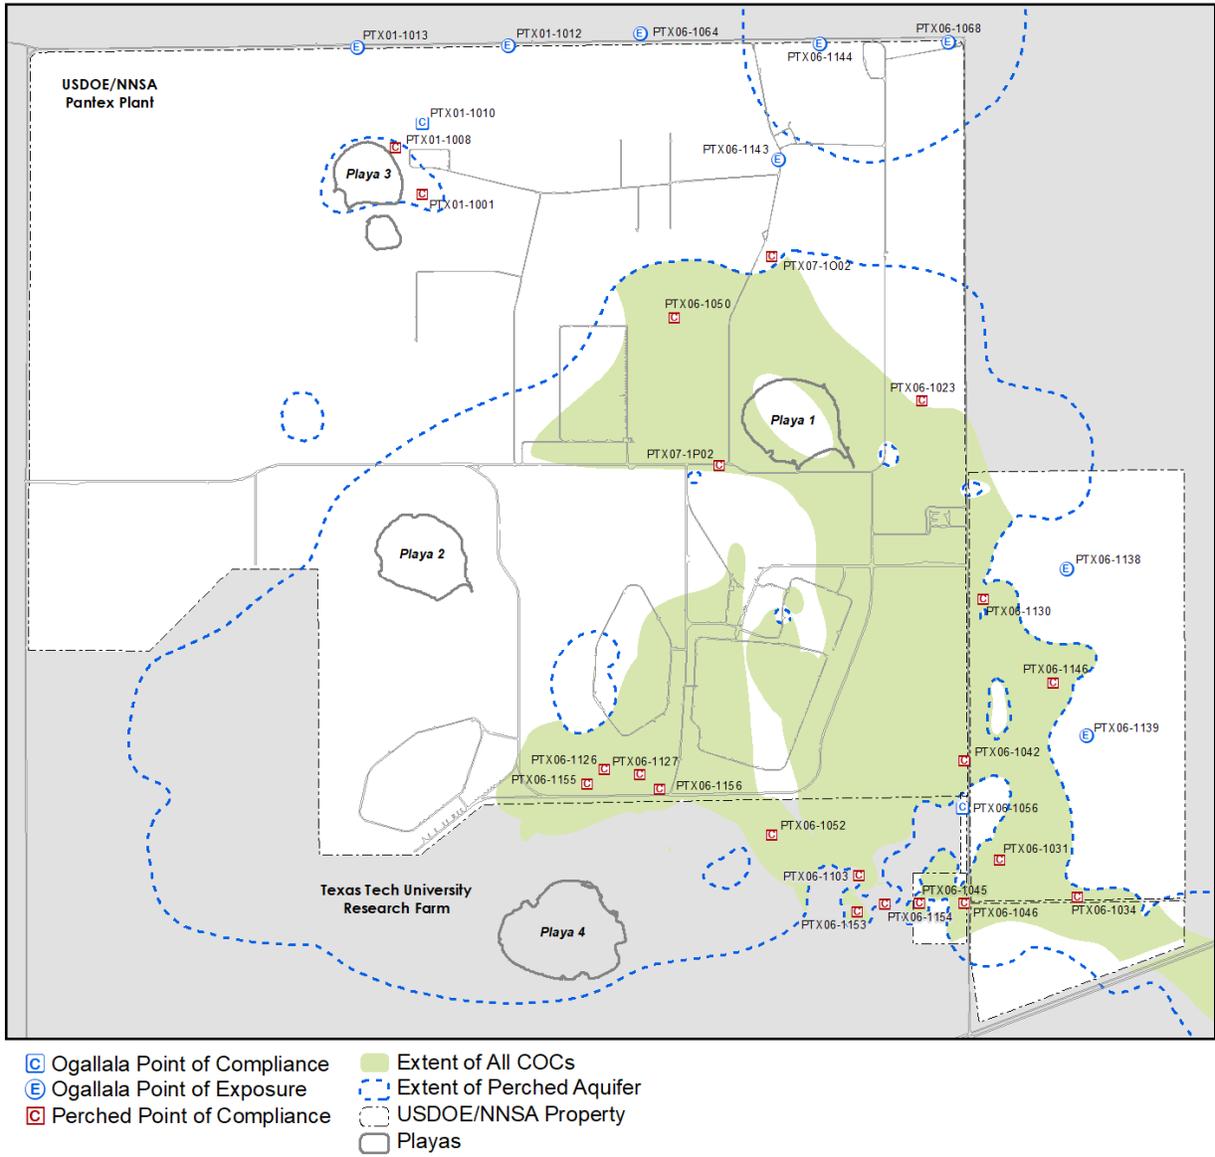
Figure 3-36. POC and POE Wells

The remediation program must continue until the POC and POE wells are compliant with the GWPS. The POC and POE wells approved in HW-50284 are depicted in Figure 3-36. All but two POC wells are in the perched aquifer. All POE wells are in the Ogallala Aquifer and are not expected to exhibit detections of organic COCs or detections above background values for inorganic COCs.

- ❖ 21 perched aquifer POC wells, with 15 exceeding the GWPS.
- ❖ 2 Ogallala Aquifer POC wells, with no GWPS exceedances.
- ❖ 8 Ogallala Aquifer POE wells, with no GWPS exceedances.

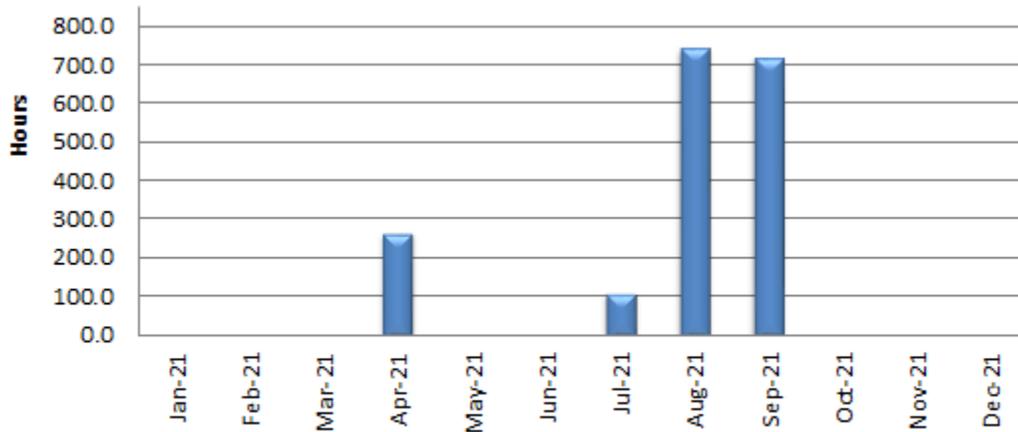
Figure 4-1. SVE system operational hours in 2021

Figure 4-1 depicts the operation of the SVE. The system was operated at 100% in April until the recirculation pump failed and then operated 100% during the next operational period.

The Burning Ground SVE system operated during April, July, August, and September, with an operational rate of 21%, or about 1834 hours of operation. A pulsing plan was implemented in 2021. However, the system was negatively impacted by a recirculation pump failure in April and was shut down until repairs were contracted and completed. The system was operated from late July through September and then shut down for the next pulsing period to prepare for operation at the first of 2022.

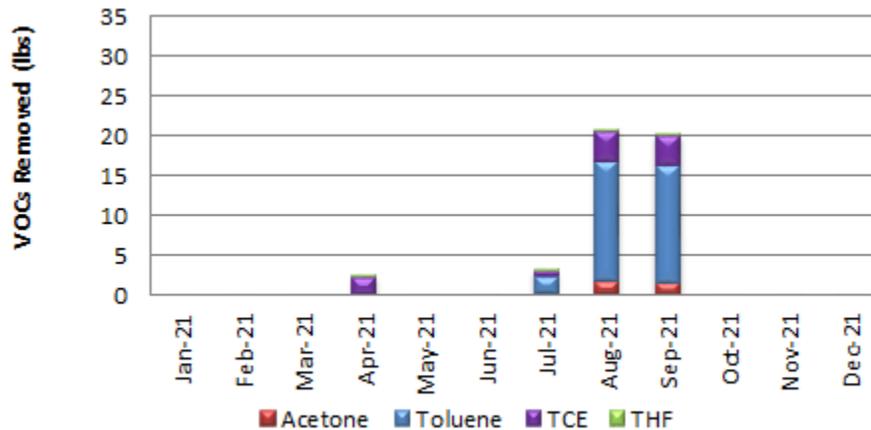
Figure 4-2. SVE System 2021 VOC Removal

Figure 4-2 shows the mass of the four highest VOC compounds (i.e., acetone, toluene, TCE, and tetrahydrofuran [THF in the figure]), removed each month of 2021. The hourly VOC removal rate has declined significantly since 2017. Data in 2021 indicated the greatest drop since the system began operating.

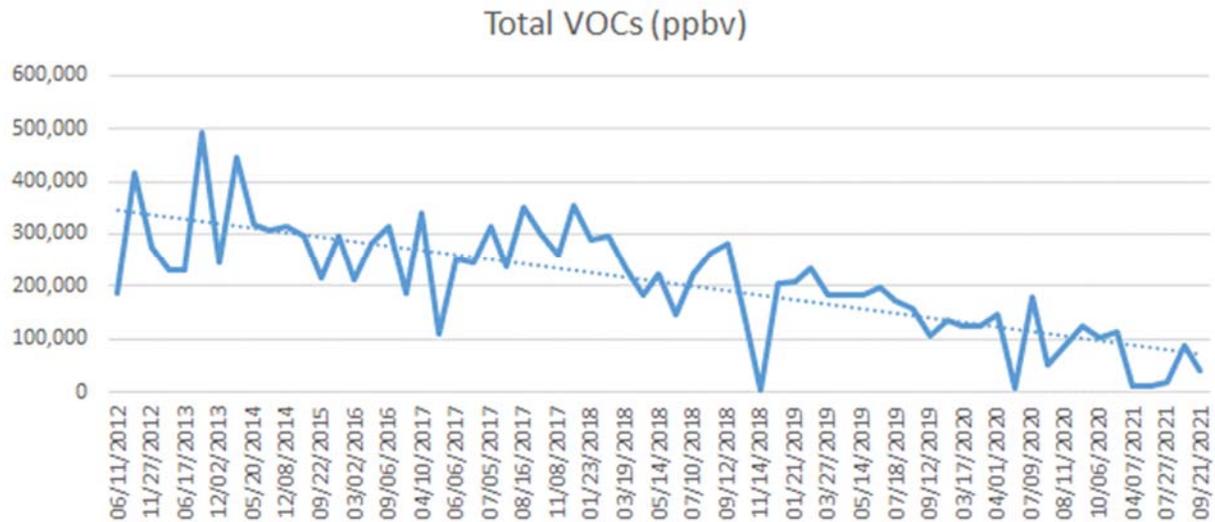
Figure 4-3. Total VOCs Since Installation of Current CatOX System

Concentrations were also evaluated to determine whether concentrations would increase after a long pause in operations. Samples collected in 2021 are indicating that a low total VOC concentration is observed at start-up (13 ppmv in April and 18 ppmv in July), even though the system was shut down for four months. With continued operation, concentrations increased slightly, remaining below 100 ppmv, then dropping off again in a short period of time. This also demonstrates the source at SVE-S-20 is significantly depleted. A small nearby source may be indicated by the rise in concentrations over time, but the data indicate that those concentrations also decline quickly, suggesting a minor source that is also near depletion. Total VOC concentrations since the installation of the current system are depicted in Figure 4-3.

The drop in influent concentrations, mass removal rates, and declining influent PID measurements (Figure 4-3) appears to indicate that the system has reached a point where the residual NAPL mass will not be effectively treated through the system's continued operation. Pantex will continue through two more pulsing events in 2022 to verify the data. Pantex anticipates recommending closure of this system in the upcoming HW-50284 renewal application that will be submitted in 2023. The SVE system has removed approximately 21,270 lbs of VOCs from soil gas and residual NAPL in the SEP/CBP area and has successfully mitigated the potential vertical movement of VOCs to groundwater.

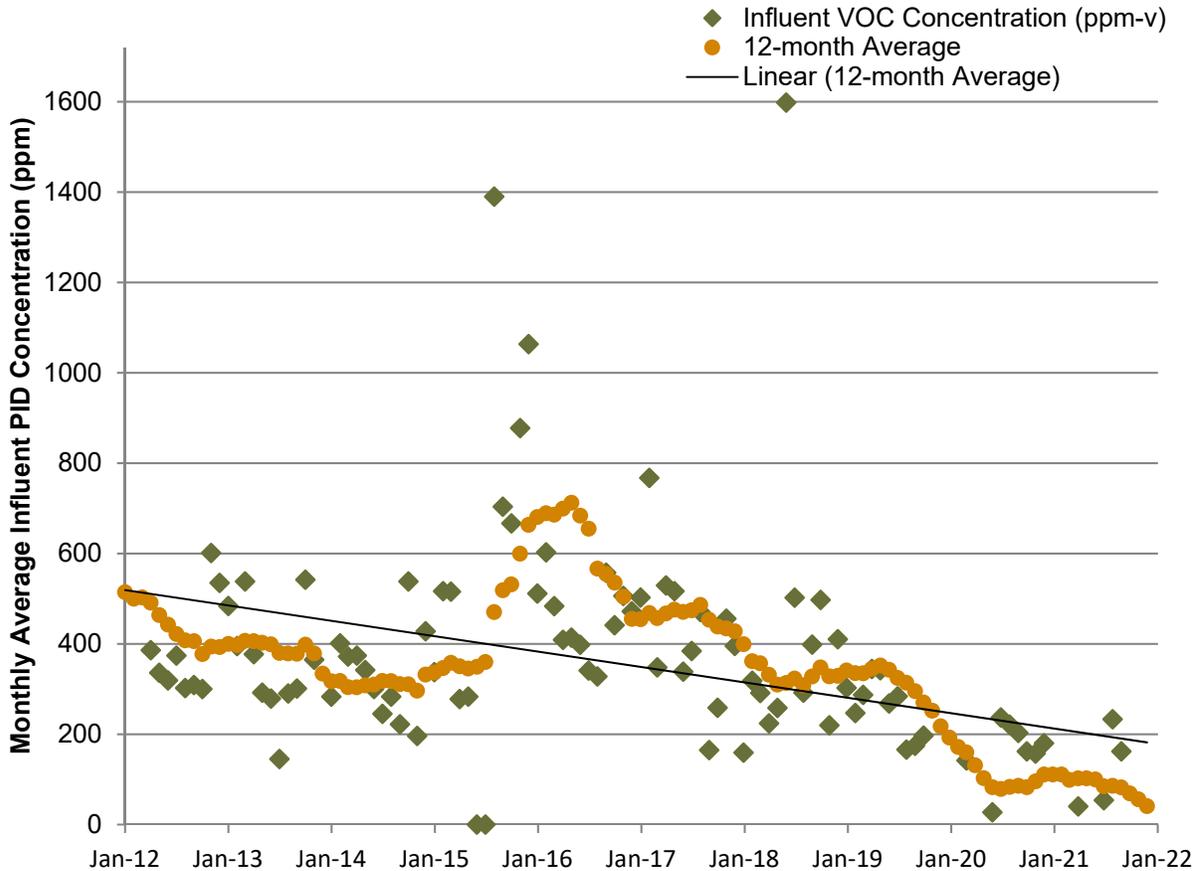
Figure 4-4. Influent Average PID VOC Concentrations vs. Time

The average monthly PID measurements collected at the system influent, summarized in Figure 4-4, show some variability, but 2021 monthly averages ranged between approximately 40 to 233 ppm. The orange circles on the chart show the 12-month rolling average, which illustrates a strong decline in average concentrations since the system modification in mid-2017. Two very high PID readings in June 2018 that were determined to be unrepresentative were omitted from the 12-month averages. Through the third quarter of 2021, average PID readings were lower than observed since the small-scale system began operating in 2012. The observed decline in influent PID readings was expected and indicates NAPL source depletion.
