Pantex Plant

2023 Annual Progress Report

Remedial Action Progress

In Support of Hazardous Waste Permit 50284 and
Pantex Plant Interagency Agreement

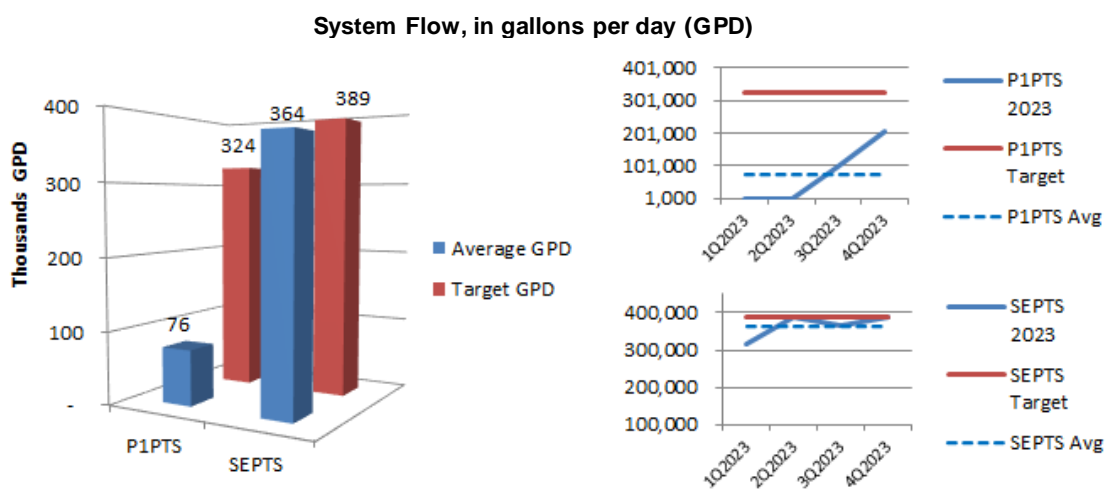
Fig. E-1. Pump and Treat System performance.

The 90% goal is applicable for the SEPTS during most of 2023, after treatment goals were revised. In accordance with the new goals, P1PTS could not be operated at times due to limited outlets for treated water. SEPTS is fully operated at all times unless there are severely limited treated water outlets. SEPTS provides the primary capture and control of the plumes that are moving to the southeast; therefore, goals have been redefined to ensure this system consistently operates.

The P1PTS was heavily impacted by the shutdown for tie-in to the new pivot irrigation system. The system was tied in by the end of August when the new pivot irrigation system started operating. Although water was still limited to the WWTF through 2023, SEPTS was able to operate fully through most of the year due to the shutdown of P1PTS, and P1PTS was able to operate by sending treated water to the new pivot system once the system was operational.

P1PTS operation was affected in December 2023 when the pivot irrigation system was shut down due to a break at the wet well. Because WWTF treated water is now routed to Playa 1 due to limited storage capacity resulting from ongoing lagoon repairs, and release to Playa 1 is limited by permit, the P1PTS was shut down.

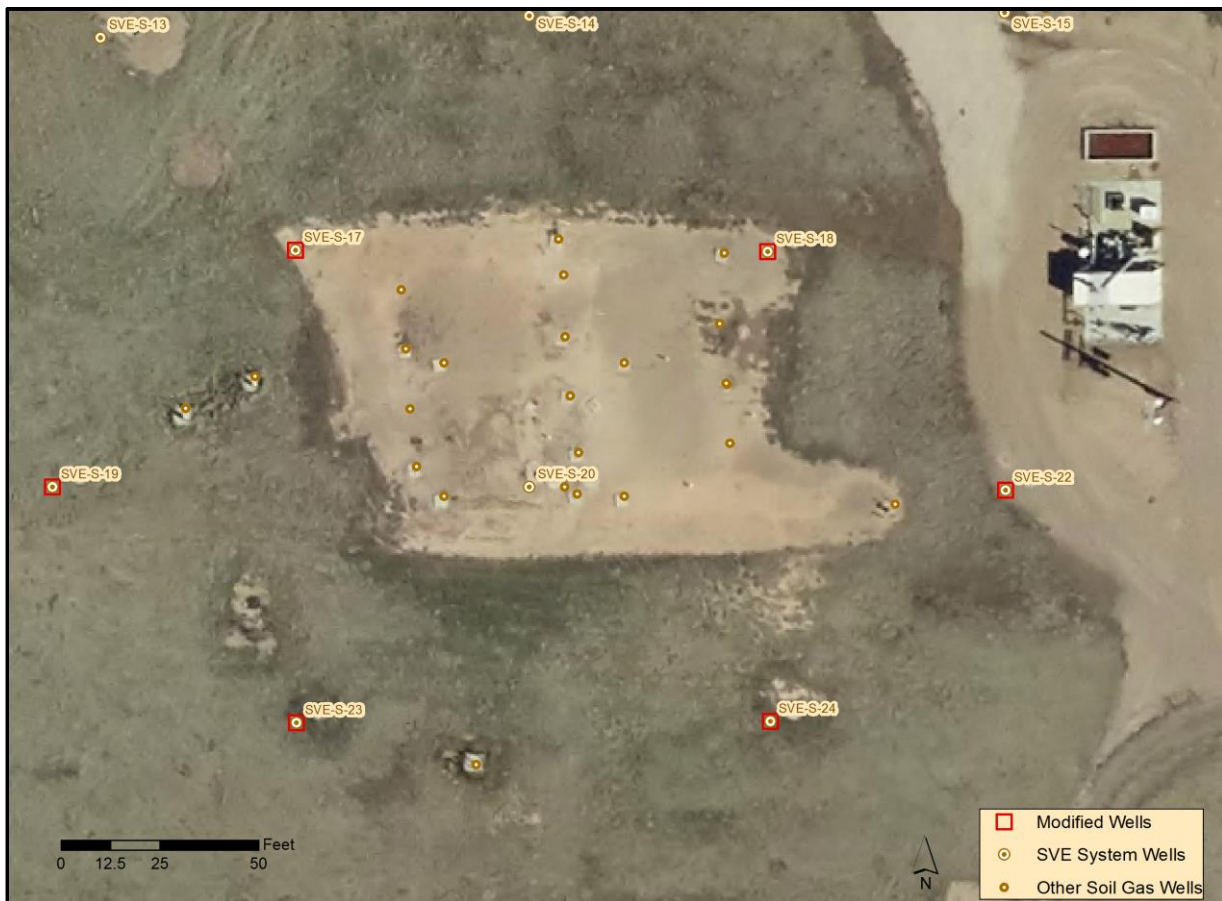
Fig. 1-4. Burning Ground SVE System wells and modifications.

The system was modified in May 2017 to increase air flow through the area surrounding SVE-S-20 and promote increased volatilization and bioremediation of the remaining soil NAPL. Six wells surrounding SVE-S-20 were modified to include aboveground piping that would allow airflow through the wells while the system is operating and pulling air from SVE-S-20 (see Fig. 1-4). Pantex increased influent flow to the SVE by 40% from 32 standard cubic ft per minute (scfm) to approximately 45 scfm, close to the maximum design flow of 50 scfm. To gain baseline information, Pantex also increased monitoring and evaluation of influent air to the SVE system and of the individual wells that were modified. The evaluations, presented in Section 4, helped provide a path to closure of the Burning Ground SVE. Pantex requested closure of the system in the report *Draft Final Burning Ground Soil Vapor Extraction System Closure Report* (Pantex, 2023). The TCEQ and EPA approved the closure report in December and October 2024, respectively. Pantex has requested the removal of the SVE system in the renewal application for HW-50284. Pantex does not plan to operate the system after 2023, although groundwater monitoring will continue for a period of time to evaluate the long-term effectiveness of the removal.

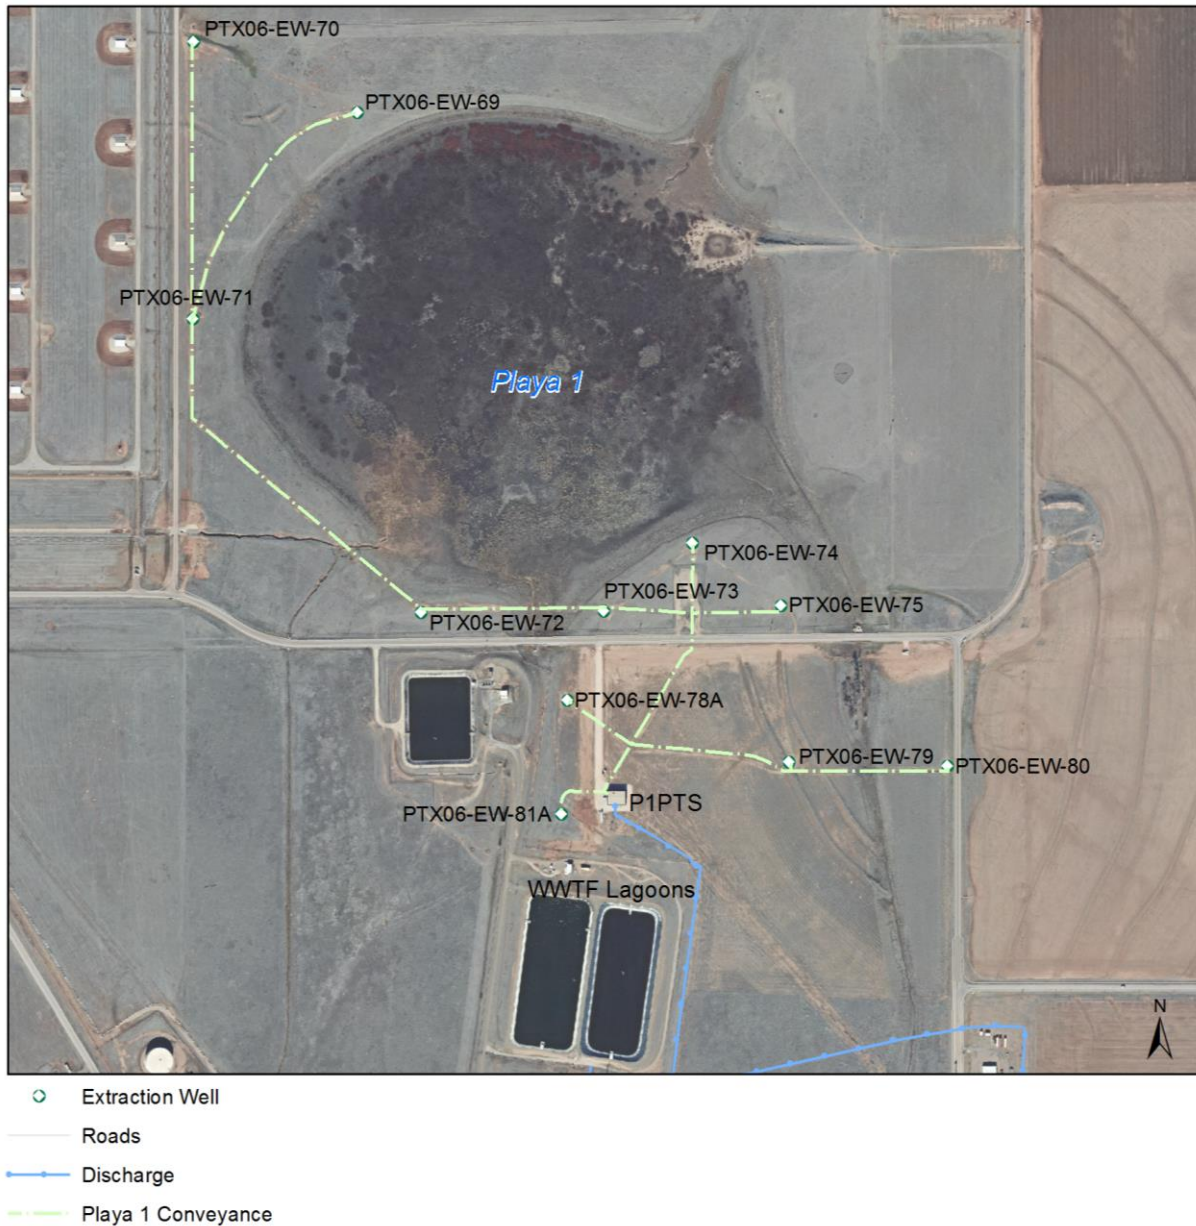
Fig. 1-6. P1PTS wells and conveyance lines.

This system consists of a treatment building and 11 extraction wells that treats small amounts of HEs and volatile organics such as trichloroethene (TCE). Boron is treated using an ion exchange vessel to concentrations below 500 micrograms per liter (ug/L) when the water will be used for irrigation purposes. In 2023, Pantex evaluated perched groundwater at P1PTS for the presence of per- and poly-fluoroalkyl substances (PFAS). PFAS were discovered at low concentrations. All PFAS concentrations are below the current promulgated Texas Risk Reduction Program residential protective concentration limits (PCLs). However, the PFOA and PFOS detected in the P1PTS influent water exceeds the newly promulgated MCLs. The current P1PTS GAC treatment is removing PFAS, along with the high explosives. Since the primary focus of this system is to remove water, only small amounts of COCs are removed during the treatment process as high explosive concentrations have greatly declined in groundwater beneath Playa 1. Fig. 1-6 Fig. 1-12 depicts the P1PTS wells and conveyance.

The P1PTS was completed in 2008 with operations starting in September 2008. This system extracts water from 11 wells near Playa 1 (see Fig. 1-6) and treats the water through a series of GAC beds and ion exchange process units to reduce HEs and metals below the GWPS established in HW-50284 and the ROD. The objective of this system is to achieve mass removal and reduce the mound of perched groundwater associated with Playa 1, which affects the movement of the Southeast Plume by reducing the hydraulic head.

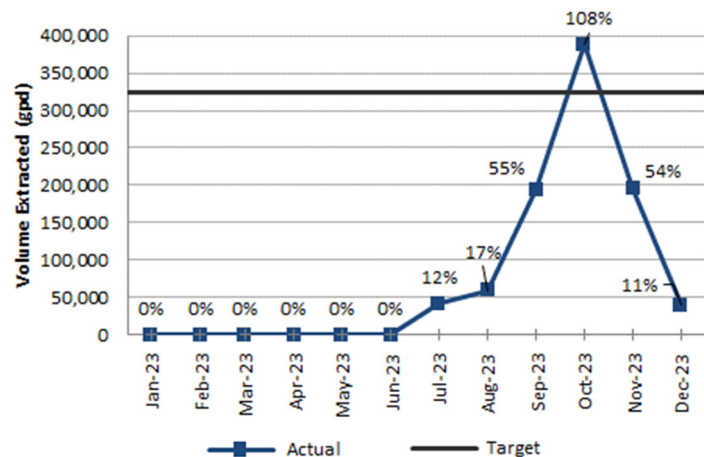
Fig. 2-4 reflects the P1PTS overall system efficiency considering system and well operation. The system treated an average of about 152,300 gpd when operating during 2023, which is approximately 42% of design capacity. The gpd is affected by system operational time, ability to extract water from the wells, and reduced flow to the WWTF and irrigation system. The system treated approximately 28.2 Mgal during 2023, with an average treatment volume of about 4.7 Mgal per month when operating.

Fig. 2-4. P1PTS average GPD and % capacity.

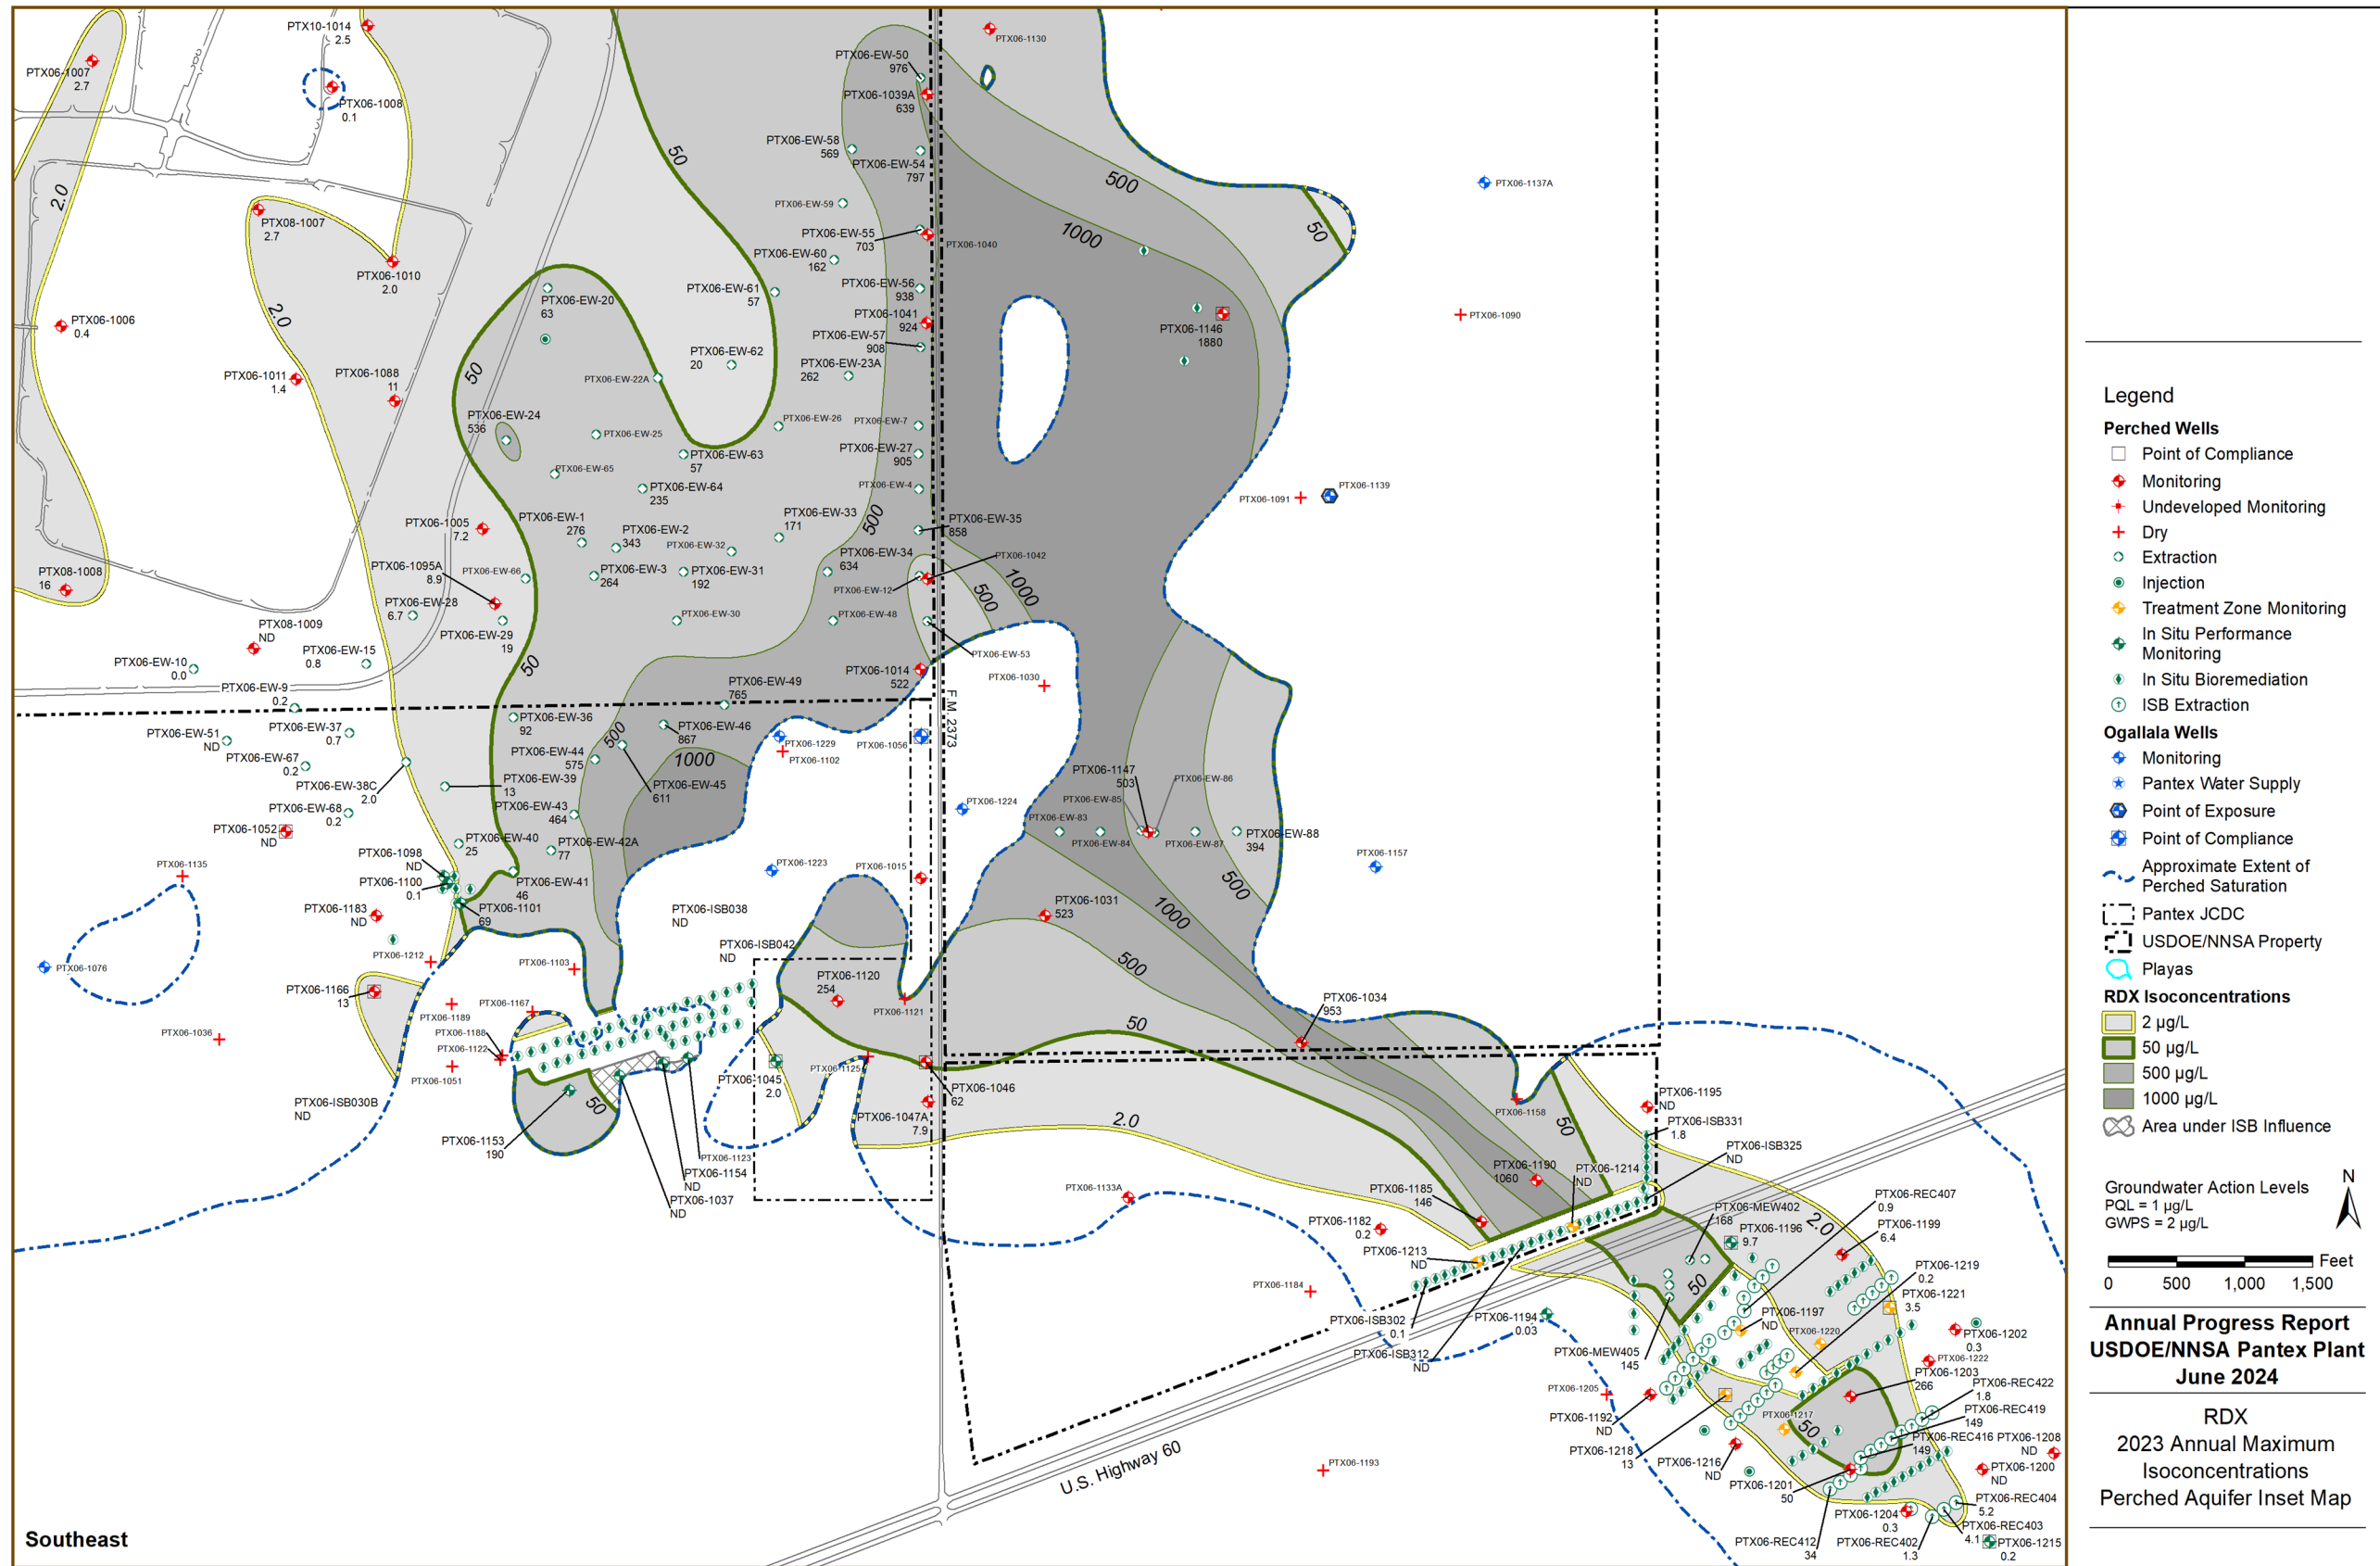
Fig. 3-13. RDX isoconcentration southeast inset map.
